ASBESTOS INSPECTION REPORT

**1017 Shakespeare Ave.
Dayton, OH 45402**

Re: Asbestos Inspection
1017 Shakespeare Ave.
Dayton, OH 45402

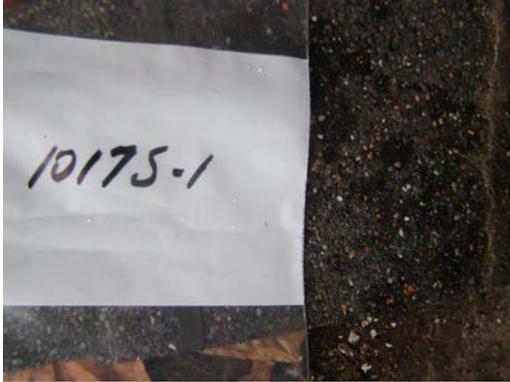
Photo 1: Roof Shingle (1017S-1) Exterior.
No Asbestos Detected.

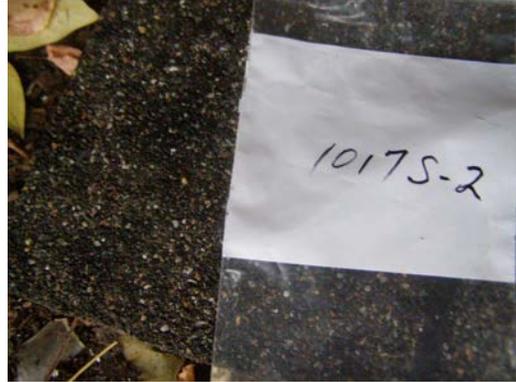
Photo 2: Roof Shingle (1017S-2) Exterior.
No Asbestos Detected.

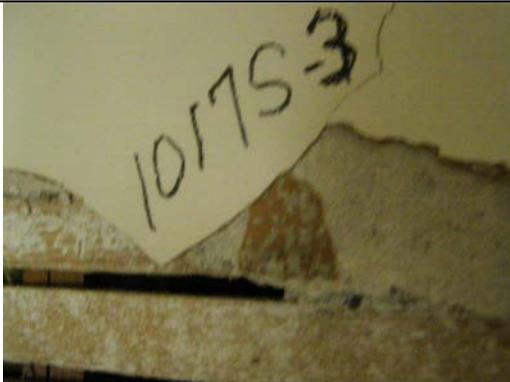
Photo 3: Plaster (1017S-3) Living Room, Wall C.
No Asbestos Detected.

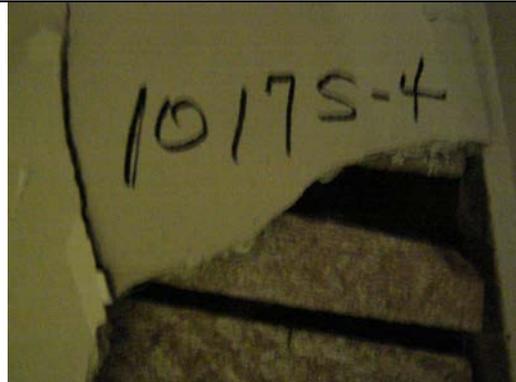
Photo 4: Plaster (1017S-4) Dining Room, Wall A.
No Asbestos Detected.

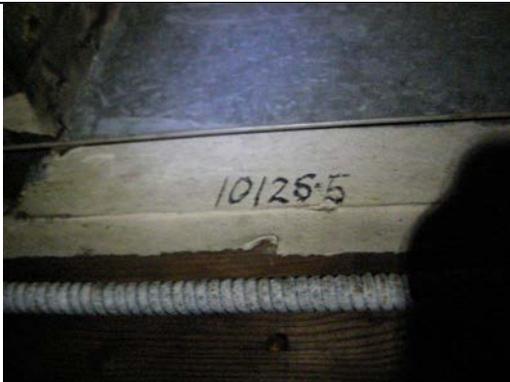
Photo 5: Seam Tape (1012S-5) Basement, Ceiling.
45% Chrysotile Asbestos Detected

Confirmed or assumed asbestos-containing materials, which will be disturbed during demolition activities, are regulated under current Federal and State regulations. Hart Environmental Resources recommends the removal of these materials by a licensed asbestos abatement contractor. It is also strongly recommended that the specifications for the removal program be developed by a licensed Asbestos Project Designer to ensure that all regulatory requirements are satisfied. The work should be properly documented in the event of future litigation.

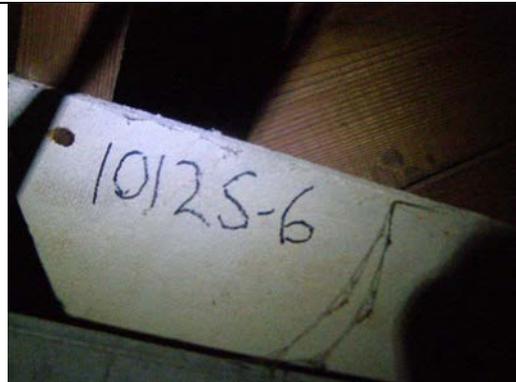
Photo 6: Furnace Board (1012S-6) Basement, Ceiling.
65% Chrysotile Asbestos Detected

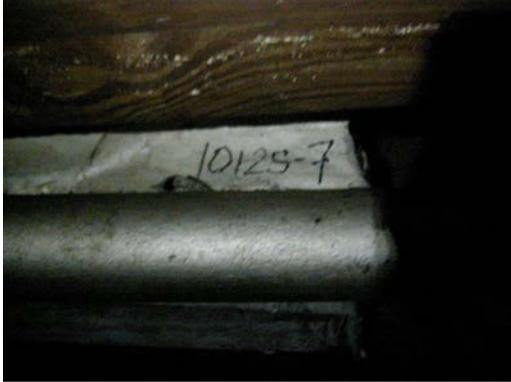
**Photo 7: Duct Work Wrap (10125-7) Kitchen, Wall D.
85% Chrysotile Asbestos Detected.**

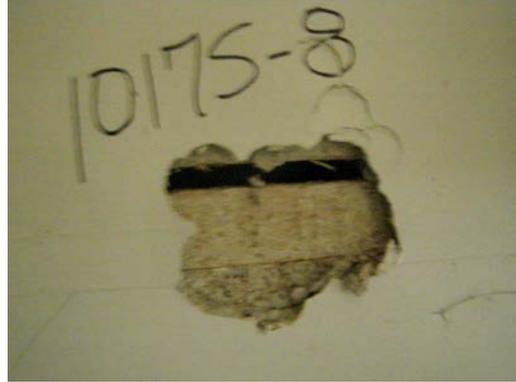
**Photo 8: Plaster (10175-8) Kitchen, Wall D.
No Asbestos Detected.**

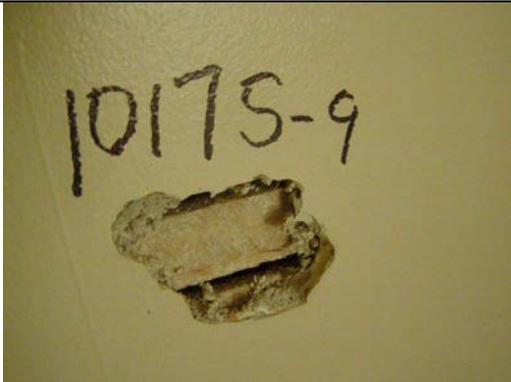
**Photo 9: Plaster (10175-9) Bedroom 1, Wall B.
No Asbestos Detected.**

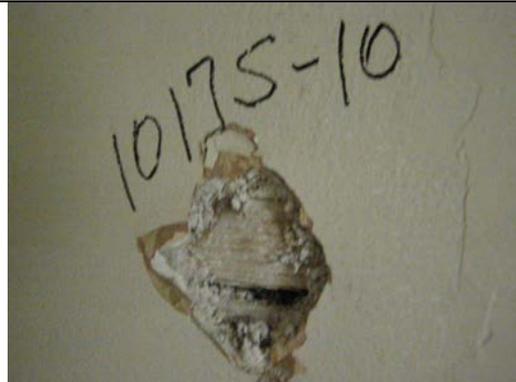
**Photo 10: Plaster (10175-10) Bedroom 2, Wall C.
No Asbestos Detected.**

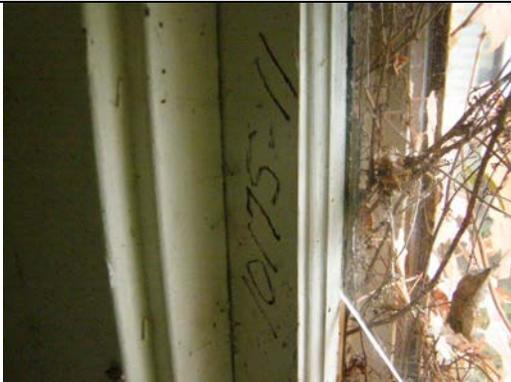
**Photo 11: Window Glazing (10175-11) Bedroom 1,
Wall D. No Asbestos Detected.**

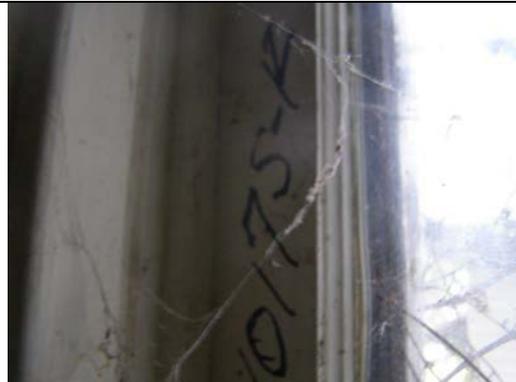
**Photo 12: Window Glazing (10175-12) Bedroom 2,
Wall D. No Asbestos Detected.**
