ASBESTOS INSPECTION REPORT

**1424 Wesleyan Rd.
Dayton, OH 45406**

**Lynda M. Hart
Asbestos Hazards Evaluation Specialist
Ohio #ES-32558
October 27, 2015**

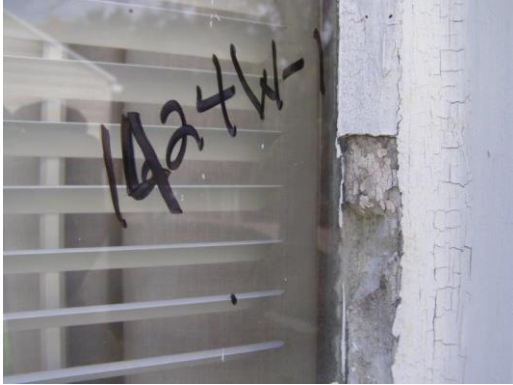
**Photo 1: Window Glazing (1424W-1) Exterior, Wall B.
2% Chrysotile Asbestos Detected (PC=1.50%).**

Confirmed or assumed asbestos-containing materials, which will be disturbed during demolition activities, are regulated under current Federal and State regulations. Hart Environmental Resources recommends the removal of these materials by a licensed asbestos abatement contractor. It is also strongly recommended that the specifications for the removal program be

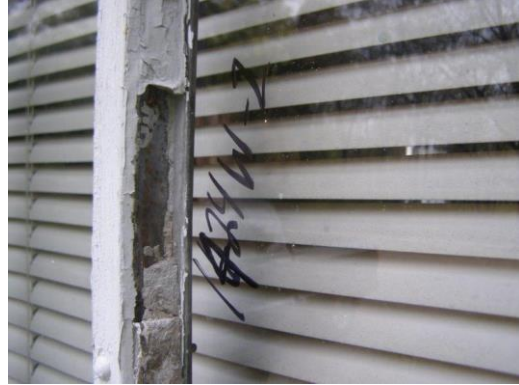
**Photo 2: Window Glazing (1424W-2) Exterior, Wall A.
2% Chrysotile Asbestos Detected (PC=1.25%).**

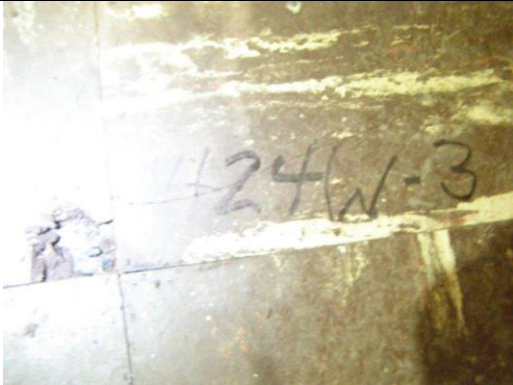
**Photo 3: Floor Tile (1424W-3) Living Room, Floor.
5% Chrysotile Asbestos Detected (PC=3.25%).**

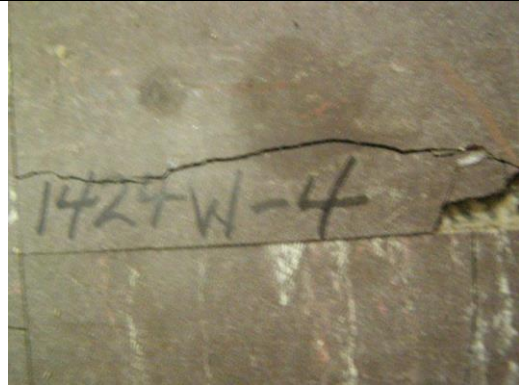
**Photo 4: Floor Tile (1424W-4) Bath Hall, Floor.
5% Chrysotile Asbestos Detected (PC=4.25%).**

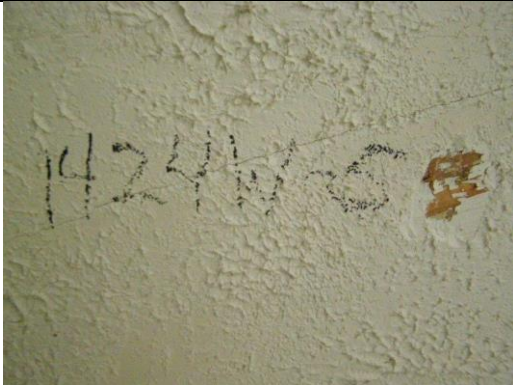
**Photo 5: Textured Paint (1424W-5) Bath, Ceiling.
No Asbestos Detected.**

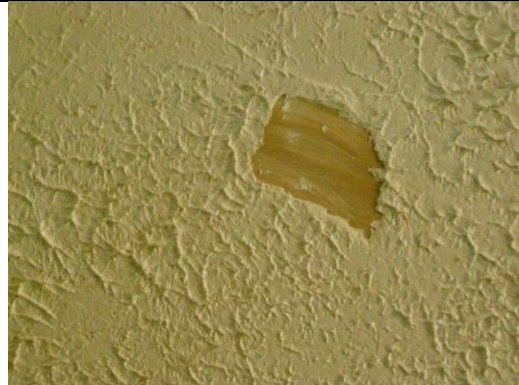
**Photo 6: Textured Paint (1424W-6) Kitchen, Ceiling.
No Asbestos Detected.**

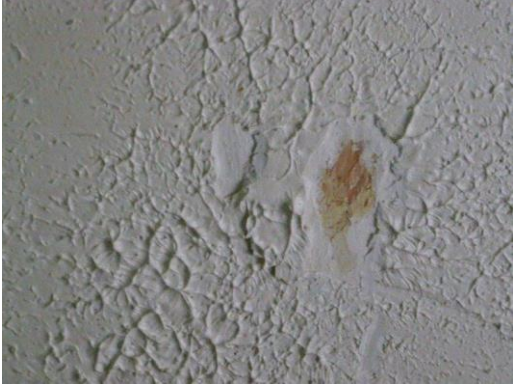
**Photo 7: Textured Paint (1424W-7) Living Room, Ceiling.
No Asbestos Detected.**

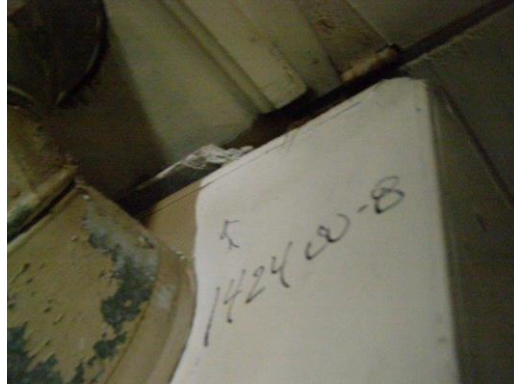
**Photo 8: Furnace Board (1424W-8) Utility Room, Ceiling.
45% Chrysotile Asbestos Detected.**

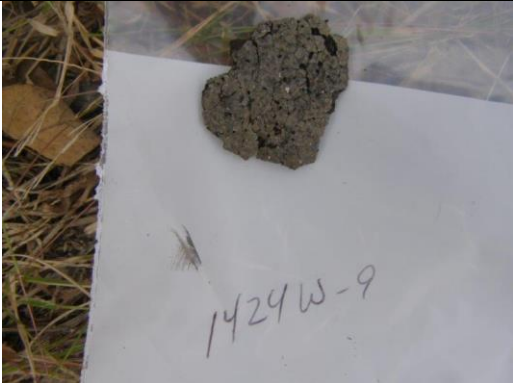
**Photo 9: Roof Shingle (1424W-9) Exterior.
No Asbestos Detected.**

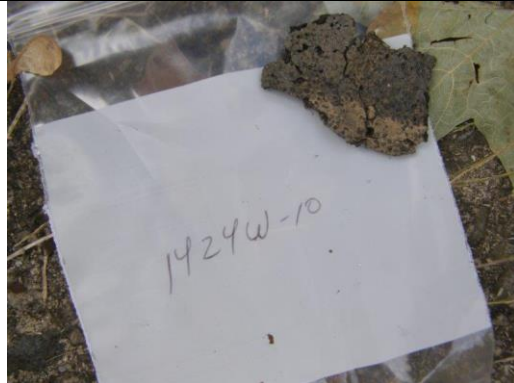
**Photo 10: Roof Shingle (1424W-10) Exterior.
No Asbestos Detected.**
