ASBESTOS INSPECTION REPORT

**1020 Cumberland Ave.
Dayton, OH 45406**

Re: Asbestos Inspection
1020 Cumberland Ave.
Dayton, OH 45406

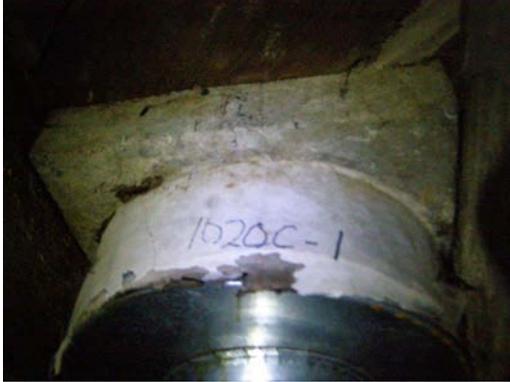
- Boot Wrap, Basement
- Duct Work Wrap, Living Room & Dining Room

Photo 1: Boot Wrap (1020C-1) Basement, Ceiling.
55% Chrysotile Asbestos Detected.

Confirmed or assumed asbestos-containing materials, which will be disturbed during demolition activities, are regulated under current Federal and State regulations. Hart Environmental Resources recommends the removal of these materials by a licensed asbestos abatement contractor. It is also strongly recommended that the specifications for the removal program be developed by a licensed Asbestos Project Designer to ensure that all regulatory requirements are satisfied. The work should be properly documented in the event of future litigation.

<u>Material</u>	<u>Est. Qty.</u>	<u>Est. Unit Cost</u>	<u>Est. Cost</u>
Boot Wrap	3 ea	\$ 25/ea	\$ 75
Duct Work Wrap	87 sq ft.	\$ 20/sq ft.	\$ 1740
Total			\$ 1815

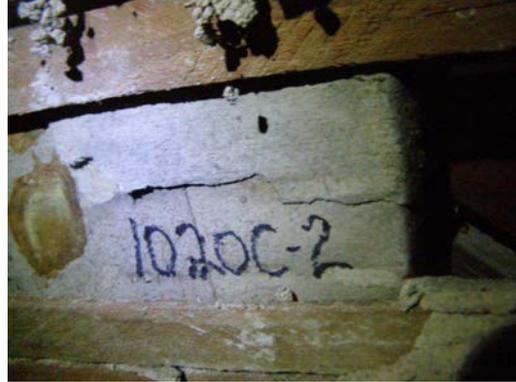
Photo 2: Duct Work Wrap (1020C-2) Living Room,
Wall D. 55% Chrysotile Asbestos Detected.

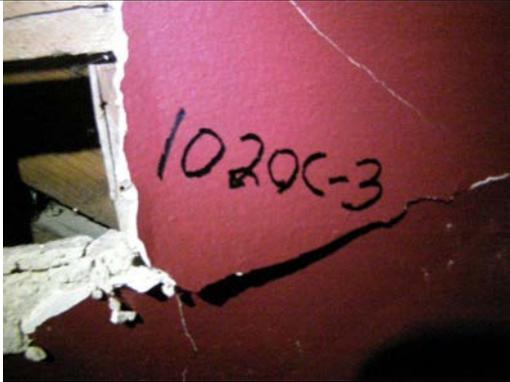
Photo 3: Plaster (1020C-3) Living Room, Wall D.
No Asbestos Detected.

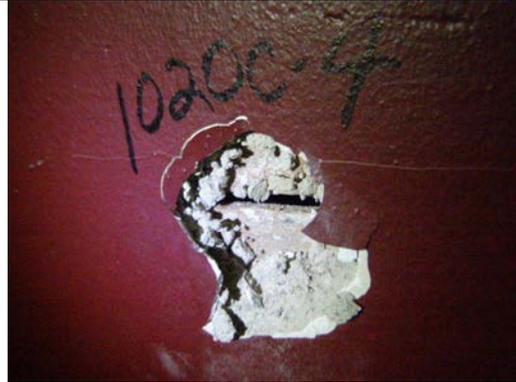
Photo 4: Plaster (1020C-4) Dining Room, Wall A.
No Asbestos Detected.

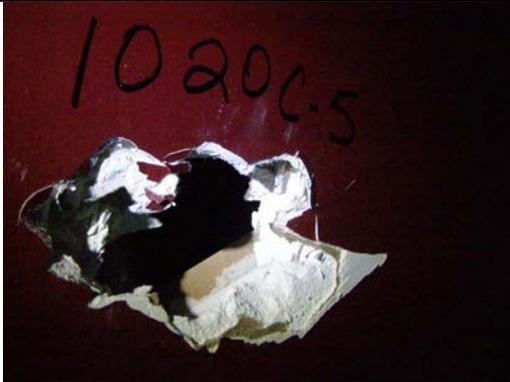
Photo 5: Plaster (1020C-5) Dining Room, Wall C.
No Asbestos Detected

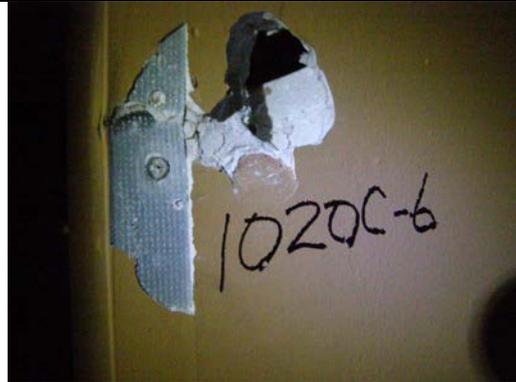
Photo 6: Drywall/J.C. (1020C-6) Kitchen, Wall B.
No Asbestos Detected

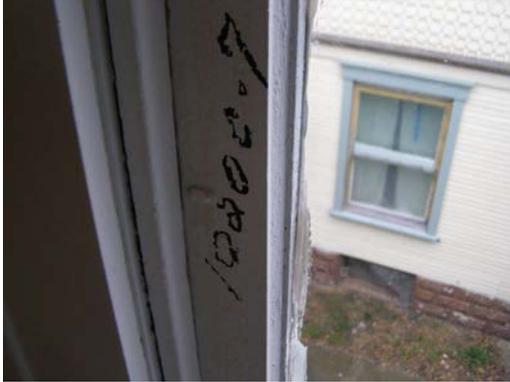
Photo 7: Window Glazing (1020C-7) Bedroom 1, Wall D. No Asbestos Detected.

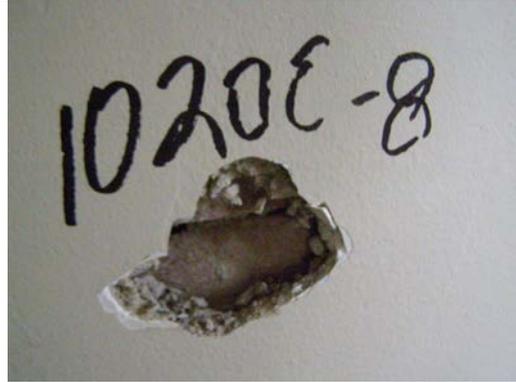
Photo 8: Plaster (1020C-8) Bedroom 1, Wall C. No Asbestos Detected.

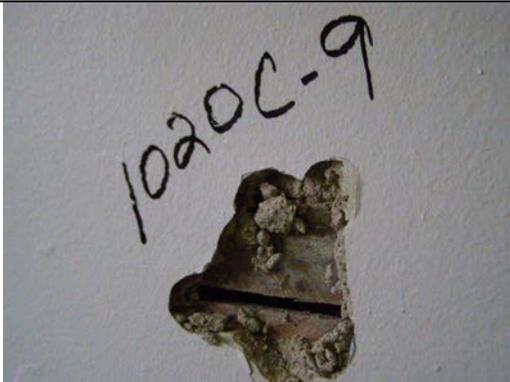
Photo 9: Plaster (1020C-9) Bedroom 2, Wall D. No Asbestos Detected.

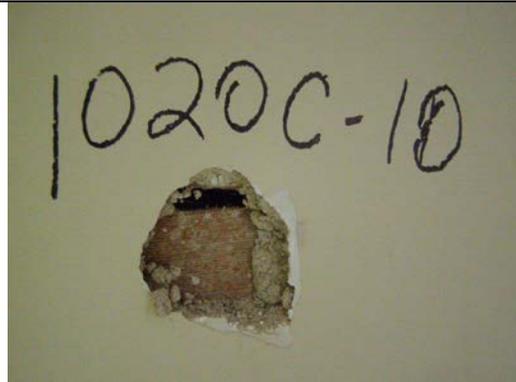
Photo 10: Plaster (1020C-10) Bedroom 2, Wall A. No Asbestos Detected.

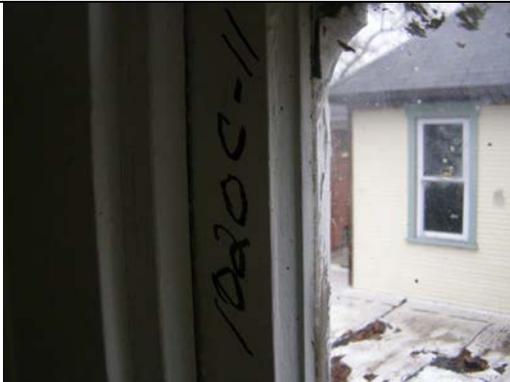
Photo 11: Window Glazing (1020C-11) Bath, Wall D. No Asbestos Detected.

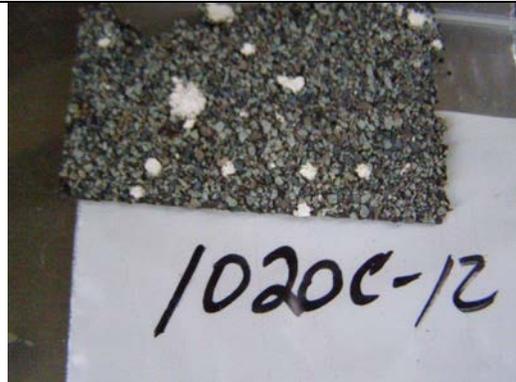
Photo 12: Roof Shingle (1020C-12) Exterior. No Asbestos Detected.

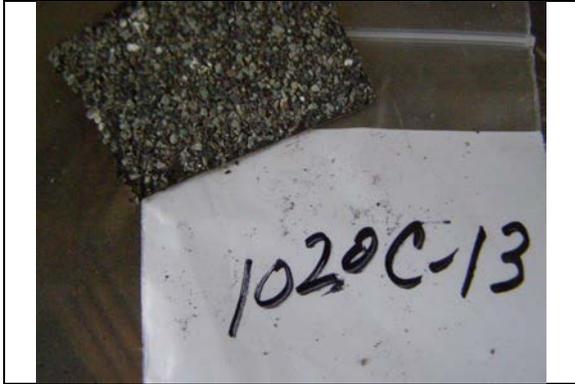
Photo 13: Roof Shingle (1020C-13) Exterior.
No Asbestos Detected.
