## **ASBESTOS INSPECTION REPORT**

**626 Hulbert St.  
Dayton, OH 45410**

Re: Asbestos Inspection  
626 Hulbert St.  
Dayton, Ohio 45403

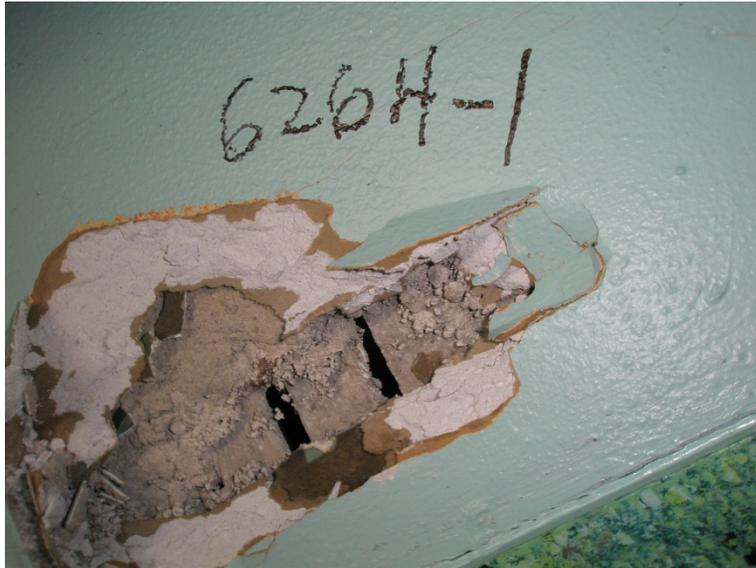
Photo 1: Wall Plaster (626H-1) Kitchen. No Asbestos Detected.

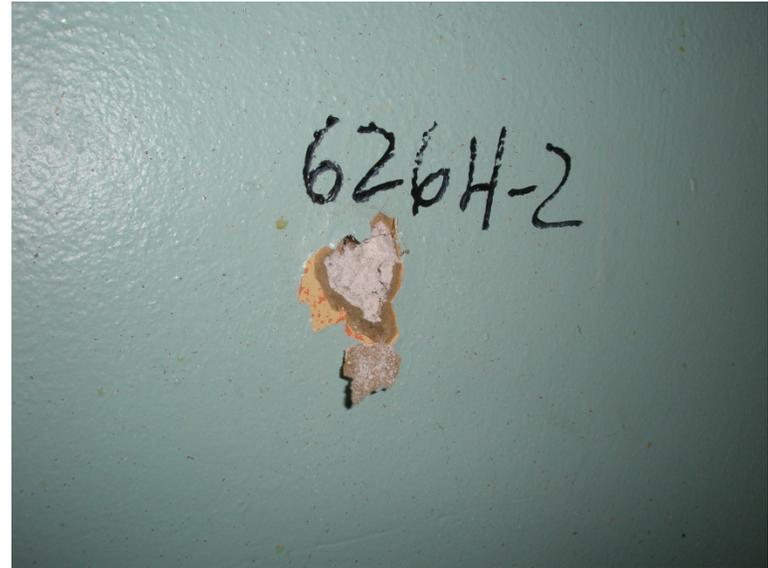
Photo 2: Drywall/JC (626H-2) Kitchen. No Asbestos Detected.

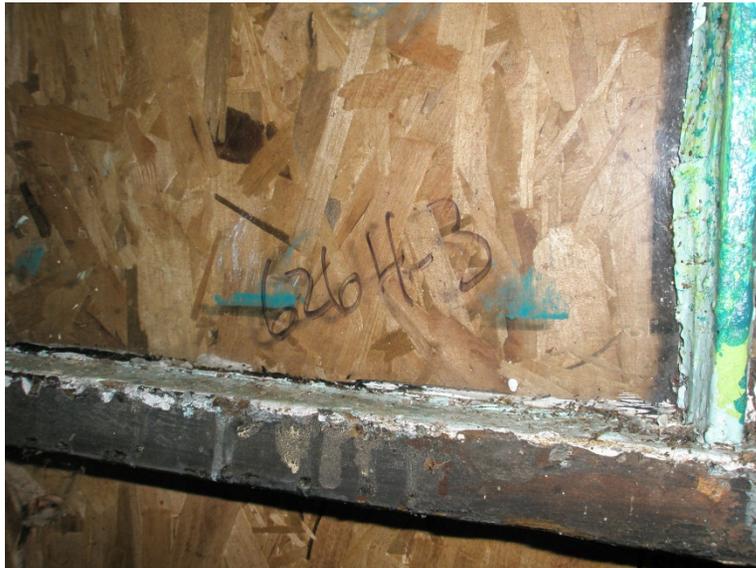
Photo 3: Window Glazing (626H-3) Kitchen. No Asbestos Detected.

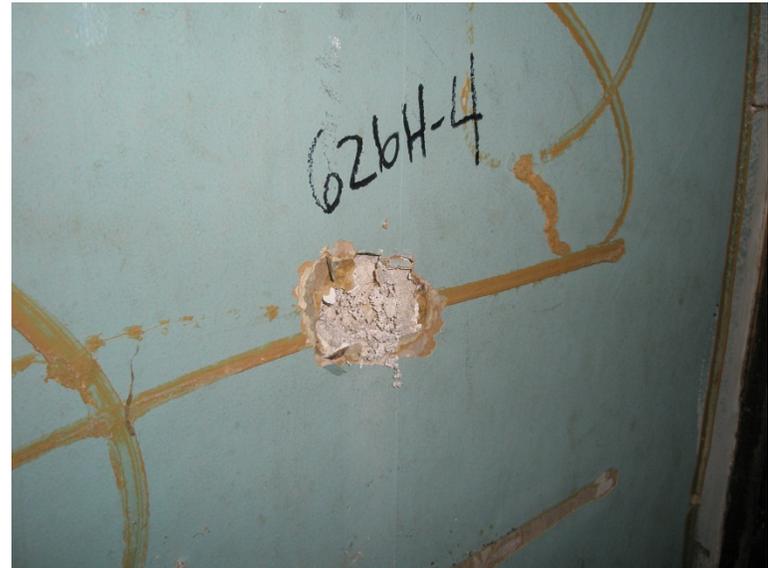
Photo 4: Wall Plaster (626H-4) Living Room. No Asbestos Detected.

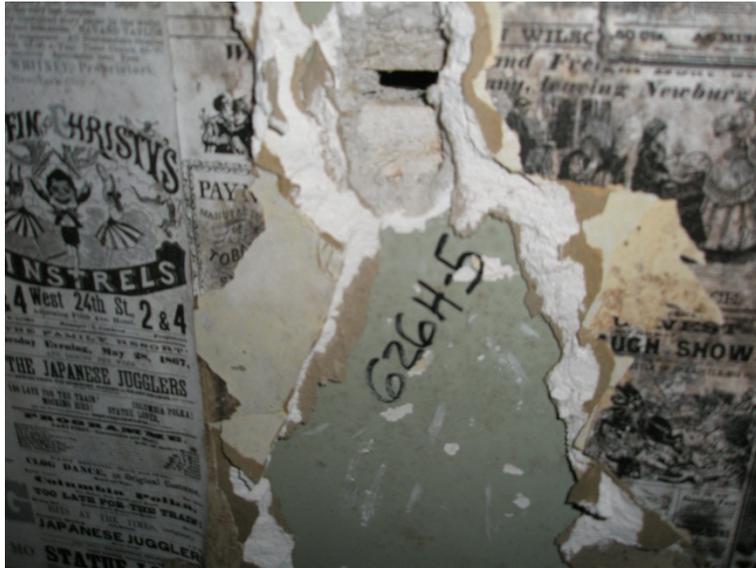
Photo 5: Wall Plaster (626H-5) Utility Room. No Asbestos Detected.

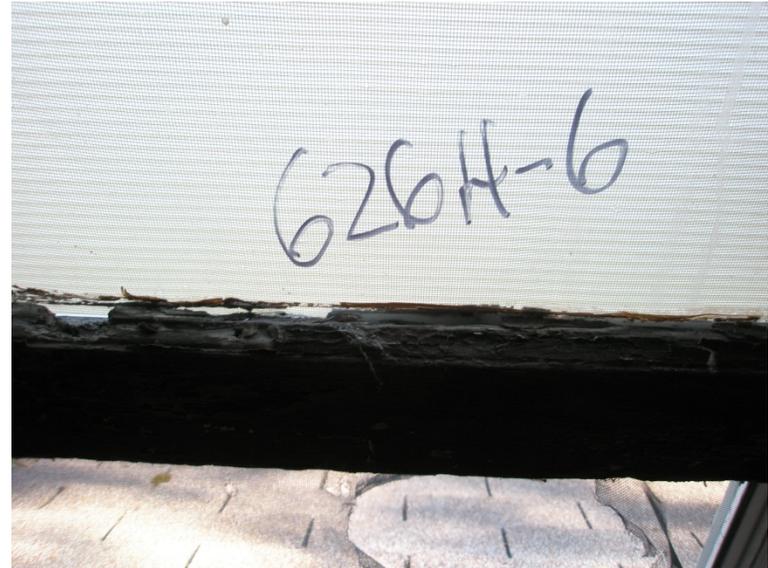
Photo 6: Window Glazing (626H-6) Bedroom 2. No Asbestos Detected.

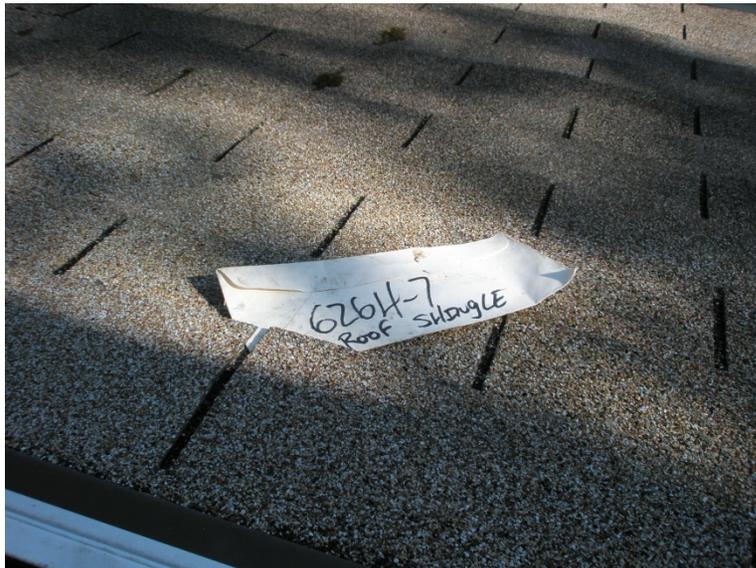
Photo 7: Brown Roofing Shingle (626H-7). No Asbestos Detected.

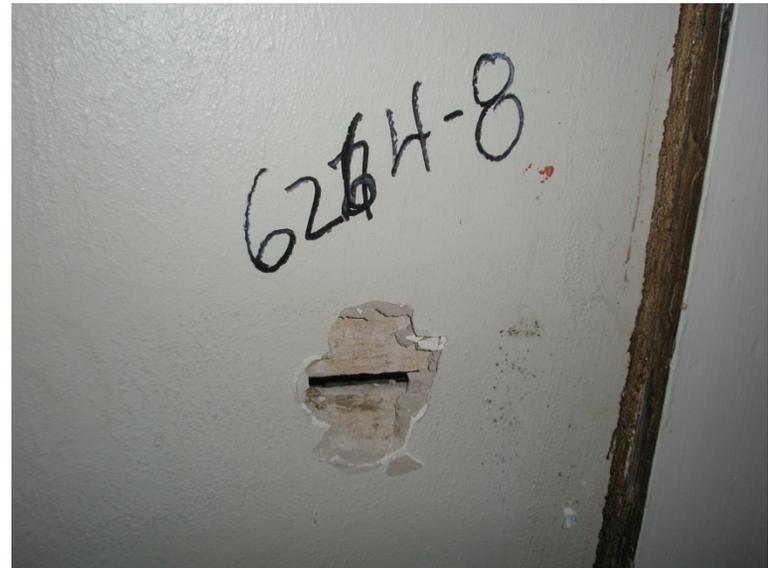
Photo 8: Wall Plaster (626H-8) Bedroom 2. No Asbestos Detected.

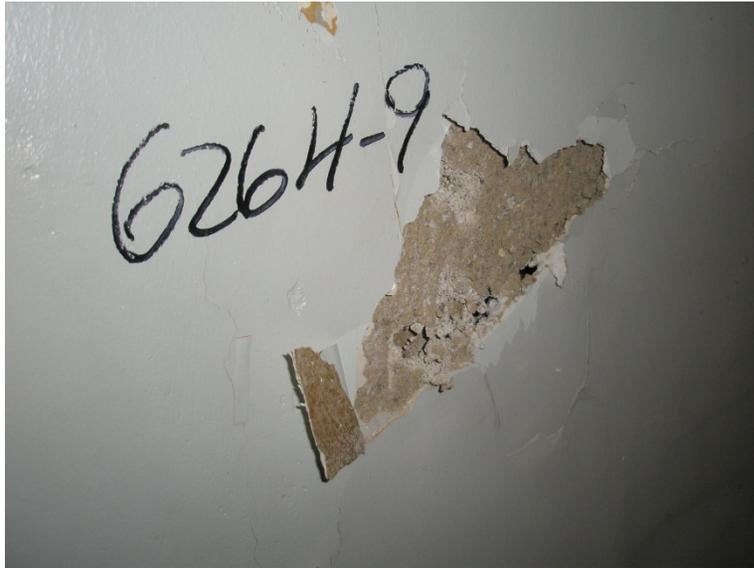
Photo 9: Wall Plaster (626H-9) Bedroom 1. No Asbestos Detected.

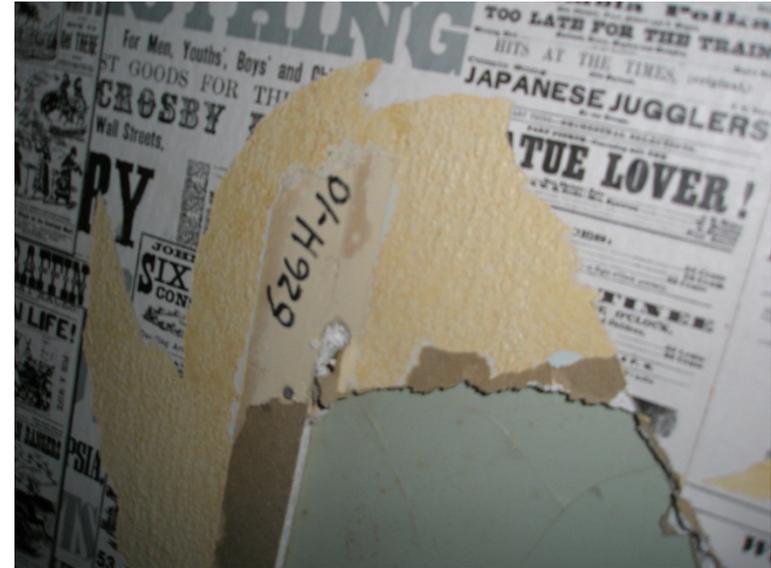
Photo 10: Drywall/JC (626H-10) Utility Room. <1% Chrysotile Asbestos Detected (.25% Point Count).

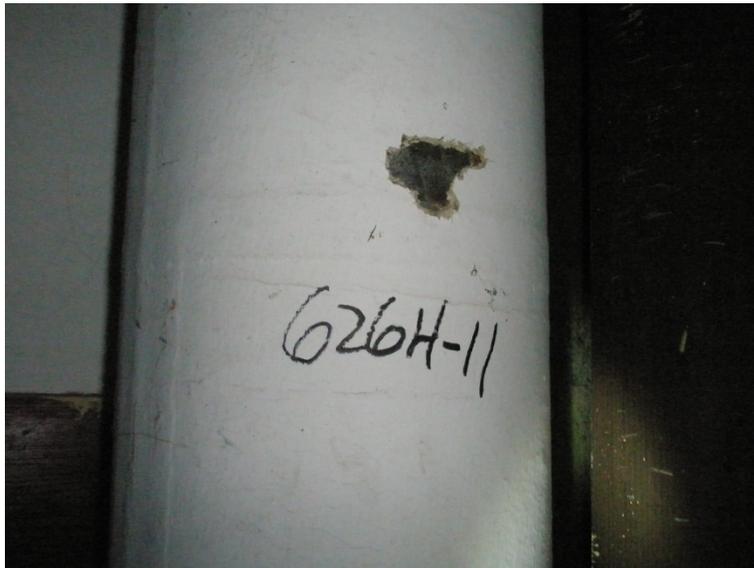
- Tan, fibrous duct wrap, Dining Room Wall.
- Light Grey, fibrous furnace board, Basement

Photo 11: Duct Wrap (626H-11) Dining Room. 75% Chrysotile Asbestos Detected.

Confirmed or assumed asbestos-containing materials, which will be disturbed during demolition activities, are regulated under current Federal and State regulations. Hart Environmental Resources recommends the removal of these materials by a licensed asbestos abatement contractor. It is also strongly recommended that the specifications for the removal program be developed by a licensed Asbestos Project Designer to ensure that all regulatory requirements are satisfied. The work should be properly documented in the event of future litigation.

<u>Material</u>	<u>Est. Qty.</u>	<u>Est. Unit Cost</u>	<u>Est. Cost</u>
Tan, fibrous duct wrap	11 Ln. Ft.	\$20/Ln. Ft.	\$220
Light Grey, furnace board	8 Sq. Ft.	\$20/Sq. Ft.	\$160
		<b>Total</b>	<b>\$380</b>

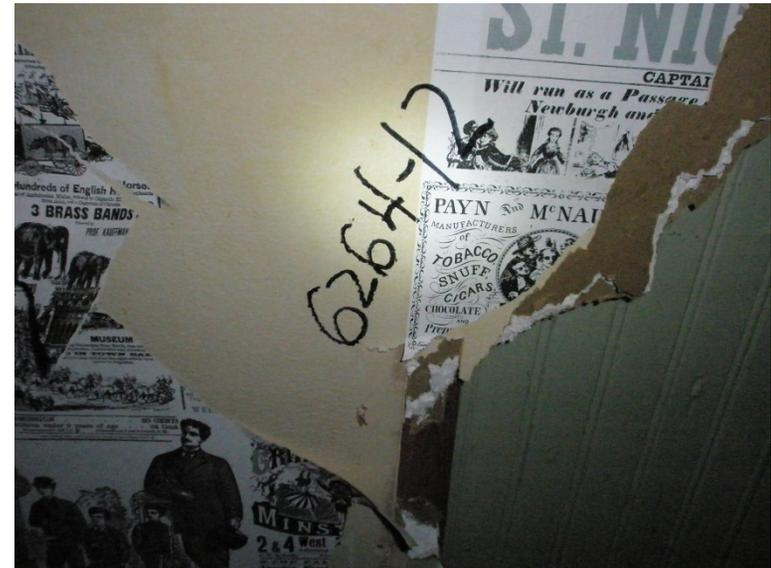
Photo 12: Drywall/JC (626H-12) Utility Room. <1% Chrysotile Asbestos Detected (.25% Point Count).

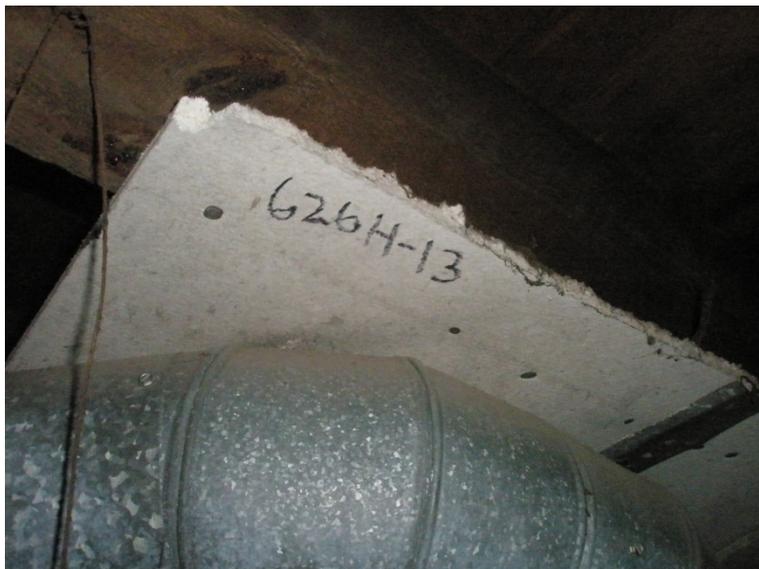
**Photo 13: Furnace Board (626H-13) Basement. 70% Chrysotile Asbestos Detected.**

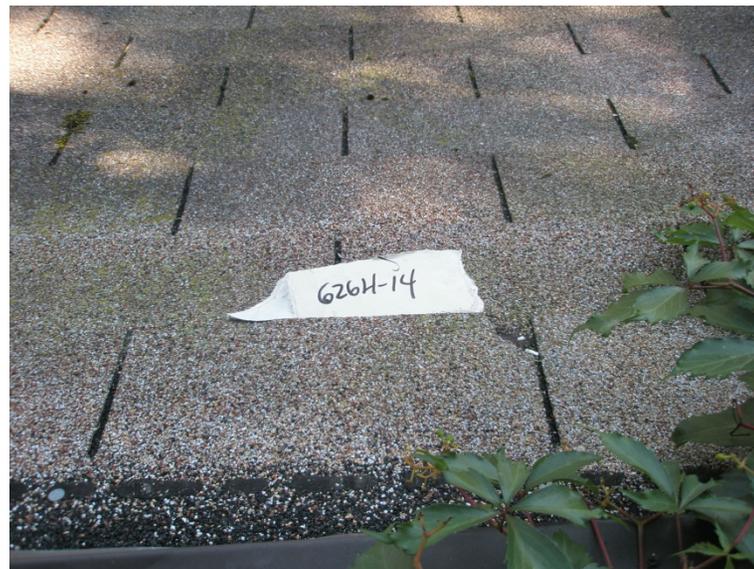
**Photo 14: Brown Roofing Shingle (626H-14). No Asbestos Detected.**
