## **ASBESTOS INSPECTION REPORT**

**1930 Rugby Rd.  
Dayton, Ohio 45406**

Re: Asbestos Inspection  
1930 Rugby Rd.  
Dayton, Ohio 45406

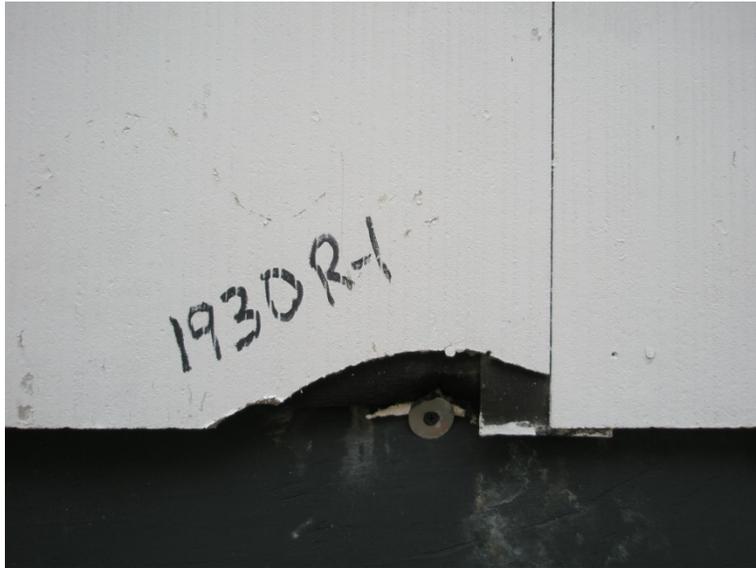
**Photo 1: Transite Shingles (1930R-1) Exterior of Home and Garage. 18% Chrysotile Asbestos Detected.**

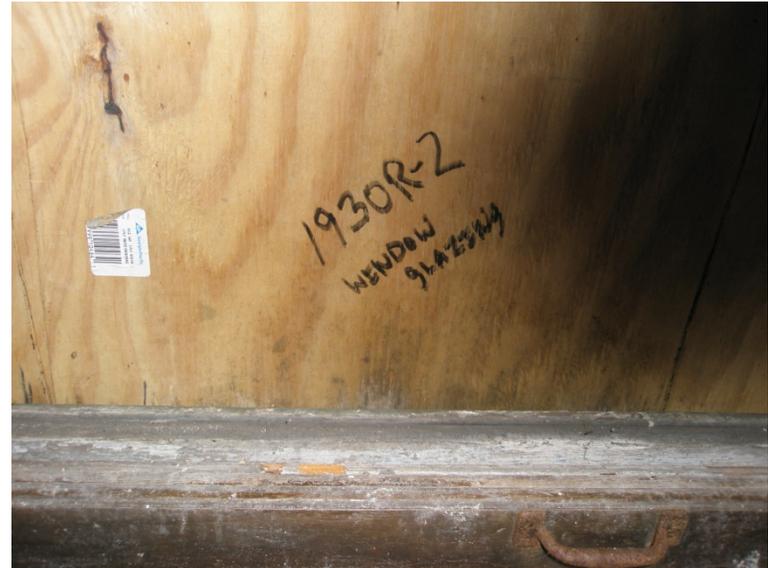
**Photo 2: Window Glazing (1930R-2) Living Room. No Asbestos Detected.**

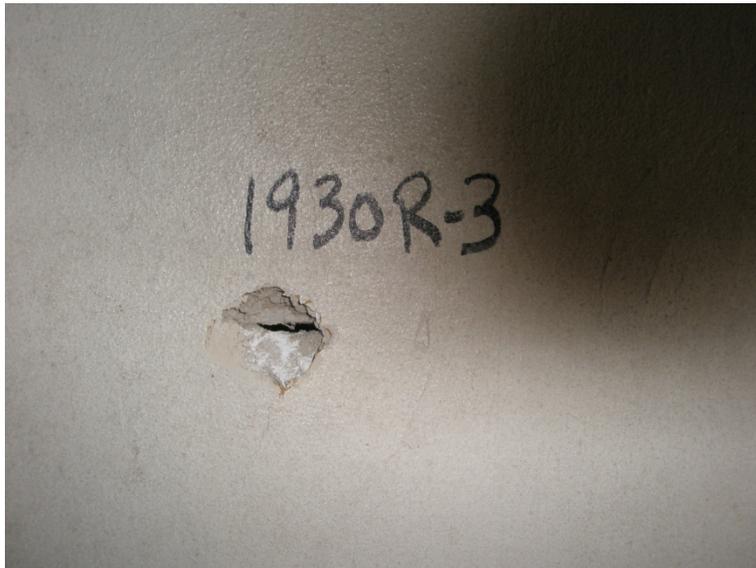
**Photo 3: Wall Plaster (1930R-3) Living Room. No Asbestos Detected.**

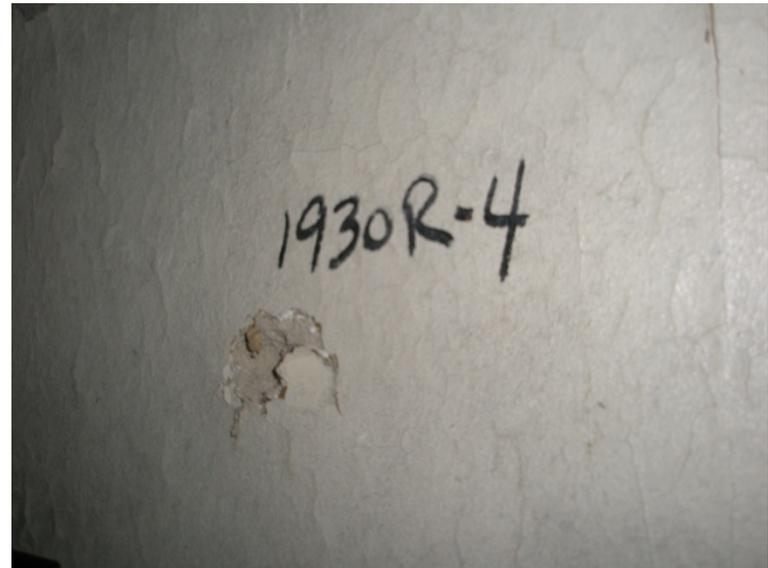
**Photo 4: Wall Plaster (1930R-4) Dining Room. <1% Chrysotile Asbestos Detected (.50% Point Count).**

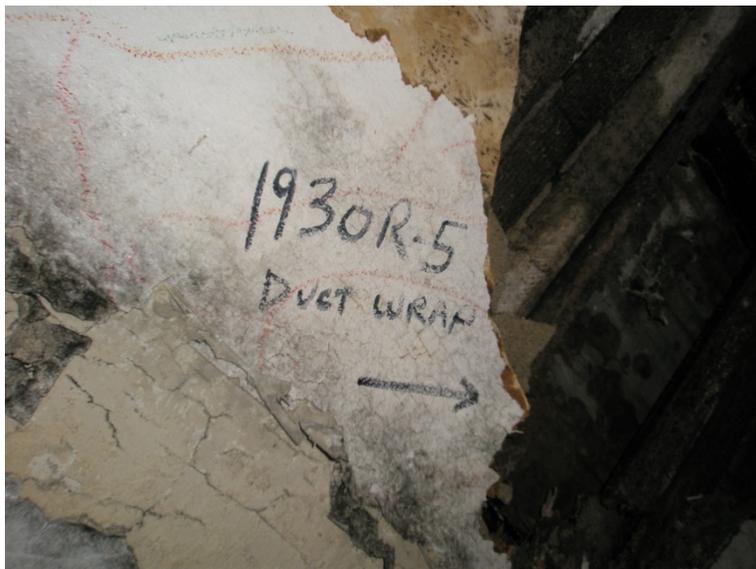
**Photo 5: Duct Wrap Insulation (1930R-5) Living Room. 60% Chrysotile Asbestos Detected.**

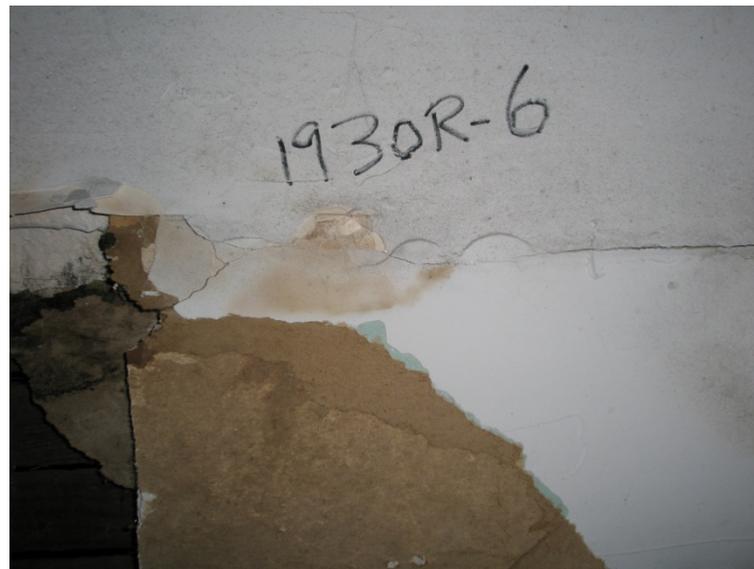
**Photo 6: Drywall/JC (1930R-6) Kitchen. No Asbestos Detected.**

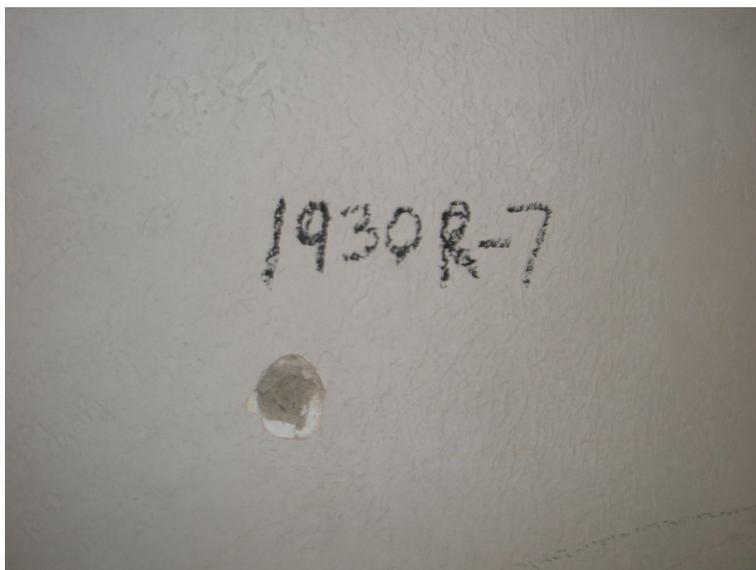
**Photo 7: Wall Plaster (1930R-7) Bedroom 3. 2% Chrysotile Asbestos Detected (.25% Point Count).**

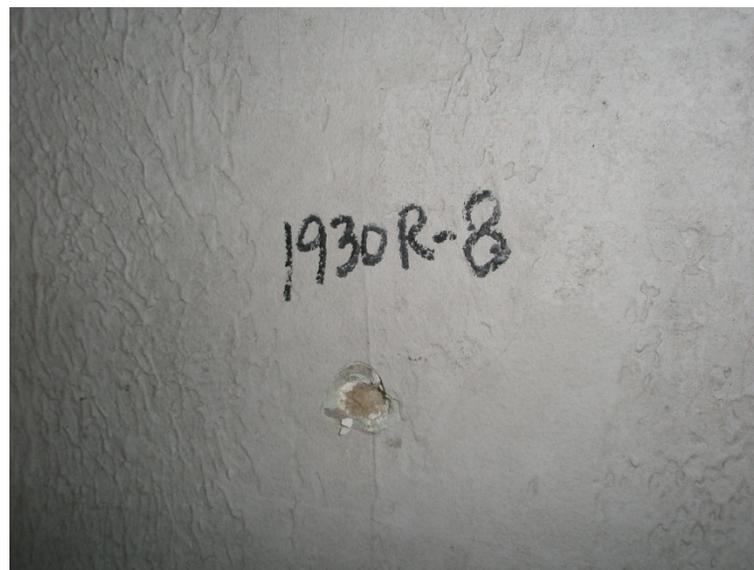
**Photo 8: Wall Plaster (1930R-8) Bedroom 1. No Asbestos Detected.**

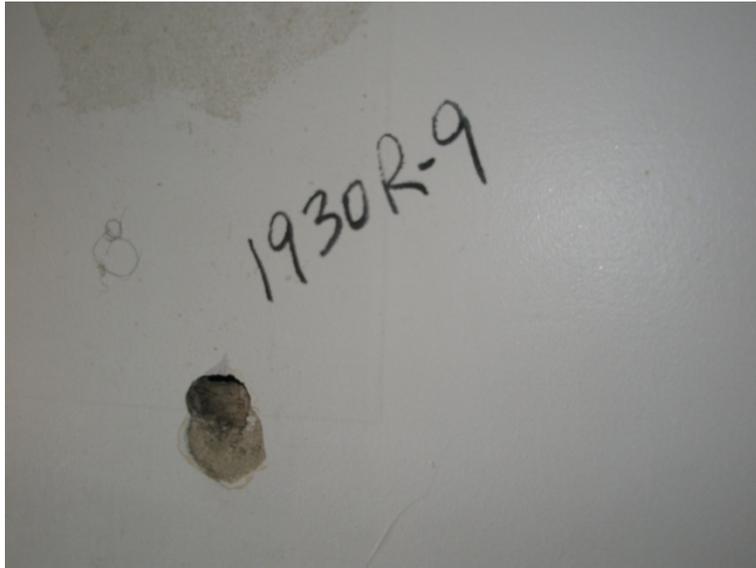
Photo 9: Wall Plaster (1930R-9) Bathroom. No Asbestos Detected.

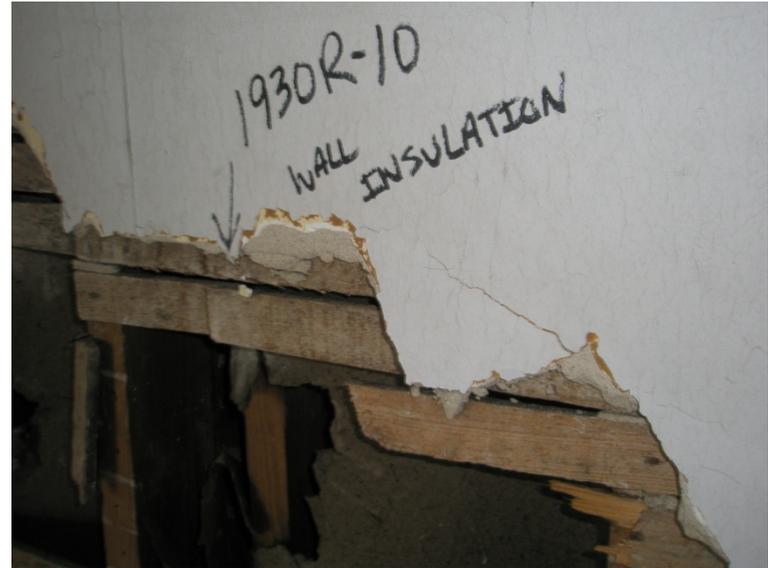
Photo 10: Wall Insulation (1930R-10) Upstairs Hallway. No Asbestos Detected.

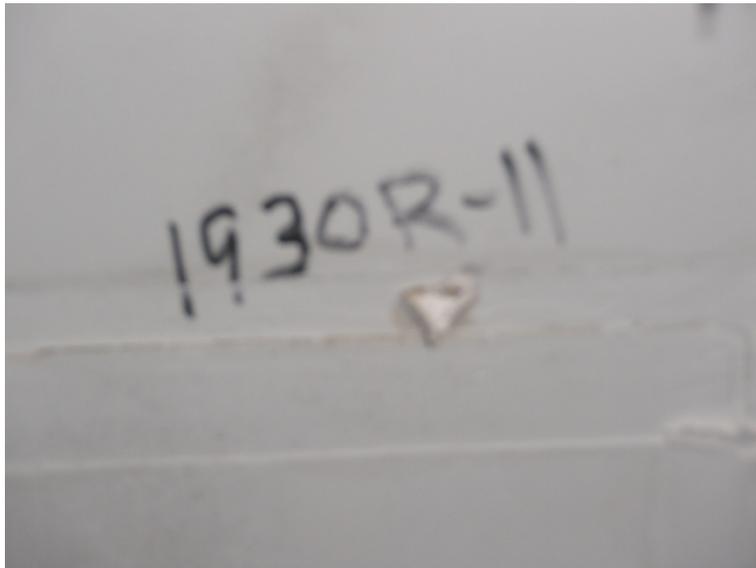
Photo 11: Drywall/JC (1930R-11) Kitchen Ceiling. No Asbestos Detected.

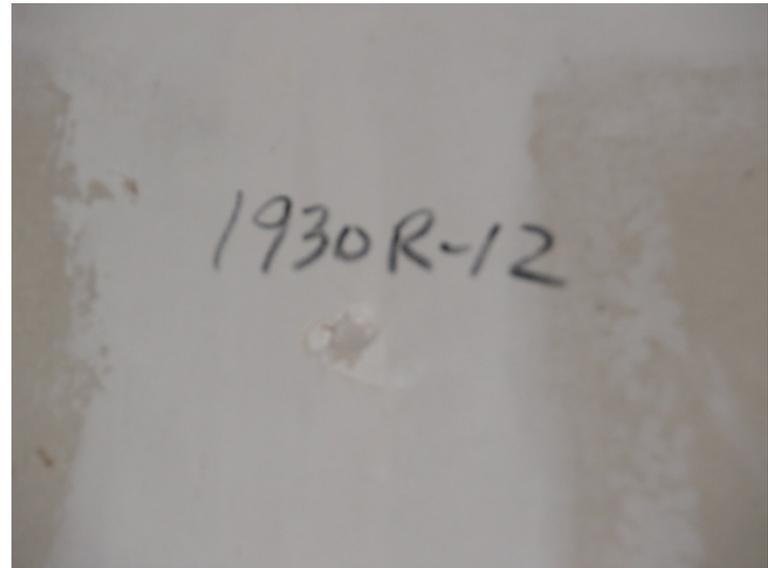
Photo 12: Drywall/JC (1930R-12) Kitchen. No Asbestos Detected.

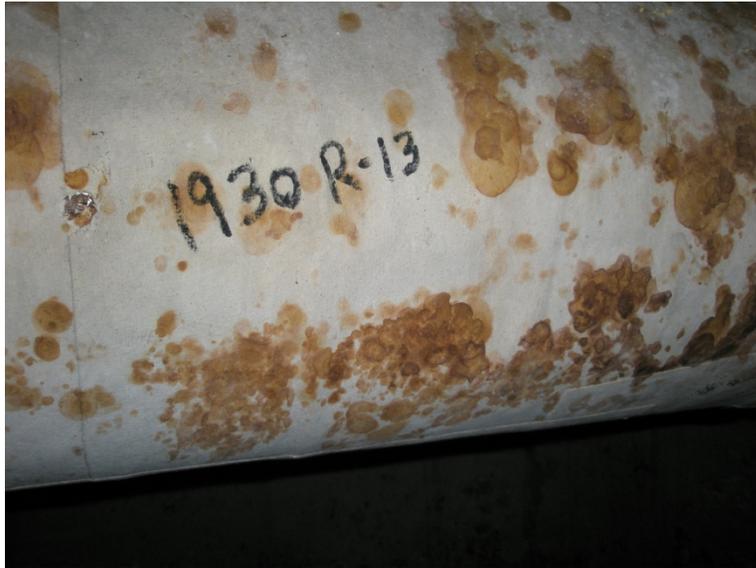
**Photo 13: Ductwork Pipe Insulation (1930R-13) Basement. 60% Chrysotile Asbestos Detected.**

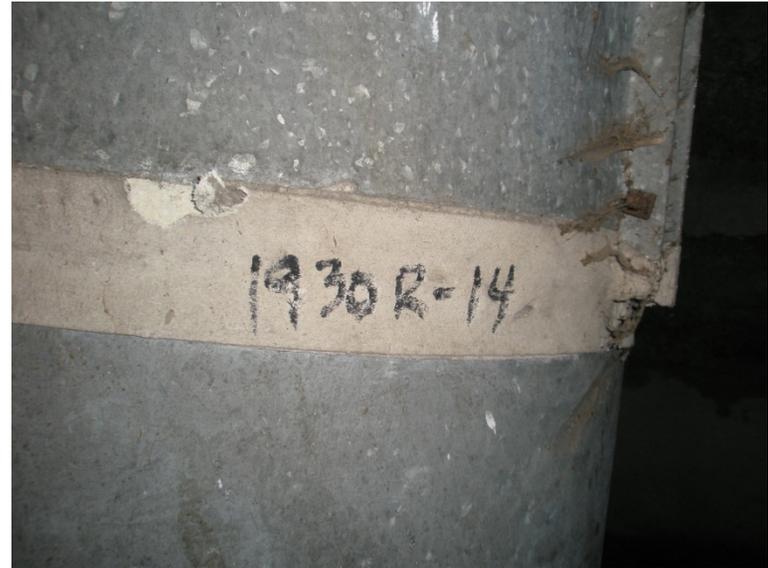
**Photo 14: Ductwork Seam Tape (1930R-14) Basement. 60% Chrysotile Asbestos.**

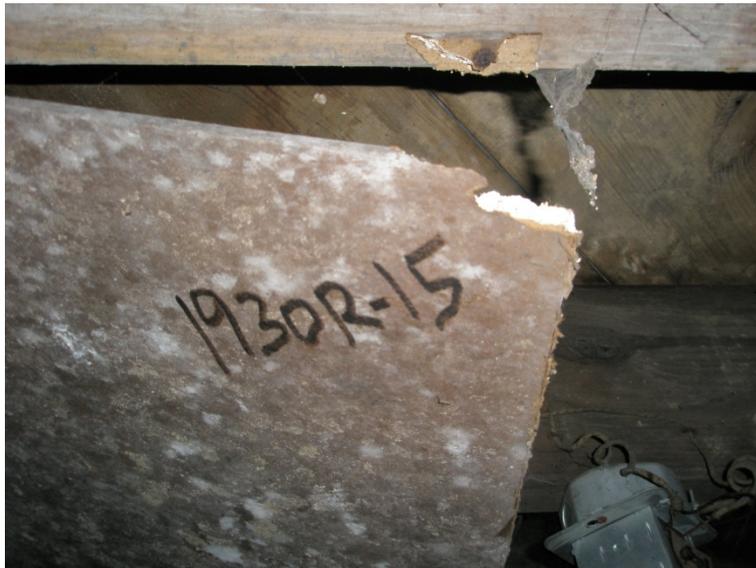
**Photo 15: Furnace Board (1930R-15) Basement. No Asbestos Detected.**

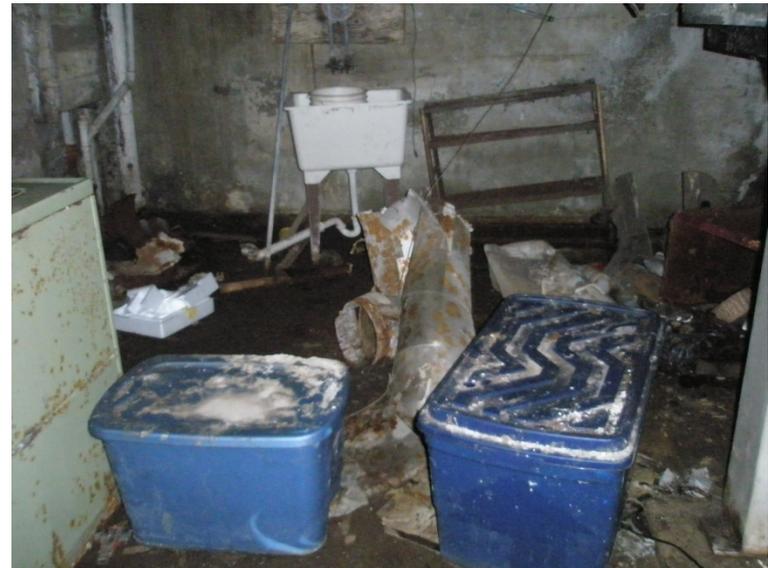
There was also a small amount of ground debris in the basement. Other sampled suspect materials were found to contain no asbestos and no regulatory requirements apply to these materials.

**Photo 16: Ground Debris, Basement.**

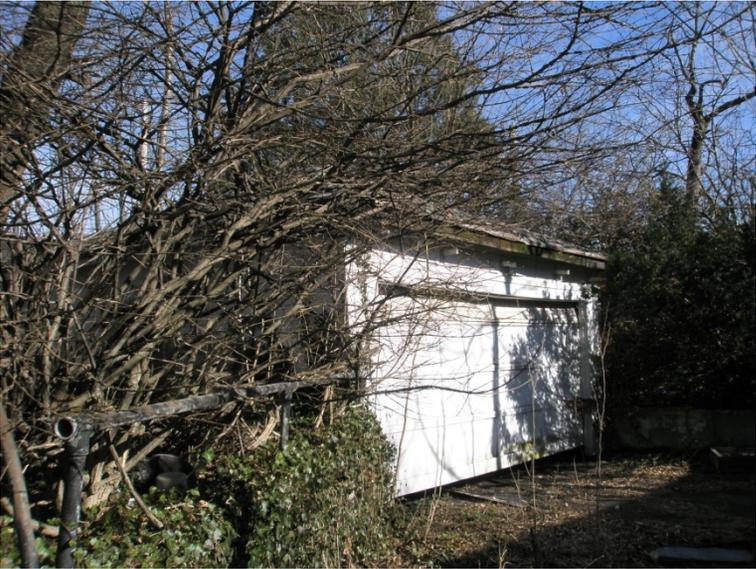
**Photo 17: Exterior Garage, Built Into Hill. Transite Shingles And Asphalt Roofing.**
