ASBESTOS INSPECTION REPORT

**2089 Auburn Ave.
Dayton, OH 45406**

Re: Asbestos Inspection
2089 Auburn Ave.
Dayton, Ohio 45406

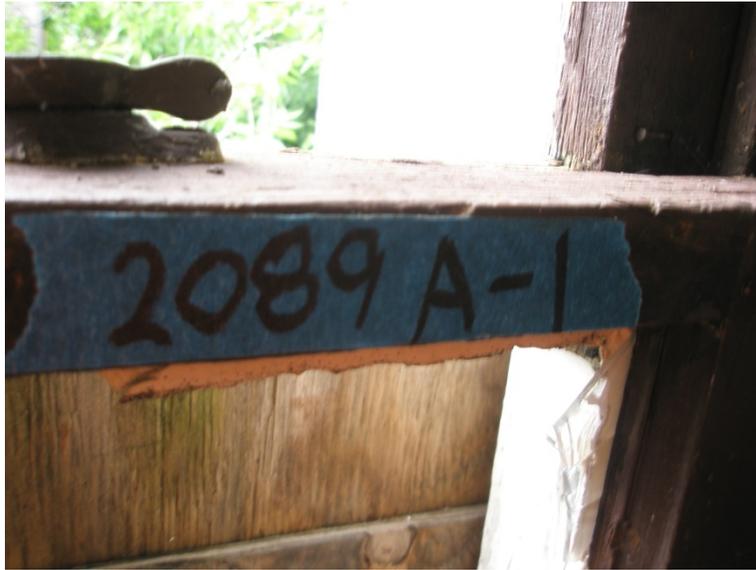
Photo 1: Window Glazing (2089A-1) Dining Room. No Asbestos Detected.

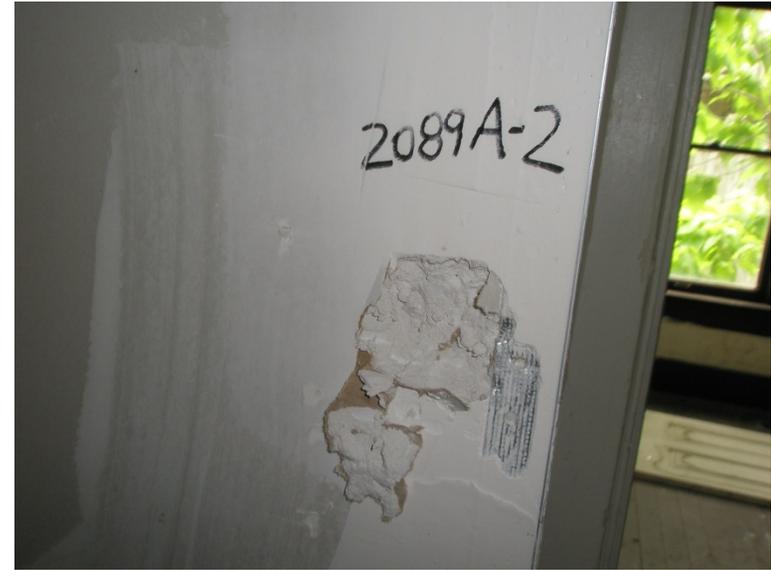
Photo 2: Drywall/JC (2089A-2) Kitchen. No Asbestos Detected.

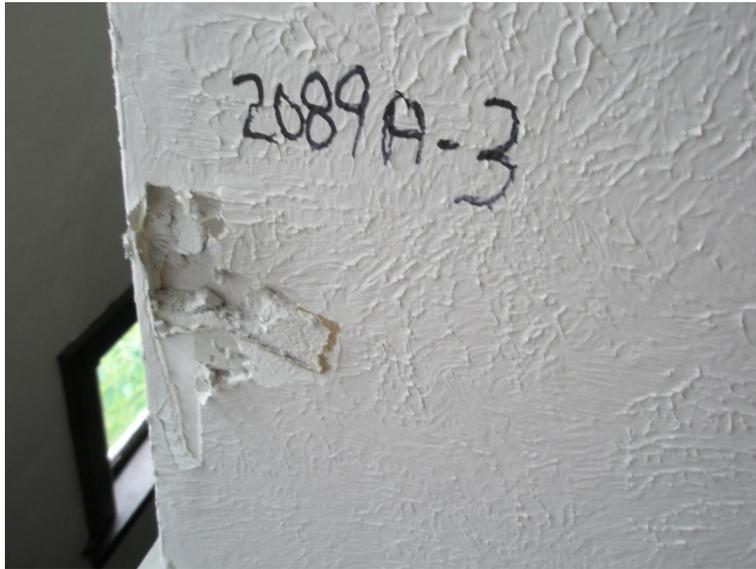
Photo 3: Drywall/JC (2089A-3) Stairway. No Asbestos Detected.

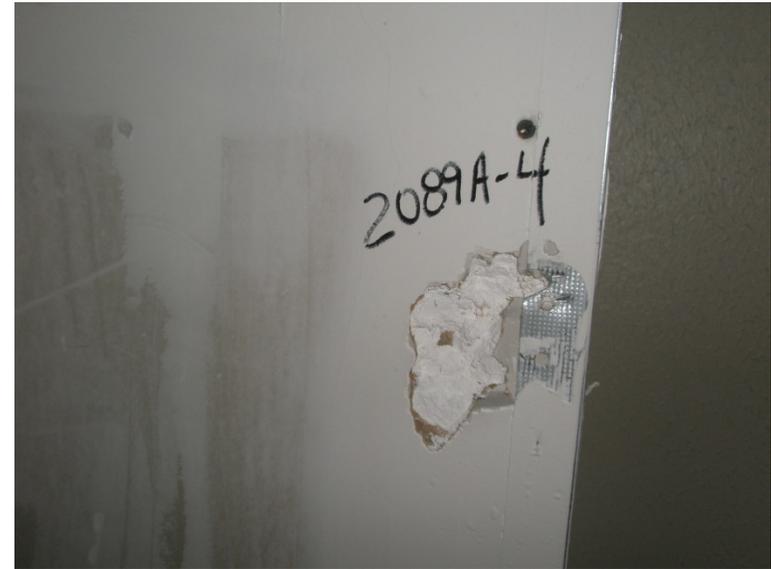
Photo 4: Drywall/JC (2089A-4) Bedroom 3. No Asbestos Detected.

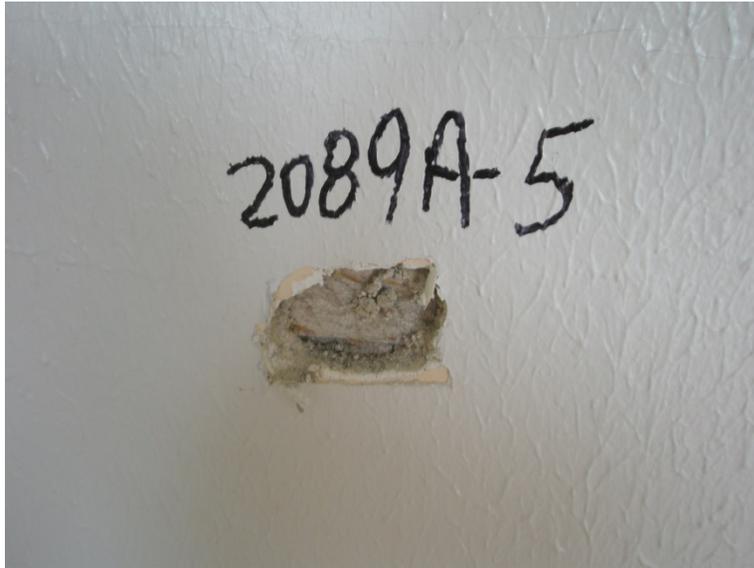
Photo 5: Wall Plaster (2089A-5) Bedroom 1. No Asbestos Detected.

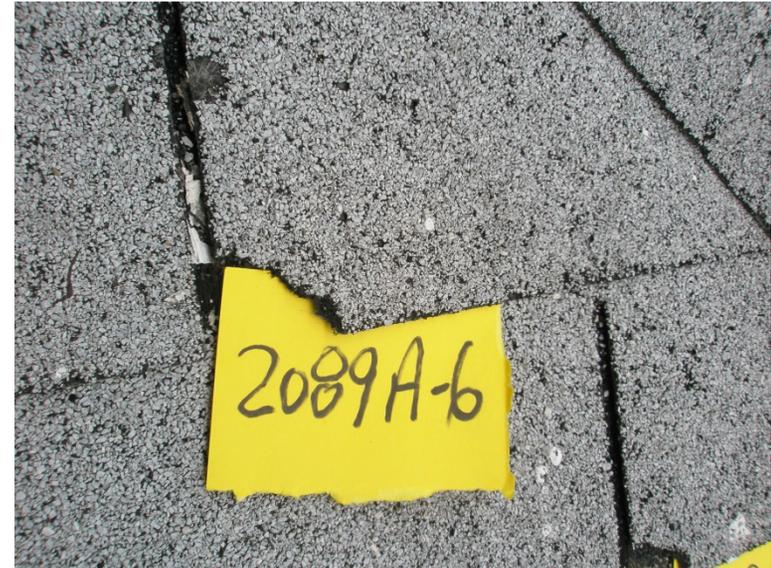
Photo 6: Roofing Shingle (2089A-6). No Asbestos Detected.

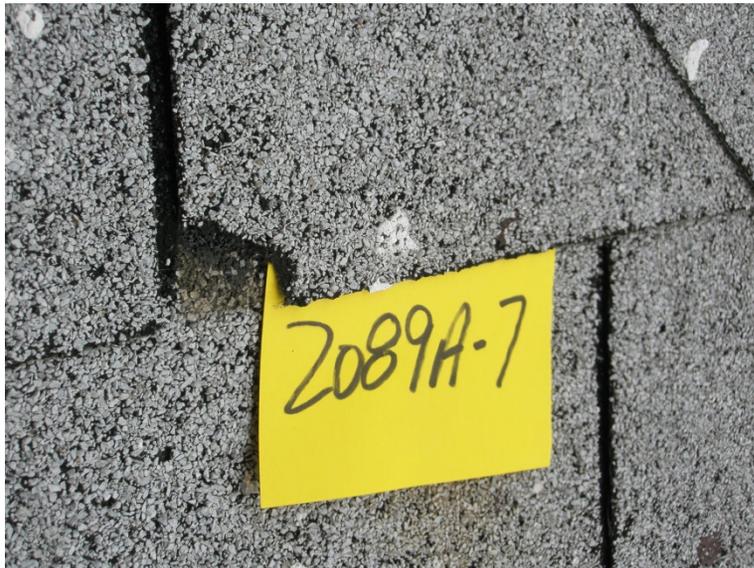
Photo 7: Roofing Shingle (2089A-7). No Asbestos Detected.

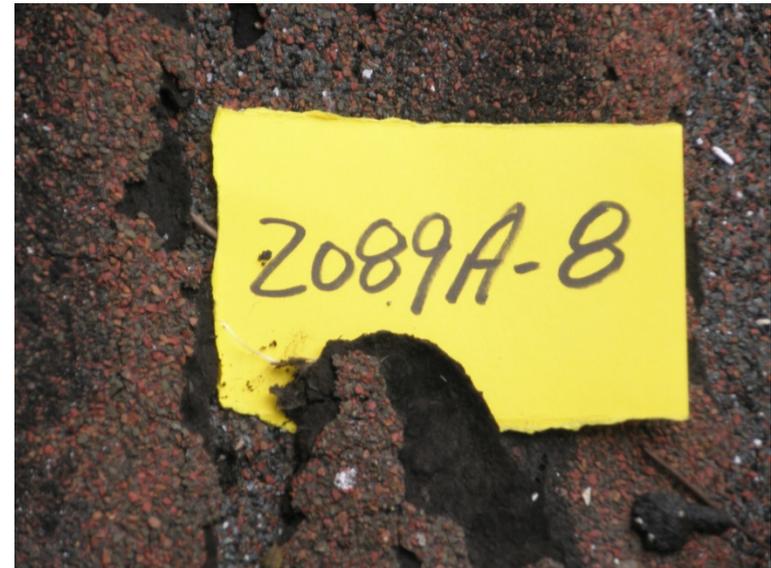
Photo 8: Roofing Shingle (2089A-8). No Asbestos Detected.

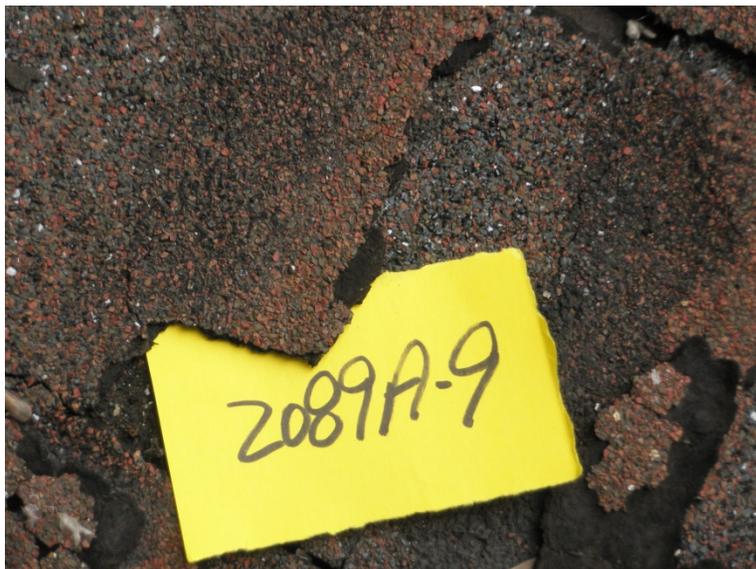
Photo 9: Roofing Shingle (2089A-9). No Asbestos Detected.

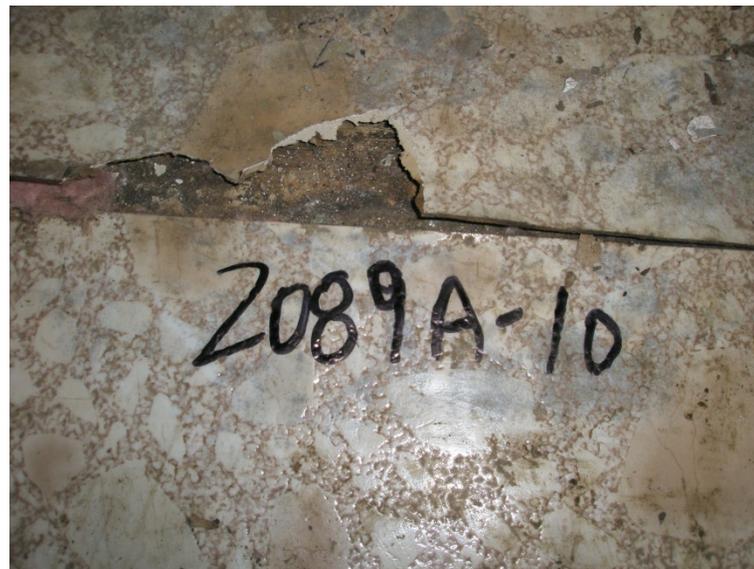
Photo 10: Beige/Brown Vinyl Linoleum (2089A-10) Kitchen. No Asbestos Detected.

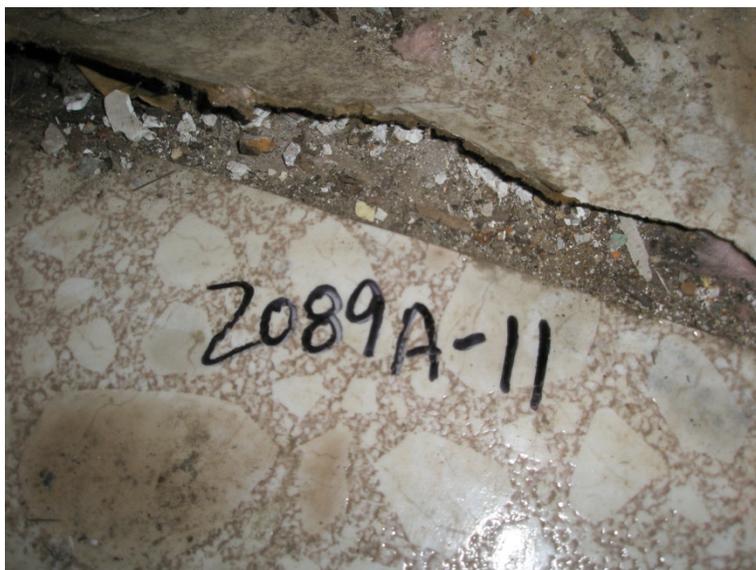
Photo 11: Beige/Brown Vinyl Linoleum (2089A-11) Kitchen. No Asbestos Detected.

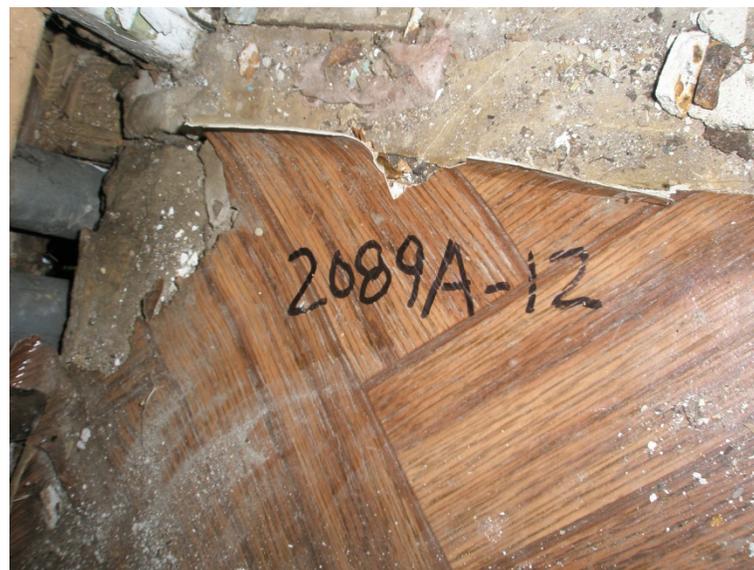
Photo 12: Brown Vinyl Linoleum (2089A-12) Back Room. No Asbestos Detected.

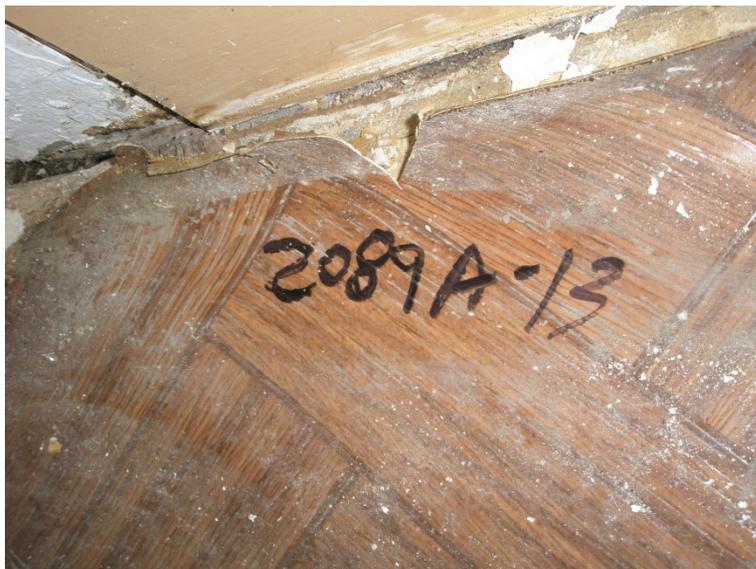
Photo 13: Brown Vinyl Linoleum (2089A-13) Back Room. No Asbestos Detected.

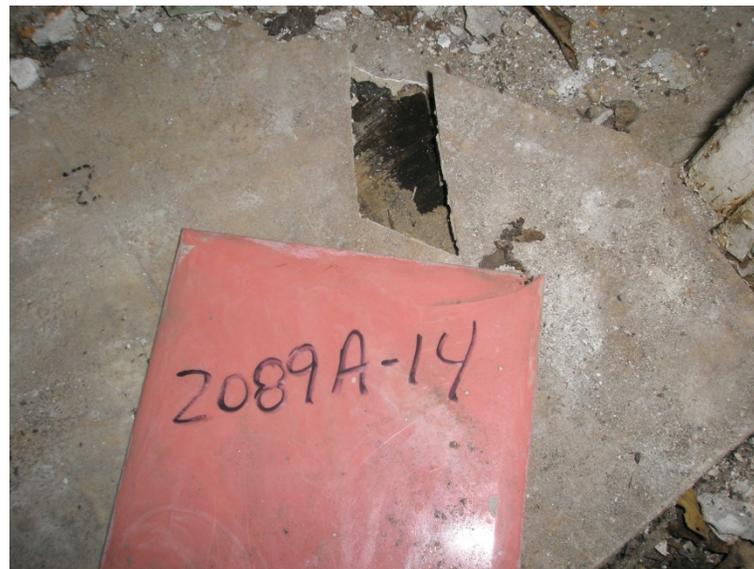
Photo 14: Brown/Beige Vinyl Linoleum (2089A-14) Bathroom 1. No Asbestos Detected.

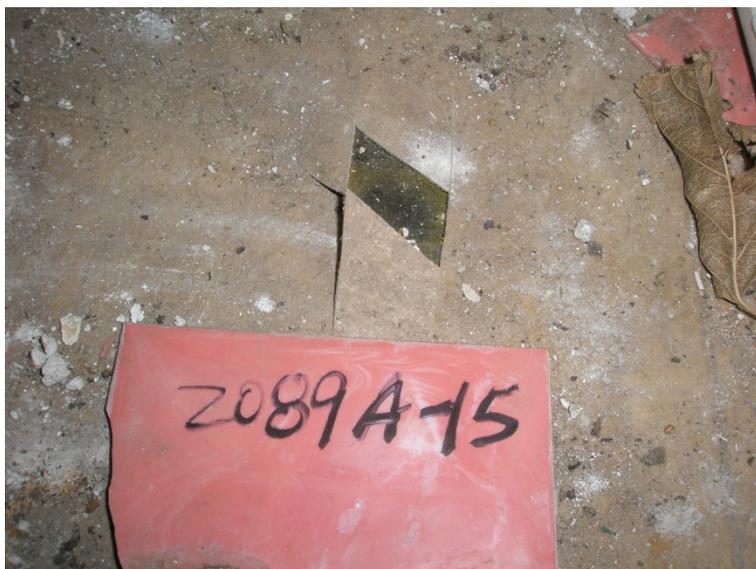
Photo 15: Brown/Beige Vinyl Linoleum (2089A-15) Bathroom 1. No Asbestos Detected.

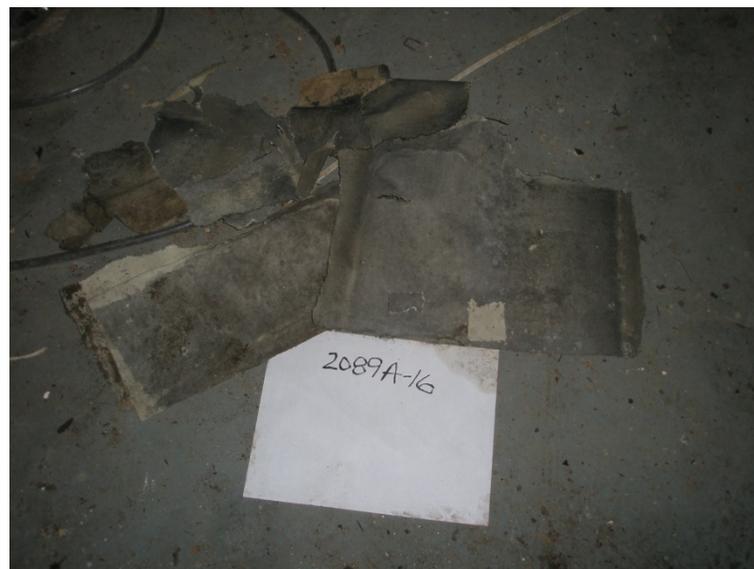
2089A-16 13-06-00332-016	25 Sq. Ft.	1	Ground Debris, Basement	Friable	65% Chrysotile Asbestos
2089A-17 13-06-00332-017A	132 Sq. Ft.	1	Dark Brown Tile, Basement Office	Non-friable	8% Chrysotile Asbestos

Photo 16: Ground Debris (2089A-16) Basement. 65% Chrysotile Asbestos Detected.

Confirmed or assumed asbestos-containing materials, which will be disturbed during demolition activities, are regulated under current Federal and State regulations. Hart Environmental Resources recommends the removal of these materials by a licensed asbestos abatement contractor. It is also strongly recommended that the specifications for the removal program be developed by a licensed Asbestos Project Designer to ensure that all regulatory requirements are satisfied. The work should be properly documented in the event of future litigation.

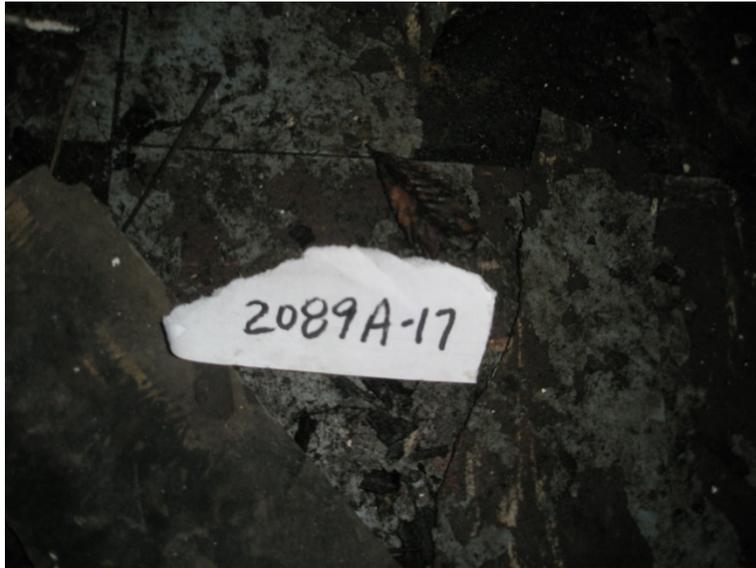
Photo 17: Dark Brown Tile (2089A-17) Basement Office. 8% Chrysotile Asbestos Detected.

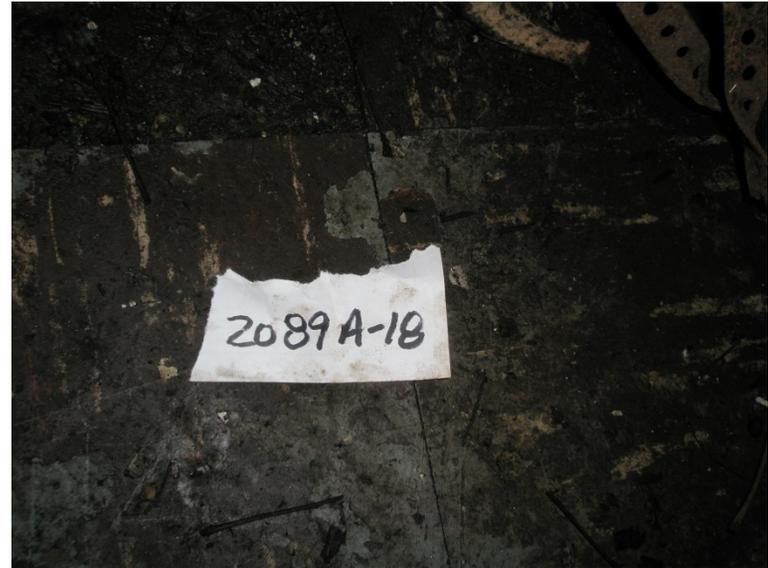
2089A-17 13-06-00332-017B	-	1	Dark Brown Tile Mastic, Basement Office	Non-friable	None Detected
2089A-18 13-06-00332-018A	See Above	1	Dark Brown Tile, Basement Office	Non-friable	7% Chrysotile Asbestos
2089A-18 13-06-00332-018B	-	1	Dark Brown Tile Mastic, Basement Office	Non-friable	None Detected
2089A-19 13-06-00332-019	-	2	Wall Plaster, Dining Room, Wall A	Non-friable	None Detected
2089A-20 13-06-00332-020	-	2	Wall Plaster, Living Room, Wall B	Non-friable	None Detected
2089A-21 13-06-00332-021	75 Sq. Ft.	1	Ductwork Wrap, Dining Room, Wall D	Friable	65% Chrysotile Asbestos
2089A-22 13-06-00332-022	-	1	Window Glazing, Sun Room, Wall B	Friable	None Detected

Photo 18: Dark Brown Tile (2089A-18) Basement Office. 7% Chrysotile Asbestos Detected.

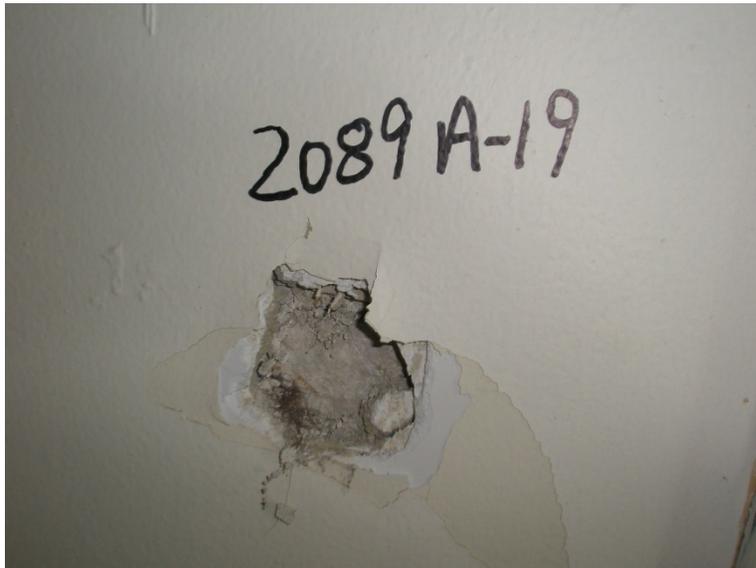
Photo 19: Wall Plaster (2089A-19) Dining Room. No Asbestos Detected.

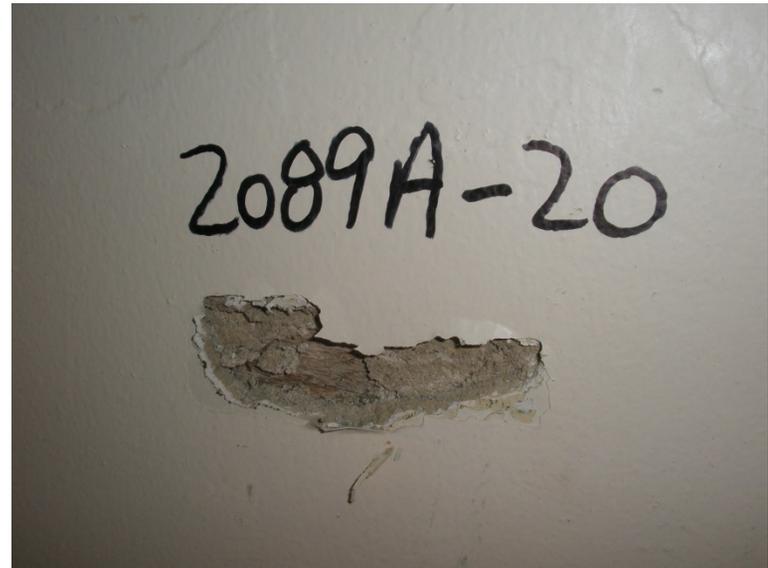
Photo 20: Wall Plaster (2089A-20) Living Room. No Asbestos Detected.

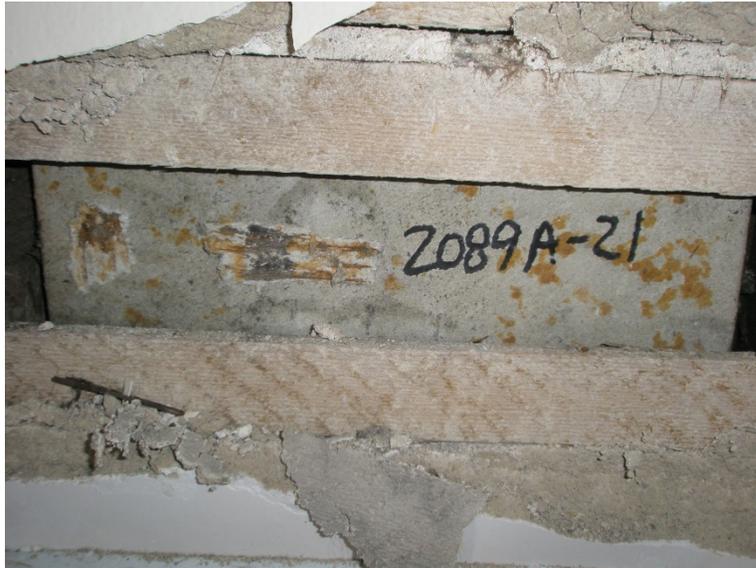
- Off-white, fibrous ground debris, Basement.
- Dark Brown, fibrous tile, Basement Office
- Off-white, fibrous ductwork wrap in Walls

Photo 21: Ductwork Wrap (2089A-21) Dining Room. 65% Chrysotile Asbestos Detected.

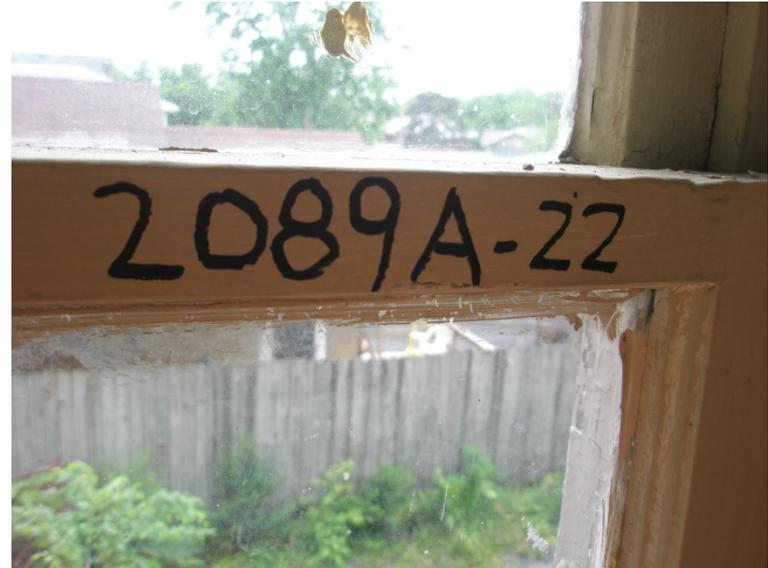
Photo 22: Window Glazing (2089A-22) Sun Room. No Asbestos Detected.

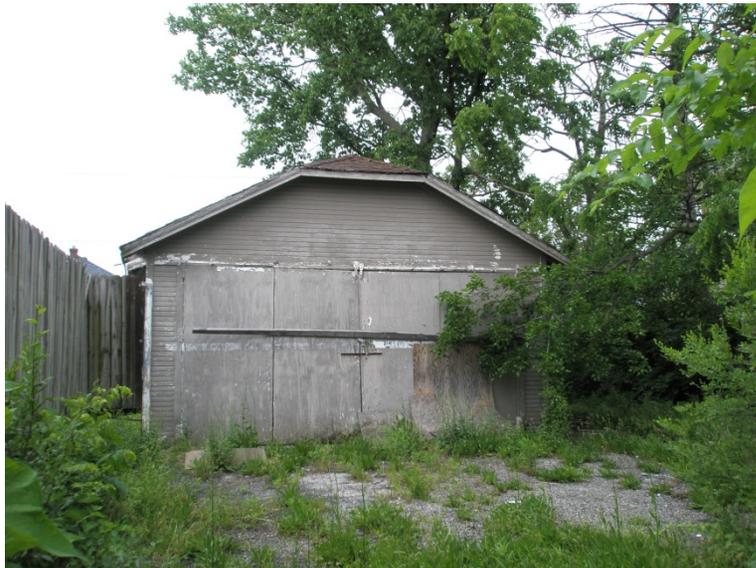
Photo 23: Detached Two-Car Garage. No Asbestos Detected.
