## **ASBESTOS INSPECTION REPORT**

**4668 Drew Way  
Dayton, OH 45416**

**Lynda M. Hart  
Asbestos Hazards Evaluation Specialist  
Ohio #ES-32558  
November 23, 2015**

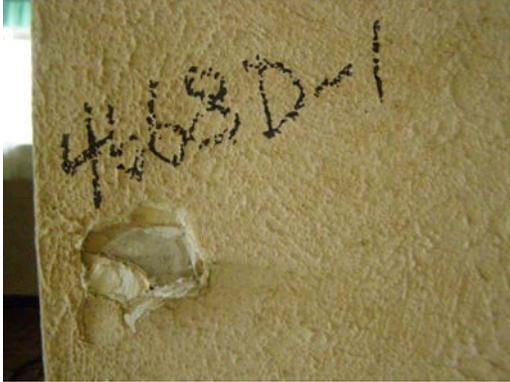
Photo 1: Drywall/Text. Paint (4668D-1) Living Room, Wall B. Trace <1% Chrysotile Asbestos Detected (Textured Paint PC=1.25%).

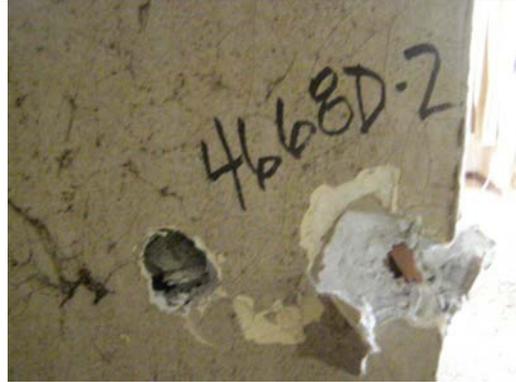
Photo 2: Drywall/Text. Paint (4668D-2) Kitchen, Wall D. Trace <1% Chrysotile Asbestos Detected (Textured Paint PC=1.50%).

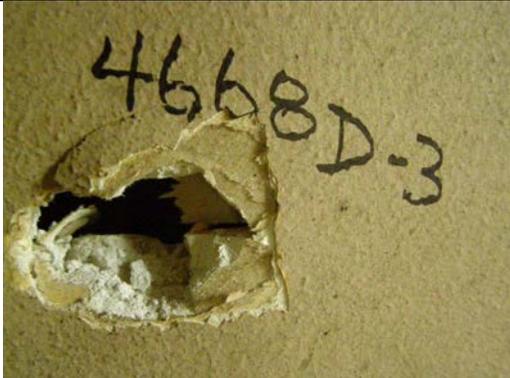
Photo 3: Drywall/Text. Paint (4668D-3) Bedroom 1, Wall B. Trace <1% Chrysotile Asbestos Detected (Textured Paint PC=1.25%).

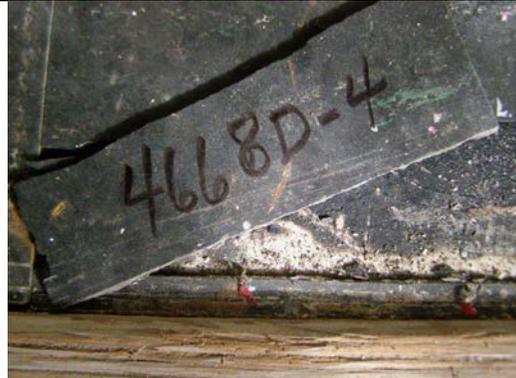
- Floor Tile, Throughout the structure
- Textured Paint - Bedrooms, Kitchen/Dining, Living Room (Walls A, B & D), Hall

Photo 4: Floor Tile (4668D-4) Bedroom 1 Closet, Floor. Tile: 4% Chrysotile Asbestos Detected (PC=2.25%). Mastic: 8% Chrysotile Asbestos Detected.

Confirmed or assumed asbestos-containing materials, which will be disturbed during demolition activities, are regulated under current Federal and State regulations. Hart Environmental Resources recommends the removal of these materials by a licensed asbestos abatement contractor. It is also strongly recommended that the specifications for the removal program be developed by a licensed Asbestos Project Designer to ensure that all regulatory requirements are satisfied. The work should be properly documented in the event of future litigation.

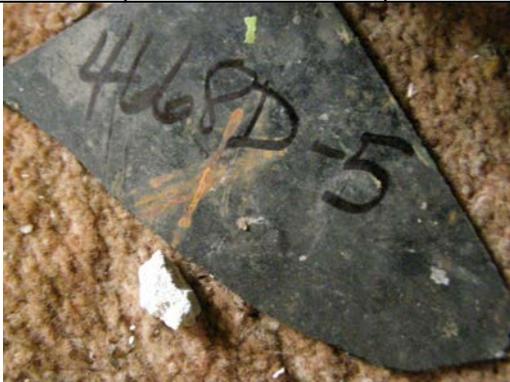
Photo 5: Floor Tile (4668D-4) Hall Closet, Floor. 5% Chrysotile Asbestos Detected (PC=2.25%).

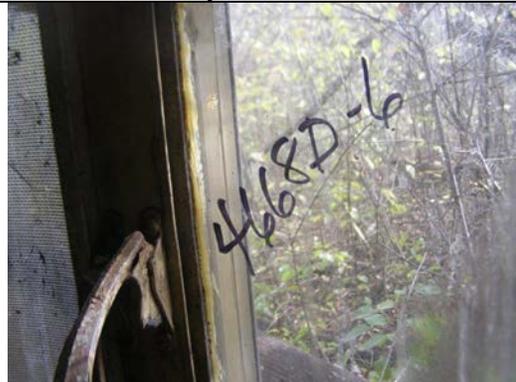
Photo 6: Window Glazing (4668D-6) Bedroom 1, Wall C. No Asbestos Detected.

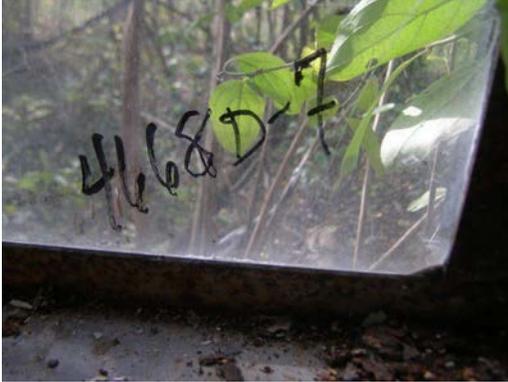
**Photo 7: Window Glazing (4668D-7) Living Room, Wall D.  
No Asbestos Detected.**

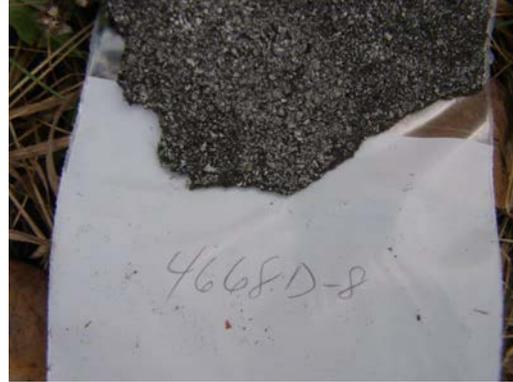
**Photo 8: Roof Shingle (4668D-8) Exterior.  
No Asbestos Detected.**

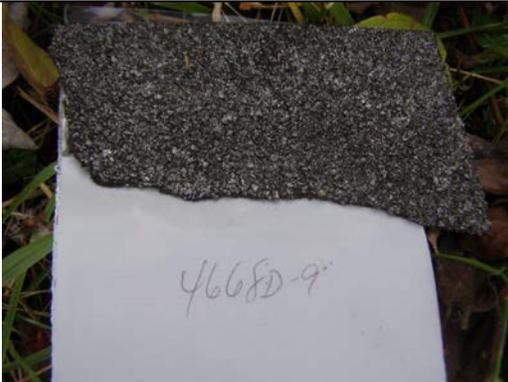
**Photo 9: Roof Shingle (4668D-9) Exterior.  
No Asbestos Detected.**
