ASBESTOS INSPECTION REPORT

**5121 Gardendale Ave.
Dayton, OH 45417**

**Lynda M. Hart
Asbestos Hazards Evaluation Specialist
Ohio #ES-32558
November 25, 2015**

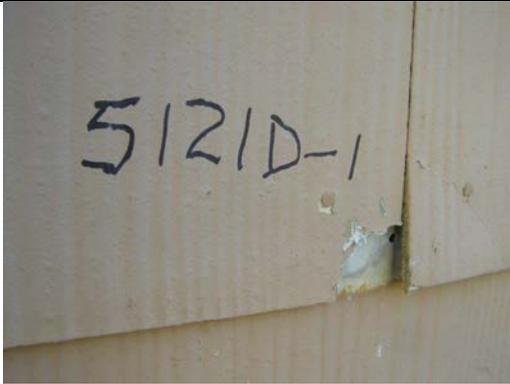
**Photo 1: Transite (5121G-1) Exterior, Wall B.
20% Chrysotile Asbestos Detected.**

Confirmed or assumed asbestos-containing materials, which will be disturbed during demolition activities, are regulated under current Federal and State regulations. Hart Environmental Resources recommends the removal of these materials by a licensed asbestos abatement contractor. It is also strongly recommended that the specifications for the removal program be developed by a licensed Asbestos Project Designer to ensure that all regulatory requirements are satisfied. The work should be properly documented in the event of future litigation.

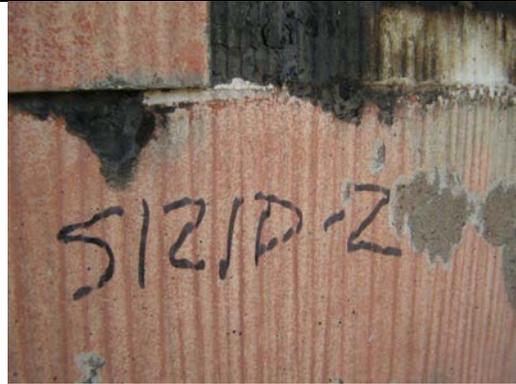
**Photo 2: Transite (5121G-2) Exterior, Wall C.
20% Chrysotile Asbestos Detected.**

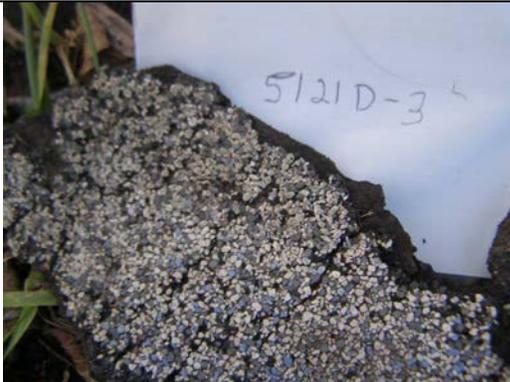
**Photo 3: Roof Shingle (5121G-3) Exterior.
No Asbestos Detected.**

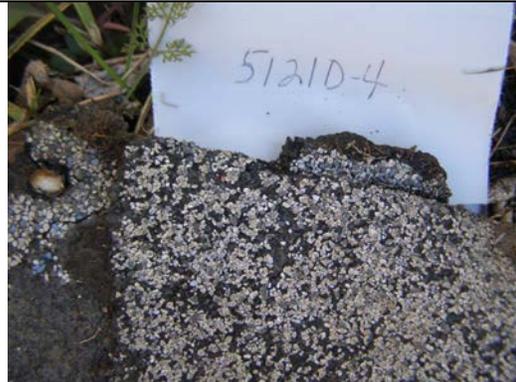
**Photo 4: Roof Shingle (5121G-4) Exterior.
3% Chrysotile Asbestos Detected (PC=1.50%).**

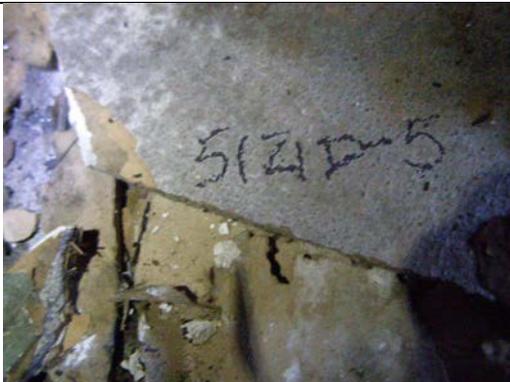
**Photo 5: Drywall (5121G-5) Living Room, Wall D.
Trace <1% Chrysotile Asbestos Detected (Joint
Compound PC=1.25%) (Composite PC=0.75%).**

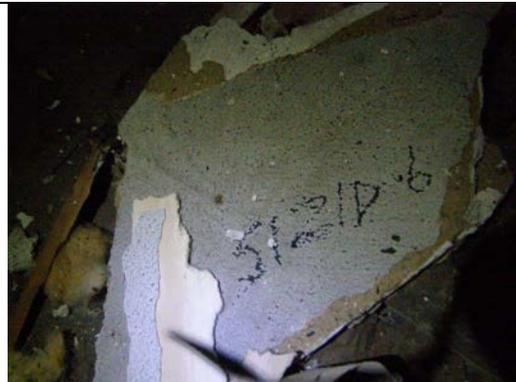
**Photo 6: Drywall (5121G-6) Bedroom 2, Floor.
Trace <1% Chrysotile Asbestos Detected (Joint
Compound PC=1.25%) (Composite PC=0.50%).**

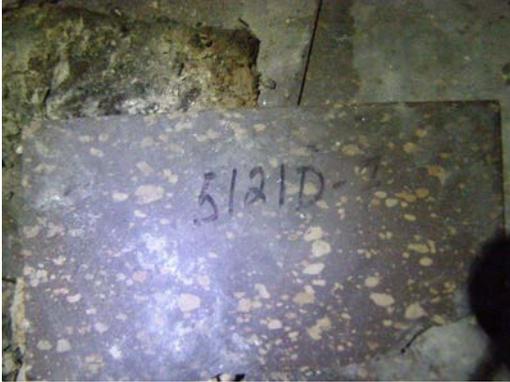
**Photo 7: Floor Tile (5121G-7) Hall, Floor.
4% Chrysotile Asbestos Detected (PC=2.0%).**

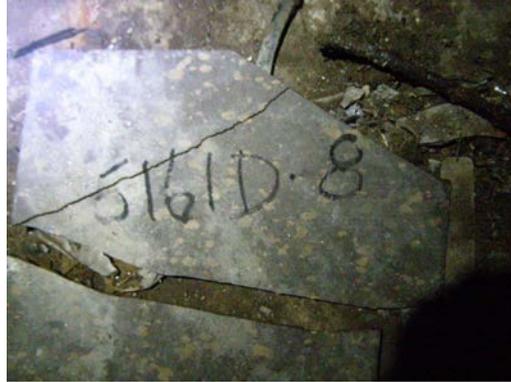
**Photo 8: Floor Tile (5121G-8) Utility Room, Floor.
4% Chrysotile Asbestos Detected (PC=2.25%).**
