ASBESTOS INSPECTION REPORT

**2205 Homesite Dr.
Dayton, OH 45414**

Re: Asbestos Inspection
2205 Homesite Dr.
Dayton, OH 45414

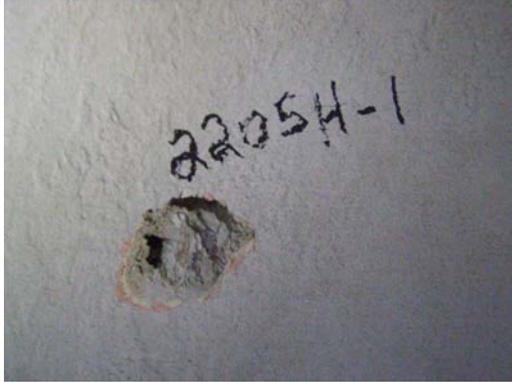
Photo 1: Plaster (2205H-1) Living Room, Wall A.
No Asbestos Detected.

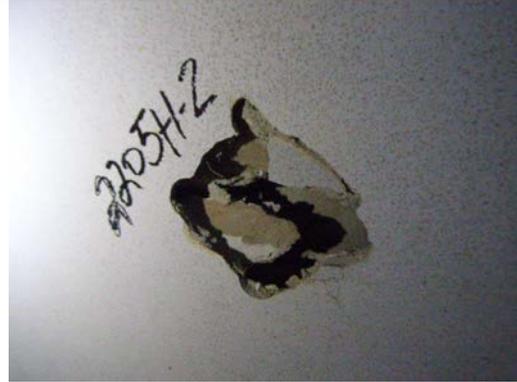
Photo 2: Plaster (2205H-2) Hall, Wall B.
No Asbestos Detected.

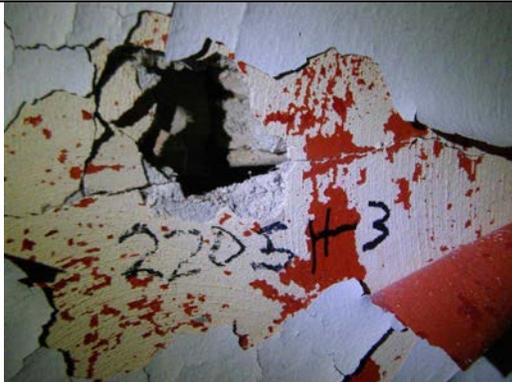
Photo 3: Plaster (2205H-3) Kitchen, Wall B.
No Asbestos Detected.

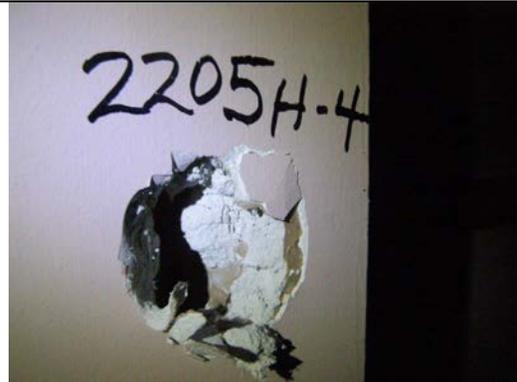
Photo 4: Drywall/J.C. (2205H-4) Bedroom 3, Wall A.
No Asbestos Detected.

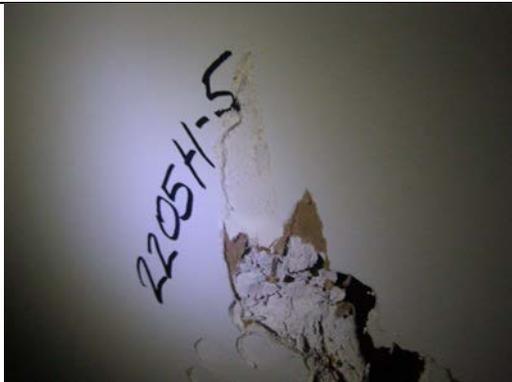
Photo 5: Drywall/J.C. (2205H-5) Bedroom 3, Wall C.
No Asbestos Detected.

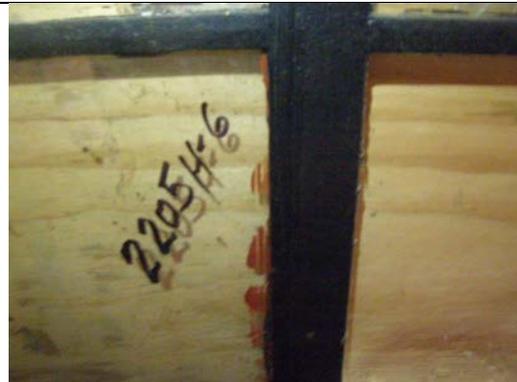
- Window Glazing, 8 metal window

Photo 6: Window Glazing (2205H-6) Family Room, Wall A.
3% Chrysotile Asbestos Detected (PC=1.25%).

Confirmed or assumed asbestos-containing materials, which will be disturbed during demolition activities, are regulated under current Federal and State regulations. Hart Environmental Resources recommends the removal of these materials by a licensed asbestos abatement contractor. It is also strongly recommended that the specifications for the removal program be developed by a licensed Asbestos Project Designer to ensure that all regulatory requirements are satisfied. The work should be properly documented in the event of future litigation.

<u>Material</u>	<u>Est. Qty.</u>	<u>Est. Unit Cost</u>	<u>Est. Cost</u>
Window Glazing	8 ea	\$ 25/ea	\$ 200

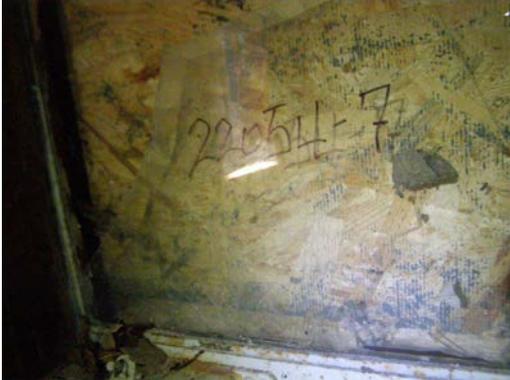
Photo 7: Window Glazing (2205H-7) Kitchen, Wall C.
3% Chrysotile Asbestos Detected (PC=1.25%).

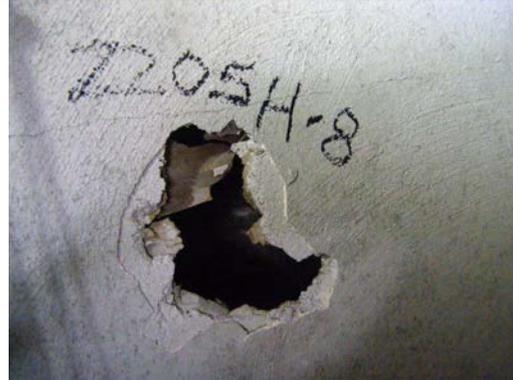
Photo 8: Plaster Bd./Drywall (2205H-8) Furnace Room,
Wall C. No Asbestos Detected.

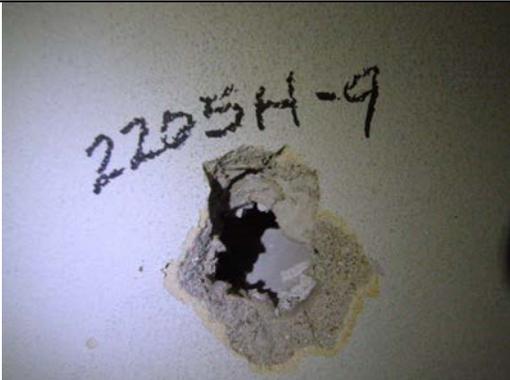
Photo 9: Plaster Bd./Drywall (2205H-9) Dining Room,
Wall B. No Asbestos Detected.
