ASBESTOS INSPECTION REPORT

**2344 Cardinal Ave.
Dayton, OH 45414**

Re: Asbestos Inspection
2344 Cardinal Ave.
Dayton, OH 45414

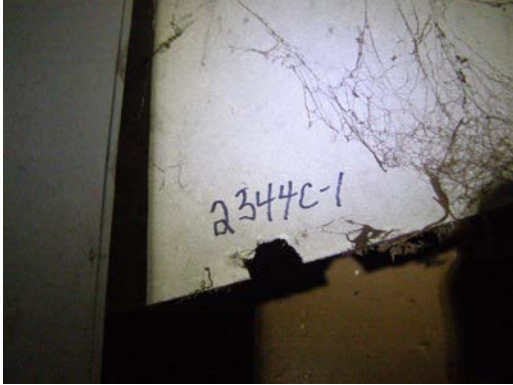
Photo 1: Furnace Board (2344C-1) Kitchen, Ceiling.
45% Chrysotile Asbestos Detected.

Confirmed or assumed asbestos-containing materials, which will be disturbed during demolition activities, are regulated under current Federal and State regulations. Hart Environmental Resources recommends the removal of these materials by a licensed asbestos abatement contractor. It is also strongly recommended that the specifications for the removal program be developed by a licensed Asbestos Project Designer to ensure that all regulatory requirements are satisfied. The work should be properly documented in the event of future litigation.

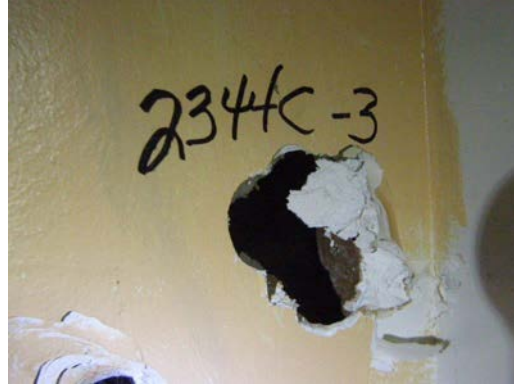
Photo 2: Drywall/J.C. (2344C-3) Bedroom 1, Wall B.
No Asbestos Detected.

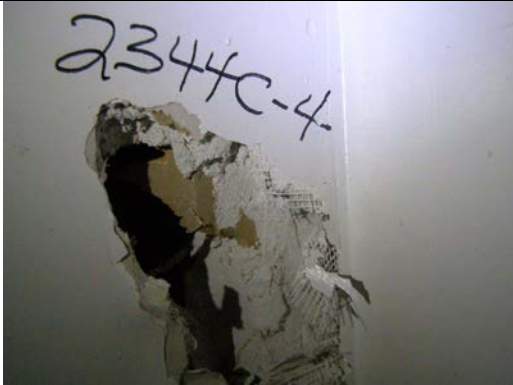
Photo 3: Drywall/J.C. (2344C-4) Living Room, Wall C.
No Asbestos Detected.

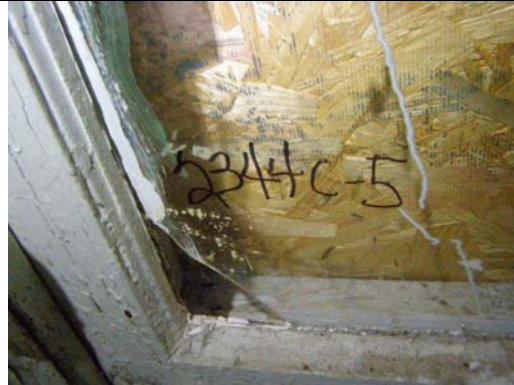
Photo 4: Window Glazing (2344C-5) Living Room,
Wall D. 2% Chrysotile Asbestos Detected (PC=1.25%).

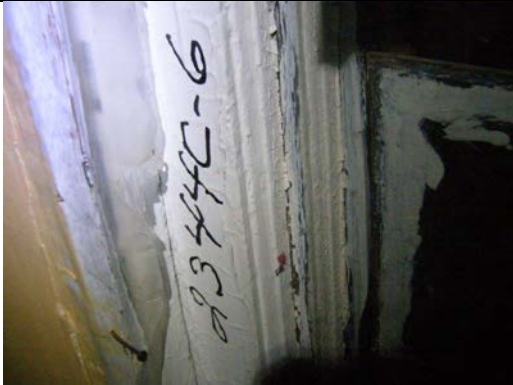
Photo 5: Window Glazing (2344C-6) Bedroom 1, Wall
B. 2% Chrysotile Asbestos Detected (PC=1.25%).

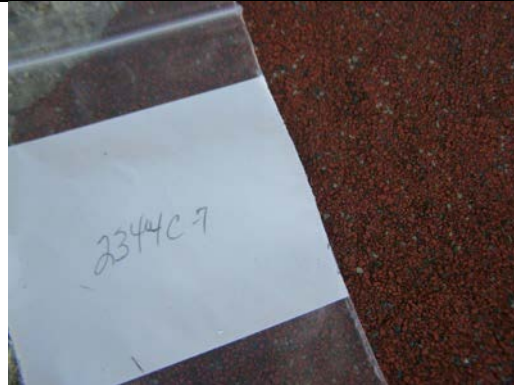
Photo 6: Roof Shingle (2344C-7) Exterior.
No Asbestos Detected.

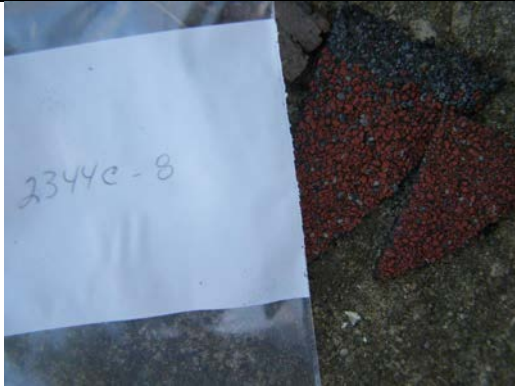
**Photo 7: Roof Shingle (2344C-8) Exterior.
No Asbestos Detected.**
