SIERRA ENVIRONMENTAL GROUP, INC.

December 15, 2015

Re: Comprehensive Pre-Demolition Asbestos Inspection
Vacant Residences
2631-2633 North Main Street
Dayton, Ohio 45405
Sierra Project Number: MCLB.003

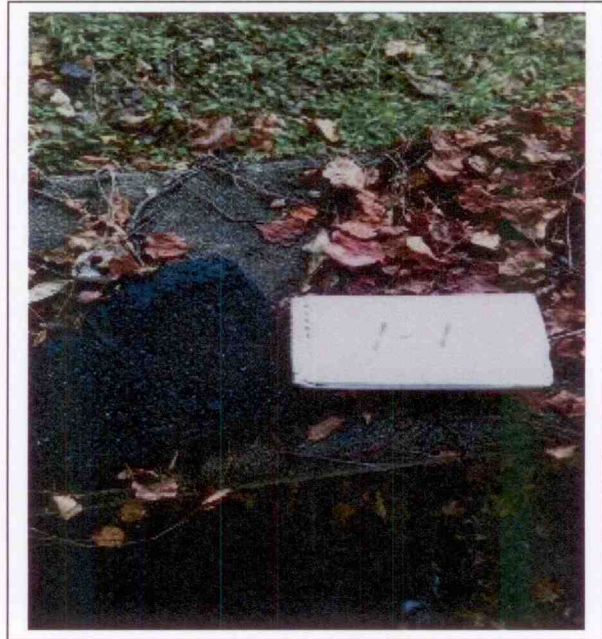
Black asphalt roof shingle

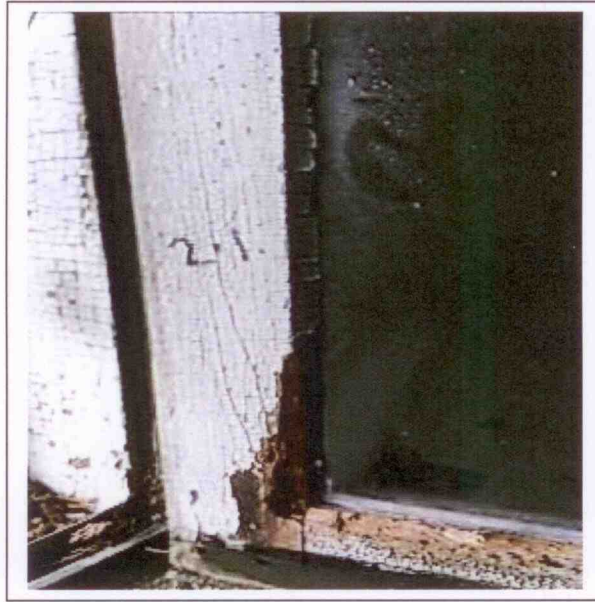
Window glaze

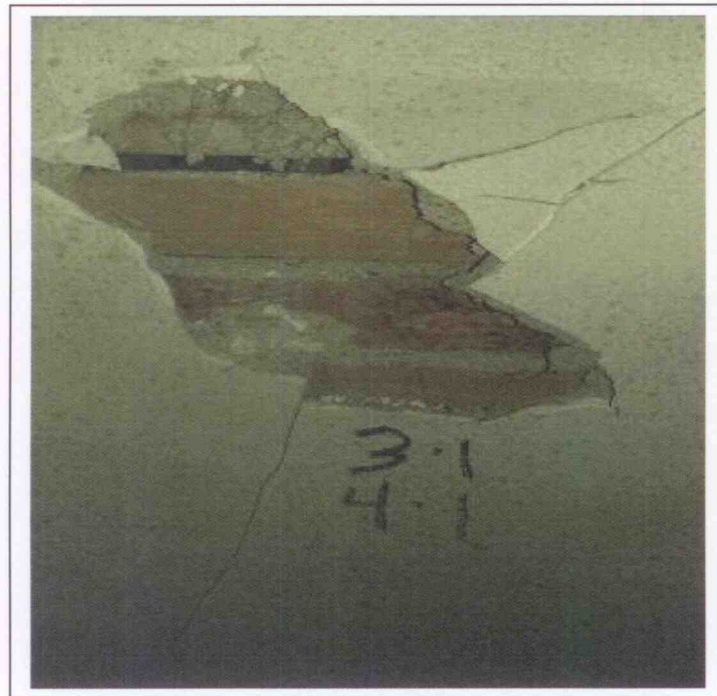
Hard wall and ceiling plaster

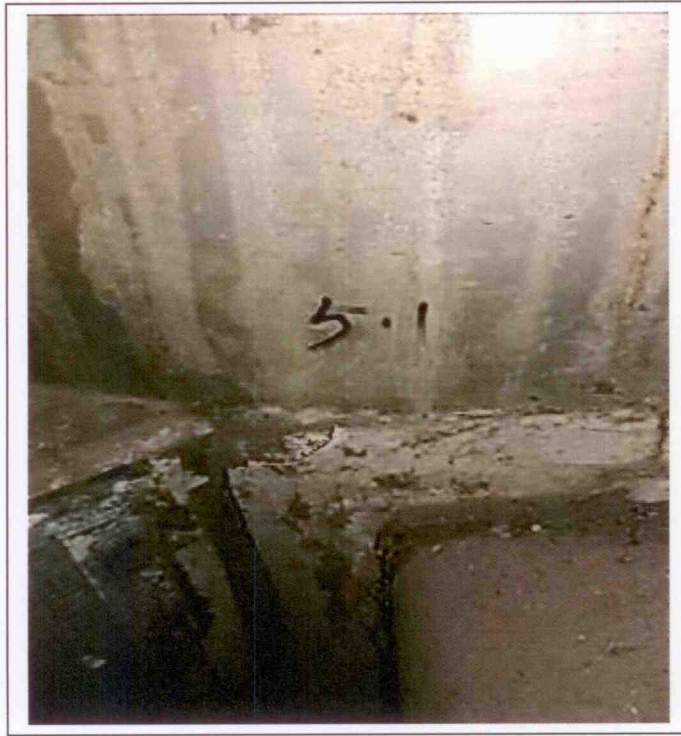
Furnace duct insulation

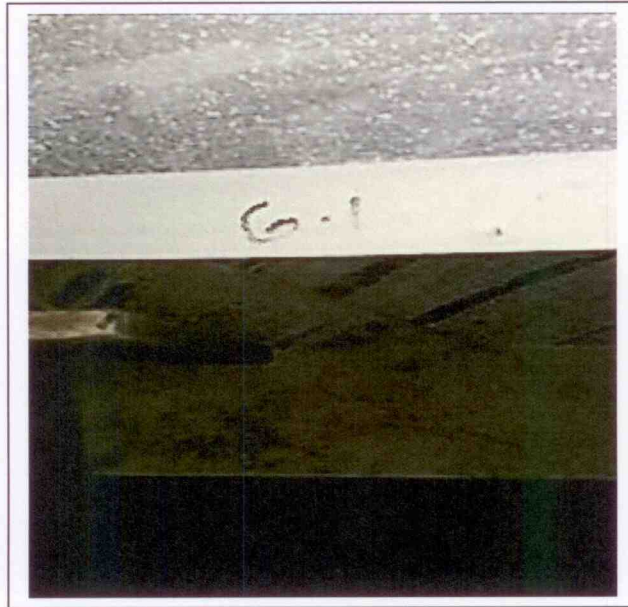
Duct insulation

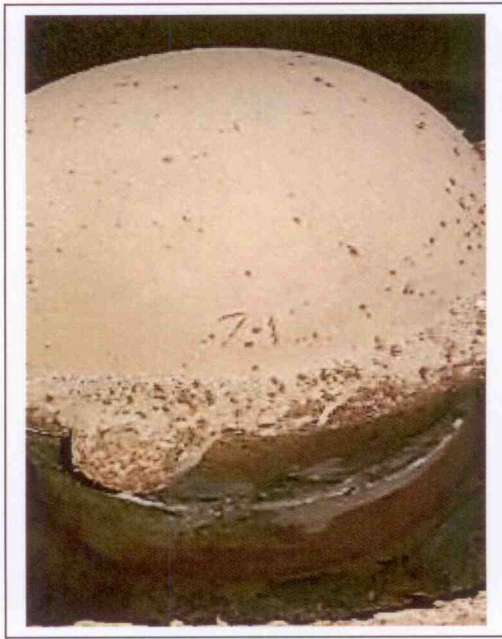
Cementitious furnace gasket

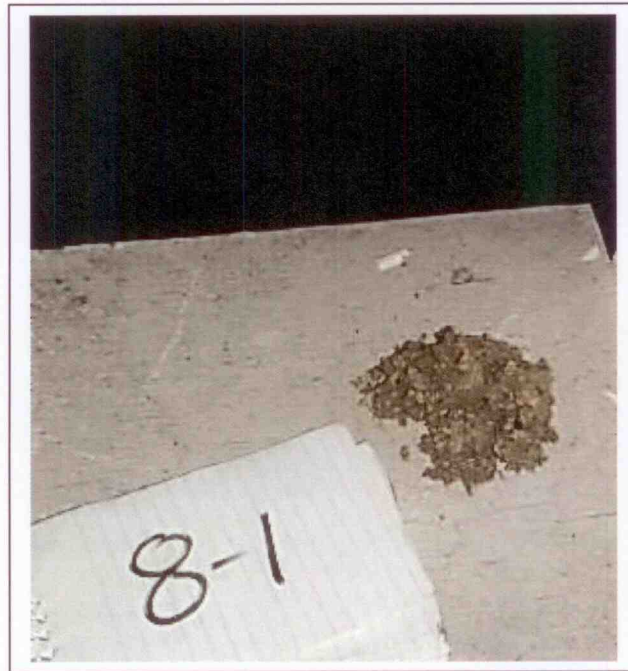
Blown-in insulation

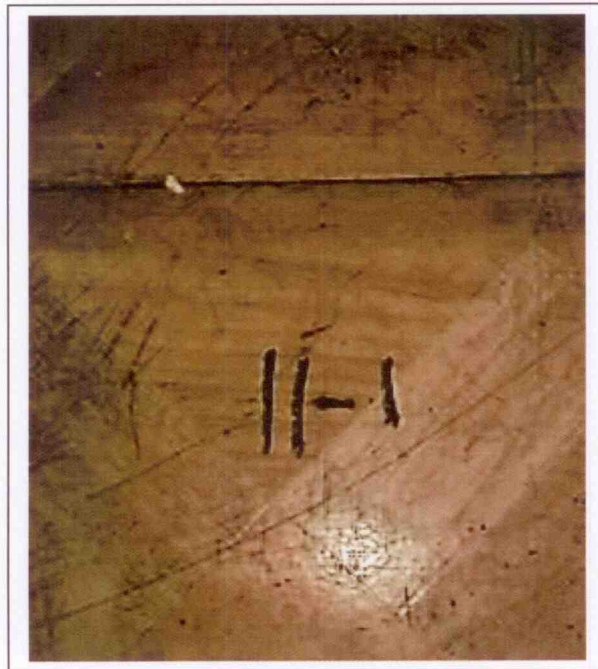
12" Yellow sticky back floor tile

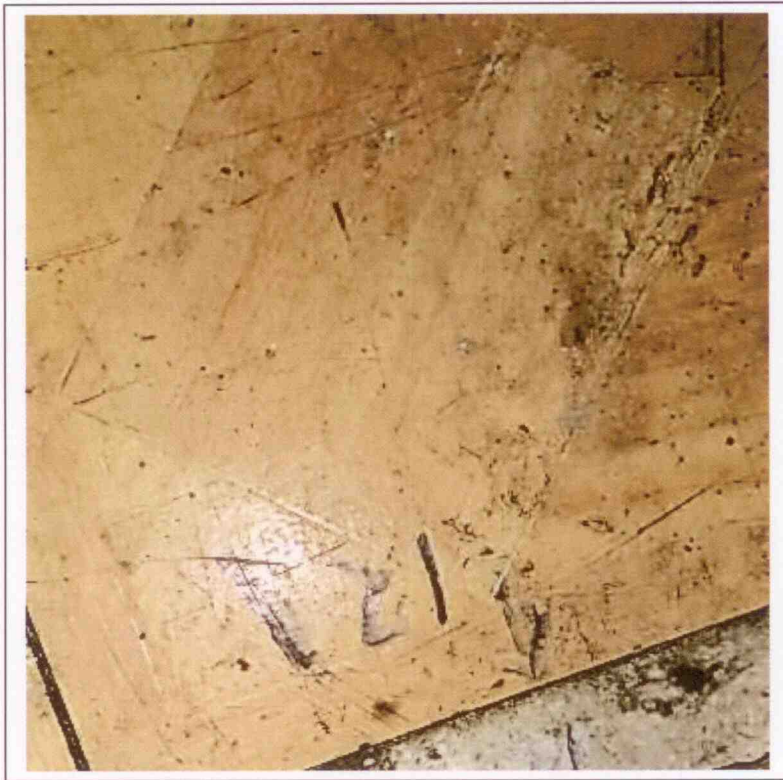
White linoleum under yellow linoleum

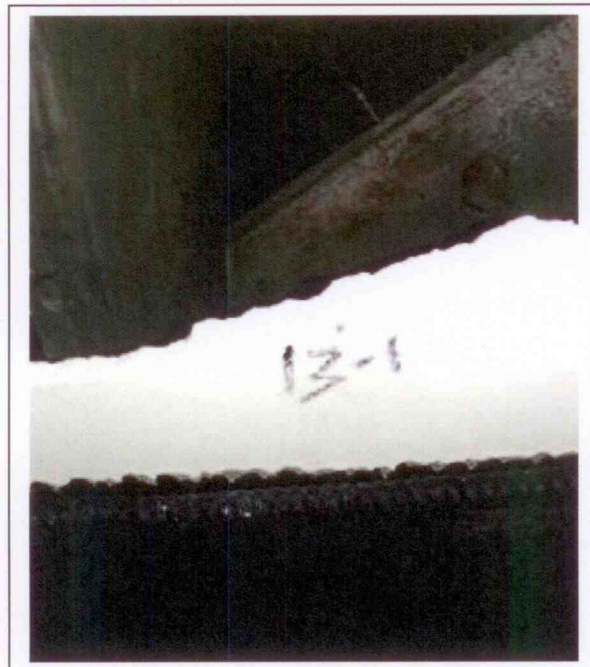
Heat shield

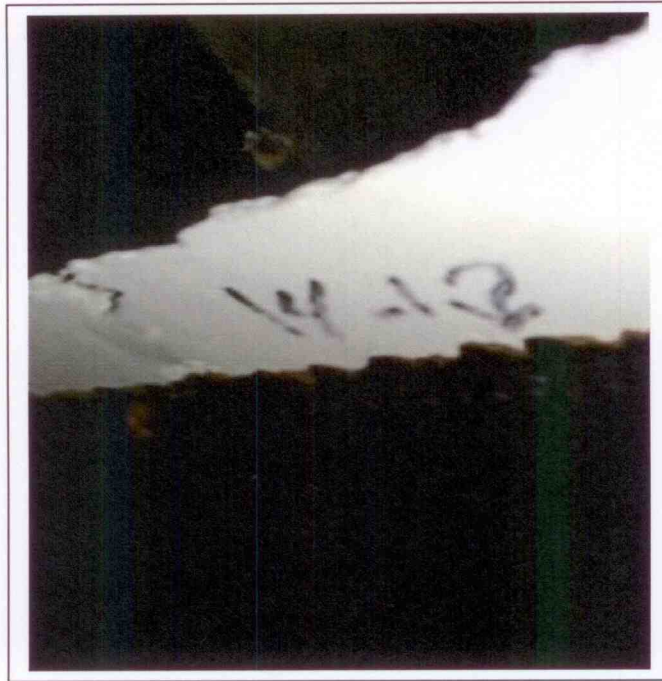
Black paper
