December 14, 2015

**Re:** Comprehensive Pre-Demolition Asbestos Inspection  
Vacant Residences  
1029-1031 West 2<sup>nd</sup> Street  
Dayton, Ohio 45402  
Sierra Project Number: MCLB.003

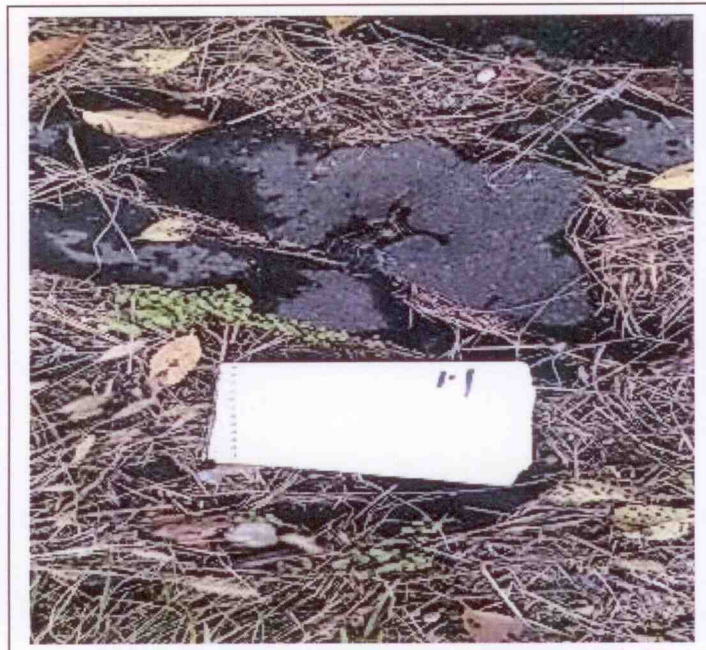
| SAMPLE<br>DESCRIPTION<br>(Material Type) | SAMPLE<br>LOCATION | HOMO AREA<br># | SAMPLE<br>I.D. NO. | ASBESTOS<br>CONTENT | FRIABLE/<br>NONFRIABLE |
|---|---|---|---|---|---|
| Asphalt roof shingle<br>(Miscellaneous) | Exterior | 1 | 1-1 | None Detected | Nonfriable |

Asphalt roof shingle

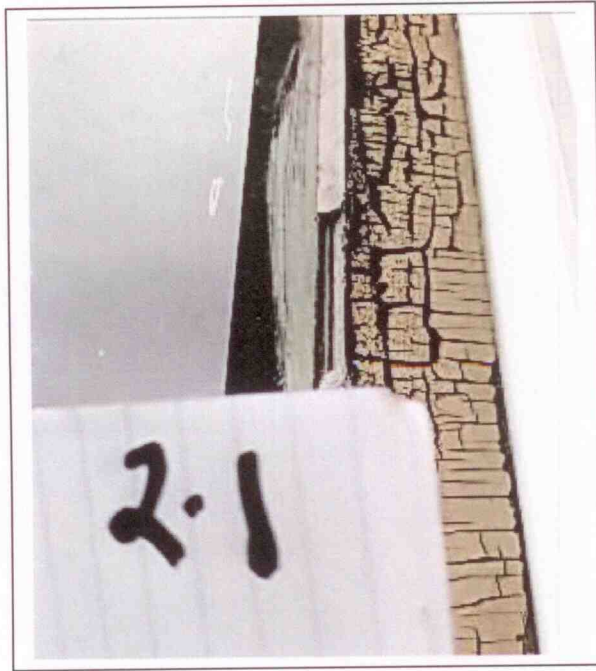
| SAMPLE<br>DESCRIPTION<br>(Material Type) | SAMPLE<br>LOCATION | HOMO AREA<br># | SAMPLE<br>I.D. NO. | ASBESTOS<br>CONTENT | FRIABLE/<br>NONFRIABLE |
|---|---|---|---|---|---|
| Window glaze<br>(Miscellaneous) | Exterior | 2 | 2-1 | None Detected | Friable |

Window glaze

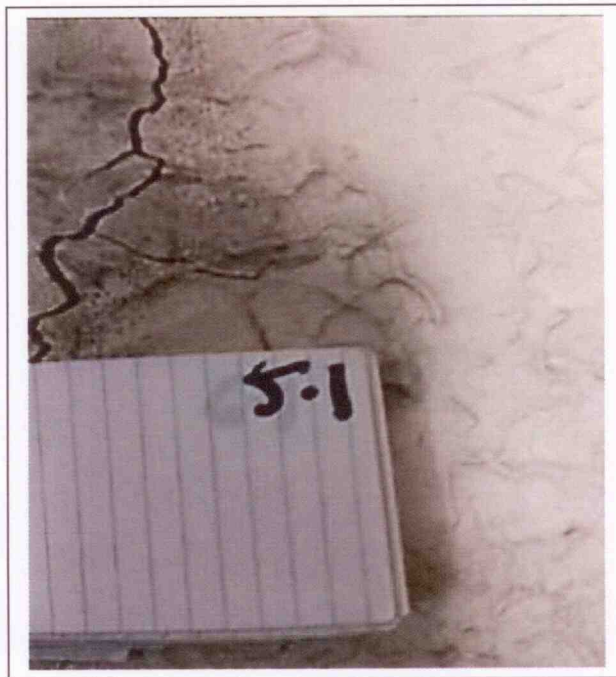
Wall texture, rough

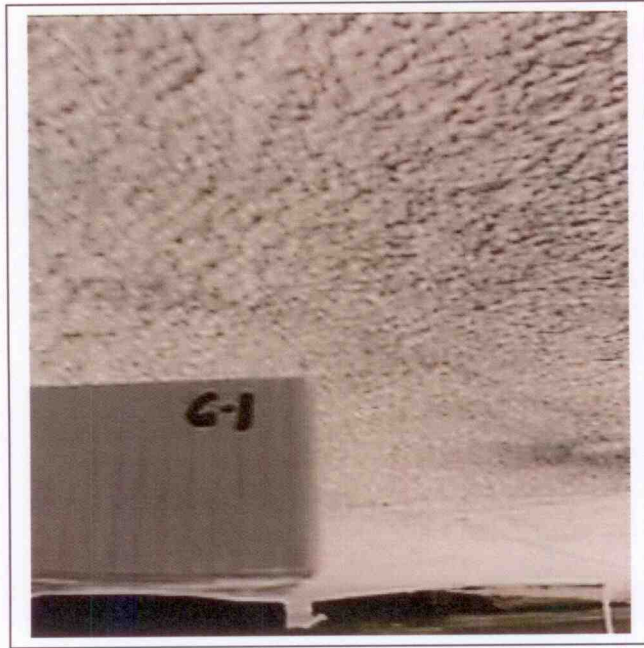
Ceiling texture, fine

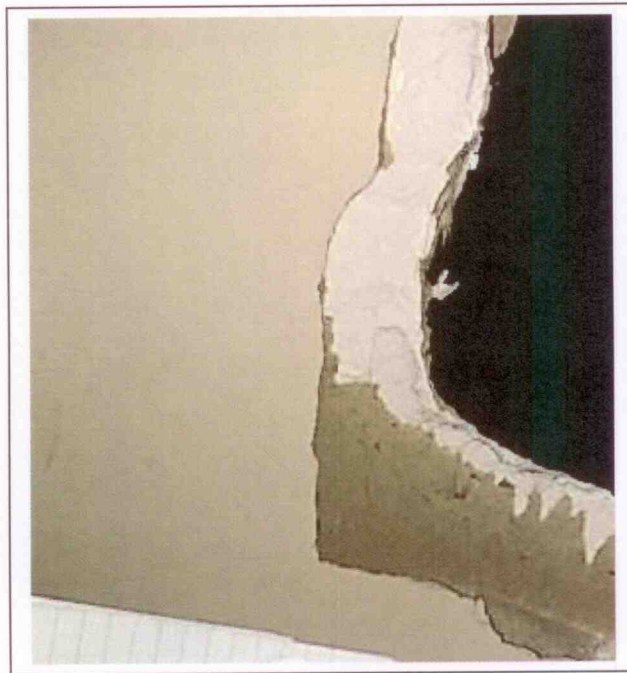
Drywall

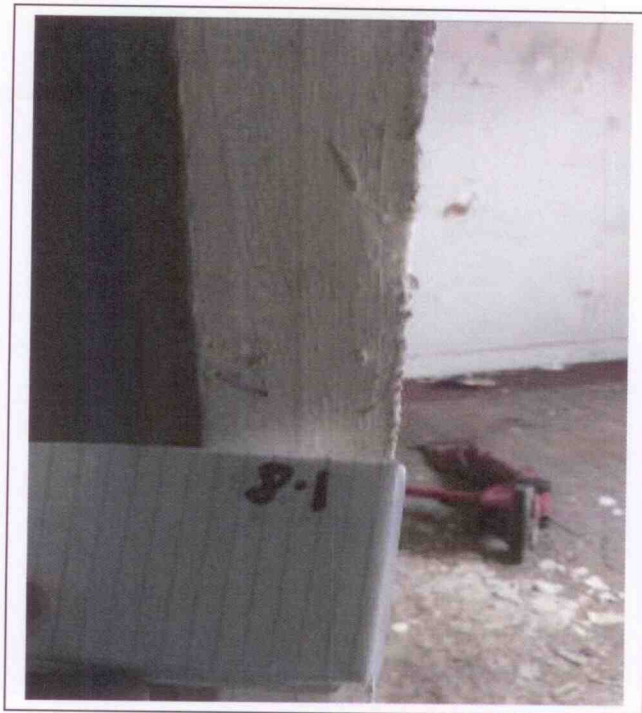
Joint compound

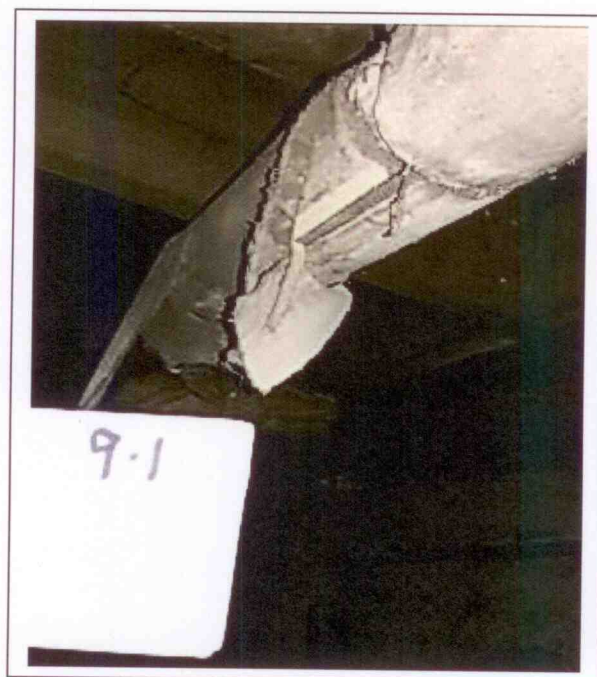
| <b>SAMPLE<br/>DESCRIPTION<br/>(Material Type)</b> | <b>SAMPLE<br/>LOCATION</b> | <b>HOMO AREA<br/>#</b> | <b>SAMPLE<br/>I.D. NO.</b> | <b>ASBESTOS<br/>CONTENT</b> | <b>FRIABLE/<br/>NONFRIABLE</b> |
|---|---|---|---|---|---|
| Aircell-paper pipe insulation<br>(Thermal System Insulation) | Basement | 9 | 9-1 | 55% Chrysotile | Friable |

| Location | Type<br>ACM | Material<br>Description | Amt. of<br>Material<br>(approx.) |
|---|---|---|---|
| Basement, 1029 side | RACM | Aircell-paper pipe insulation | 150 lf |
| Basement, 1031 side | RACM | Aircell-paper pipe insulation | 150 lf |

Aircell-paper pipe insulation

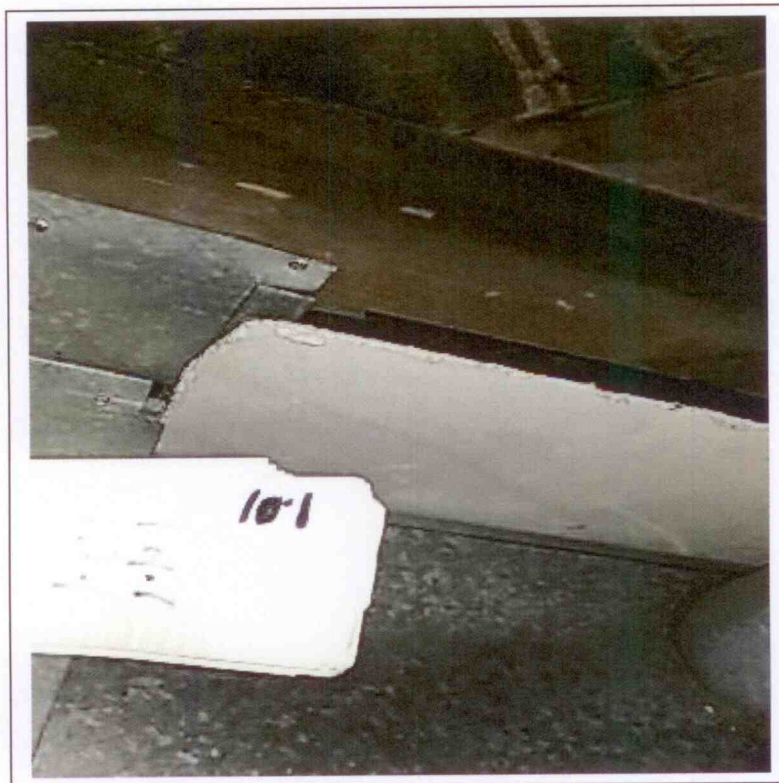
| <b>SAMPLE<br/>DESCRIPTION<br/>(Material Type)</b> | <b>SAMPLE<br/>LOCATION</b> | <b>HOMO AREA<br/>#</b> | <b>SAMPLE<br/>I.D. NO.</b> | <b>ASBESTOS<br/>CONTENT</b> | <b>FRIABLE/<br/>NONFRIABLE</b> |
|---|---|---|---|---|---|
| Heat shield<br>(Thermal System Insulation) | Basement | 10 | 10-1 | 42% Chrysotile | Friable |

| Location | Type<br>ACM | Material<br>Description | Amt. of<br>Material<br>(approx.) |
|---|---|---|---|
| Basement, 1031 side | RACM | Heat shield | 12 sf |

Heat shield

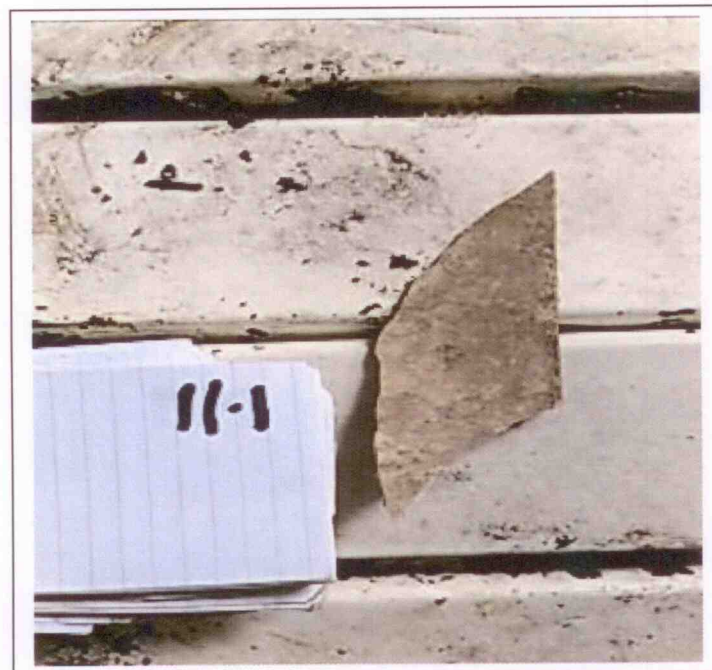
12" Tan floor tile

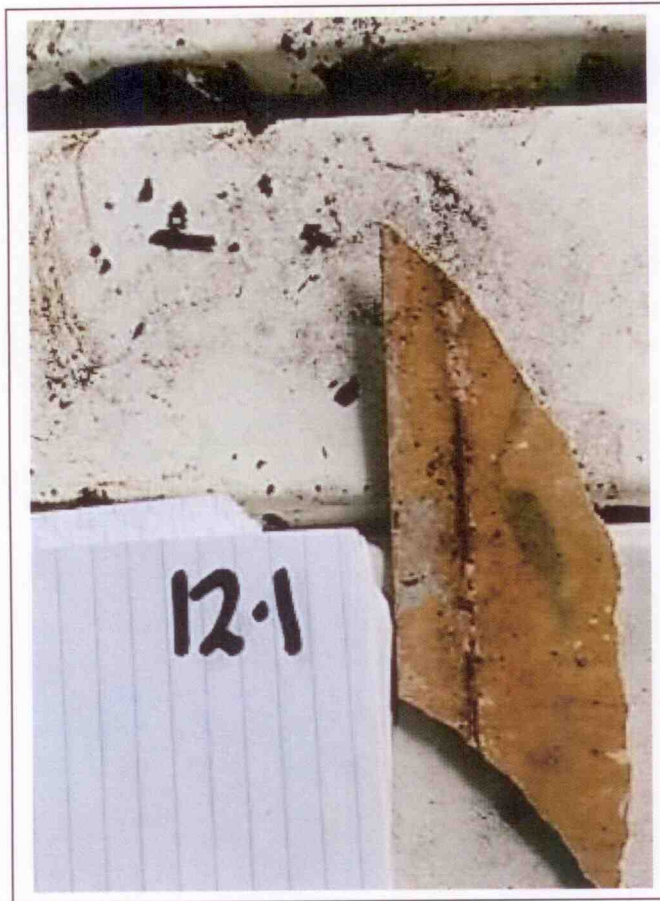
Brown mastic associated with 12" tan floor tile
