**SIERRA** ENVIRONMENTAL GROUP, INC.

December 11, 2015

**Re:** Comprehensive Pre-Demolition Asbestos Inspection  
Vacant Residence  
1535 West 2<sup>nd</sup> Street  
Dayton, Ohio 45402  
Sierra Project Number: MCLB.003

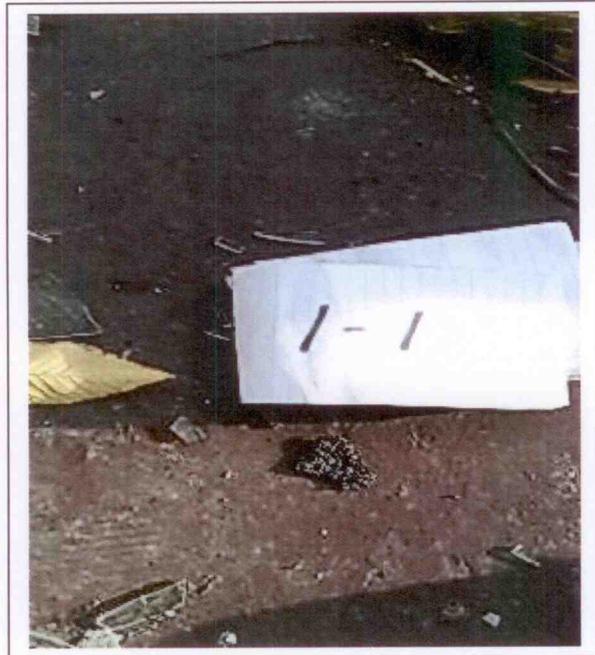
Asphalt roof shingle

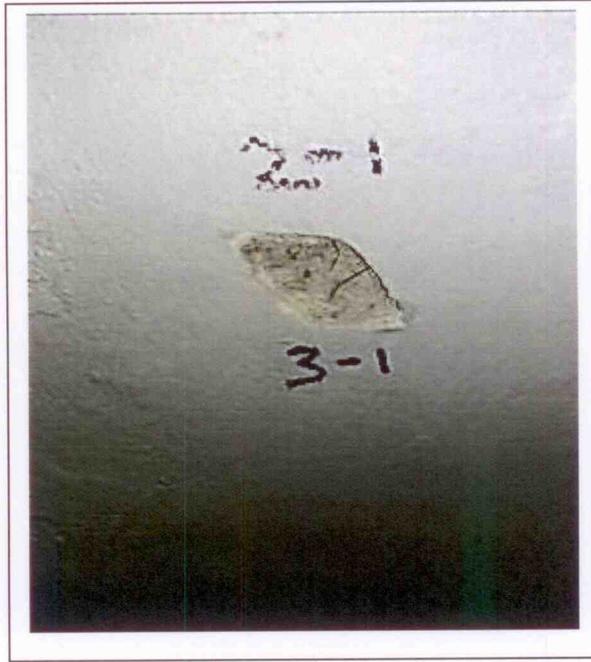
Hard wall and ceiling plaster

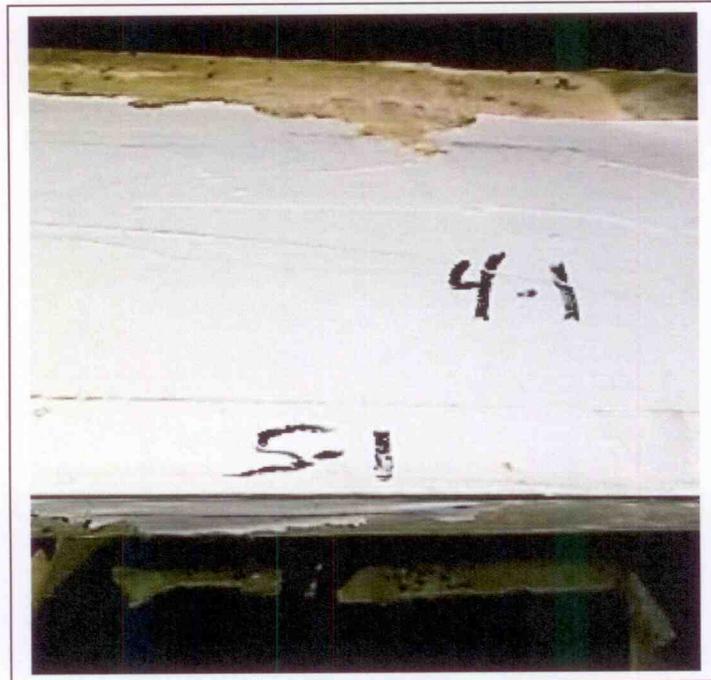
Drywall and associated joint compound

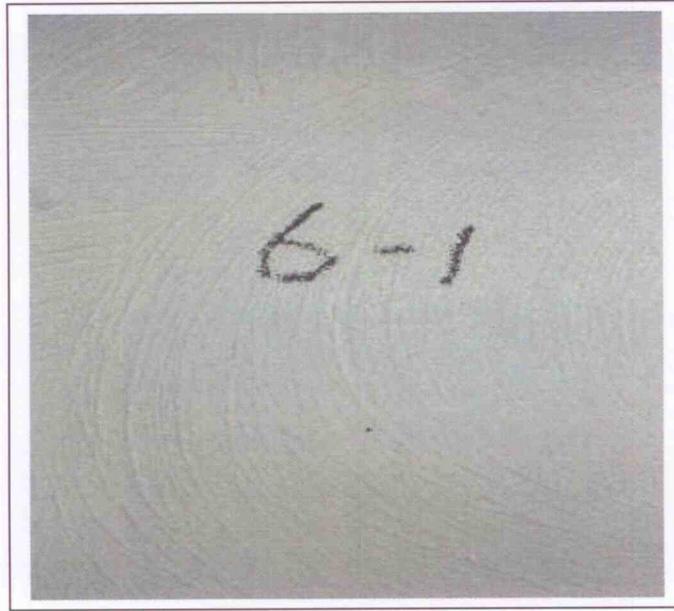
Textured ceiling, swirl pattern

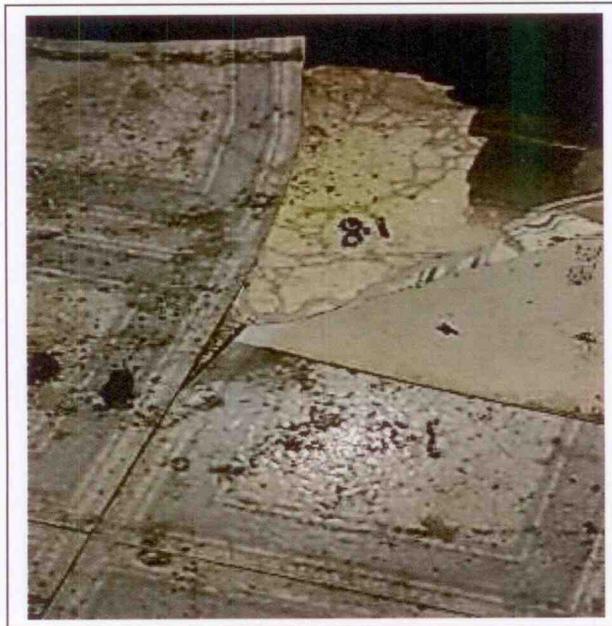
12" Grey sticky back floor tile over tan linoleum

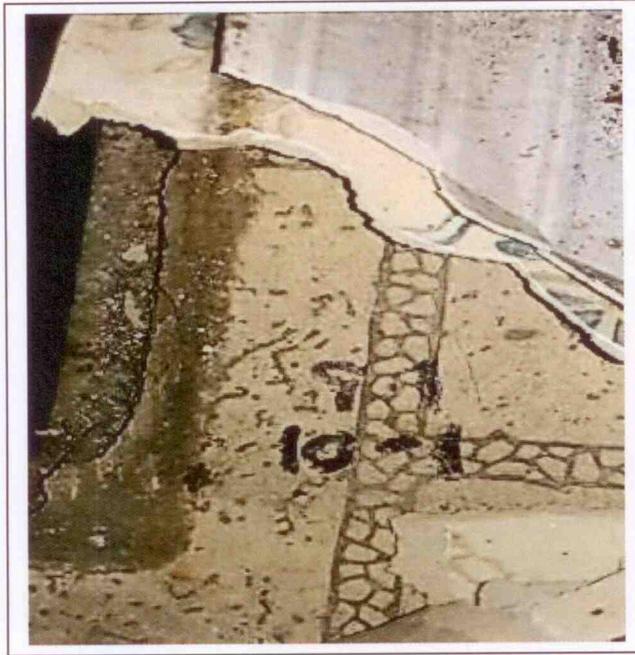
Tan floor tile (Miscellaneous)	Kitchen	9	9-1	2% Chrysotile	Nonfriable
Tan floor tile (Miscellaneous)	Kitchen	9	9-2	Stopped Analysis	Nonfriable
Brown mastic associated with tan floor tile (Miscellaneous)	Kitchen	10	10-1	None Detected	Nonfriable
Brown mastic associated with tan floor tile (Miscellaneous)	Kitchen	10	10-2	None Detected	Nonfriable
Black floor mastic (Miscellaneous)	Bathroom near kitchen	11	11-1	4% Chrysotile	Nonfriable
Black floor mastic (Miscellaneous)	Bathroom near kitchen	11	11-2	Stopped Analysis	Nonfriable
Textured wall (Surfacing, <1,000 sf)	Stairwell to 2nd floor	12	12-1	None Detected	Nonfriable

Tan floor tile and associated mastic

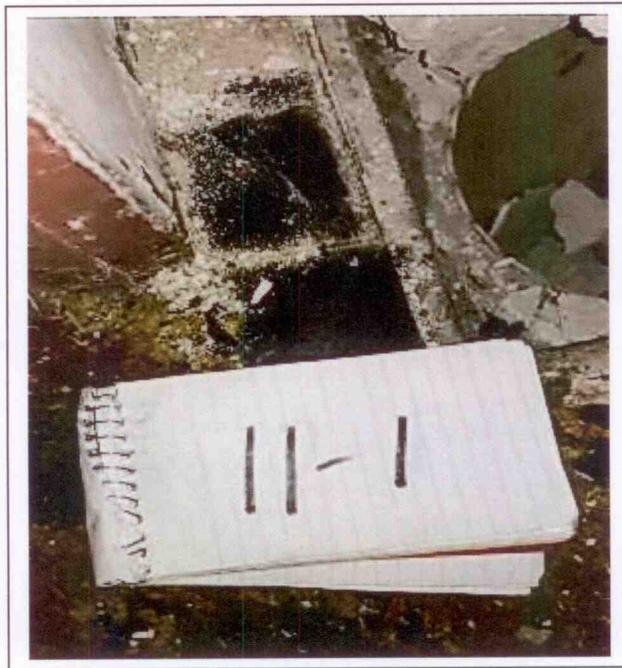
Kitchen	I	Tan floor tile (3rd layer)	140 sf
Bathroom near kitchen	I	Tan floor tile	80 sf
Bathroom near kitchen	I	Black floor mastic	80 sf
Back room 1	I	12"x12" Grey floor tile	170 sf
Back room 2	I	12"x12" Grey floor tile	170 sf
Basement	RACM	Duct insulation	30 sf
Basement	RACM	Heat shield	20 sf
Basement	II	Cementitious panel	20 sf

Black floor mastic

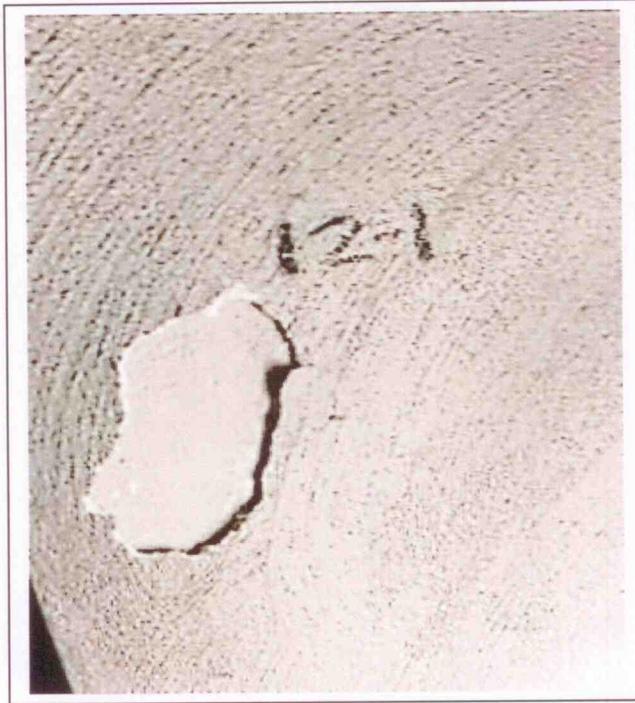
Textured wall, fine

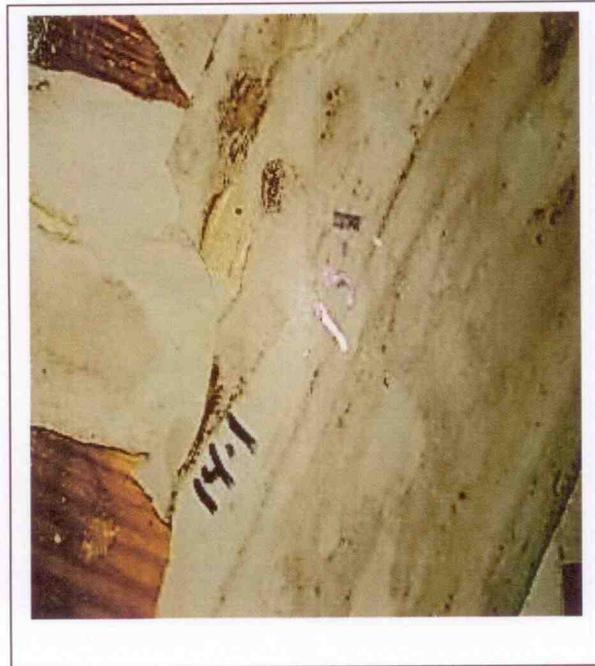
12" Grey floor tile and associated brown mastic

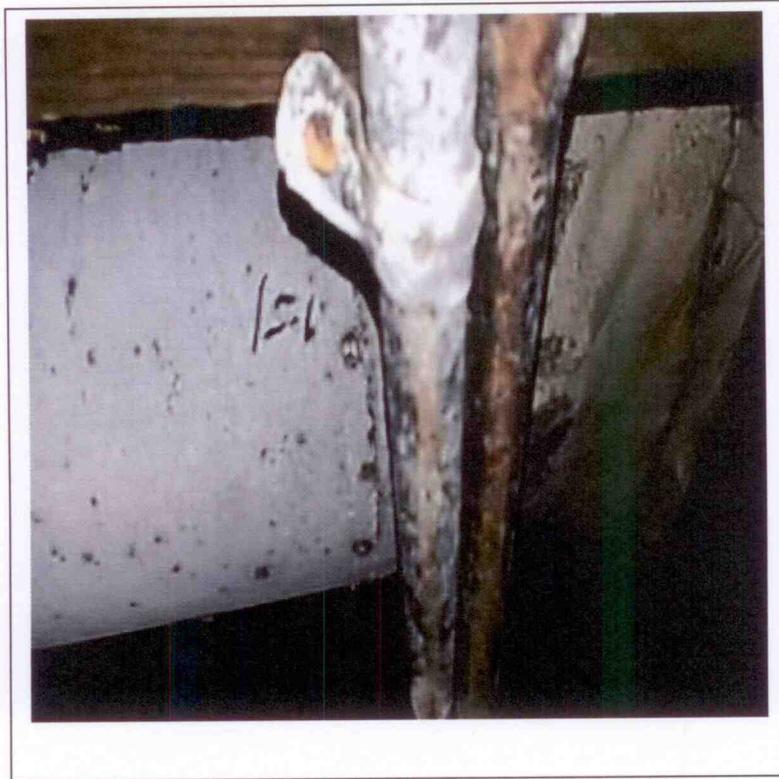
Duct insulation

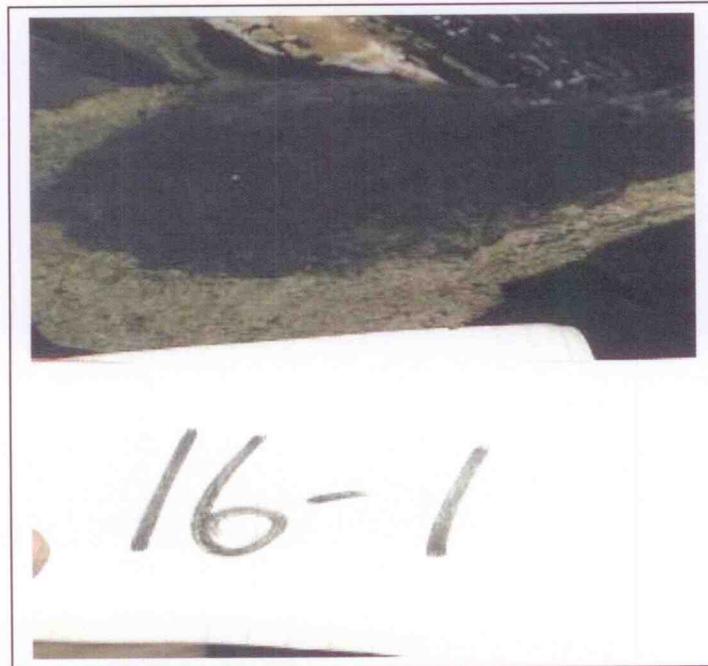
Heat shield

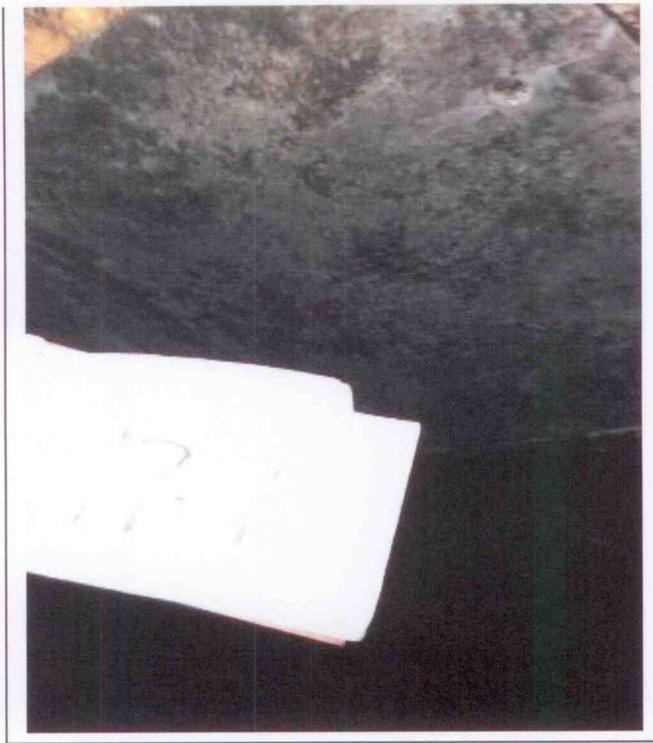
Cementitious ceiling panel
