SIERRA ENVIRONMENTAL GROUP, INC.

December 14, 2015

Re: Comprehensive Pre-Demolition Asbestos Inspection
Vacant Residence
1541 West 2nd Street
Dayton, Ohio 45402
Sierra Project Number: MCLB.003

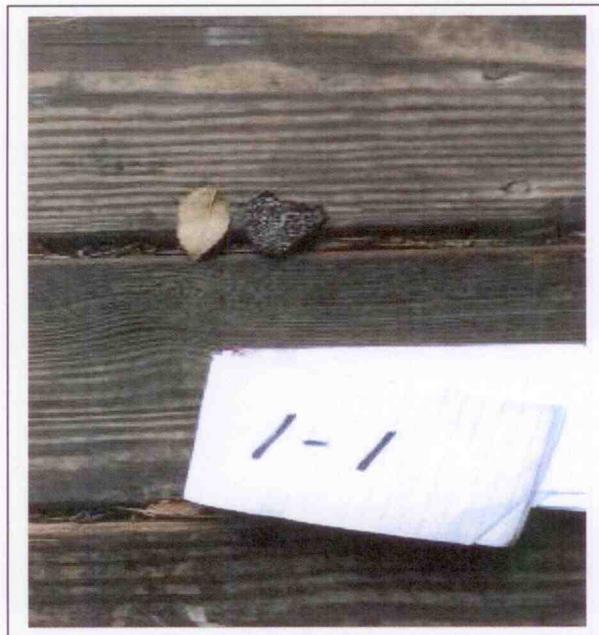
Asphalt roof shingle

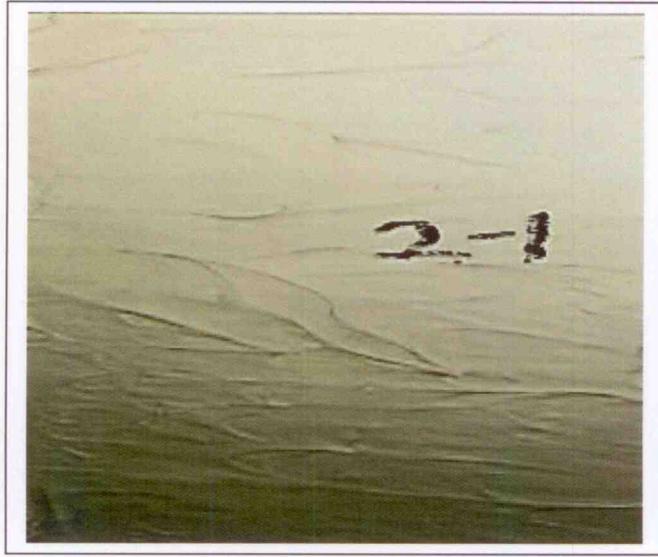
Wall texture, swirl

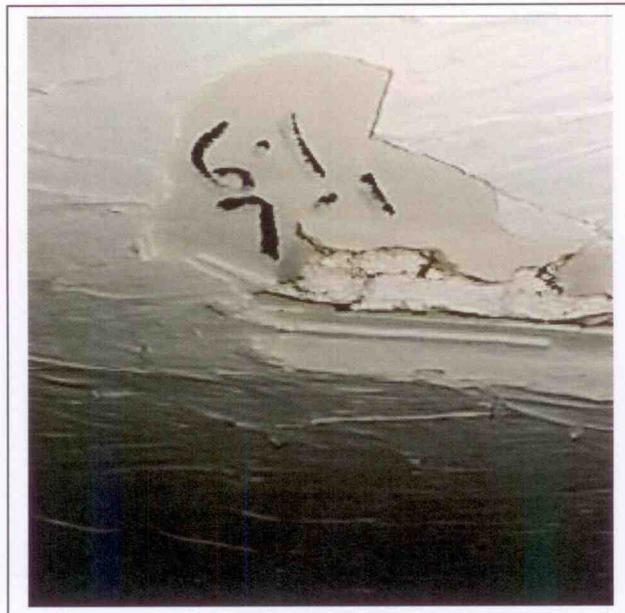
Drywall and associated joint compound

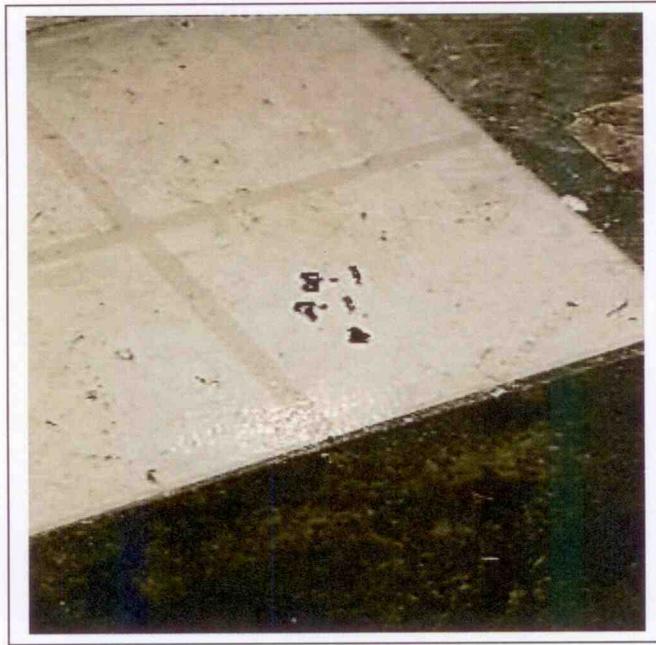
12" White floor tile and associated black mastic

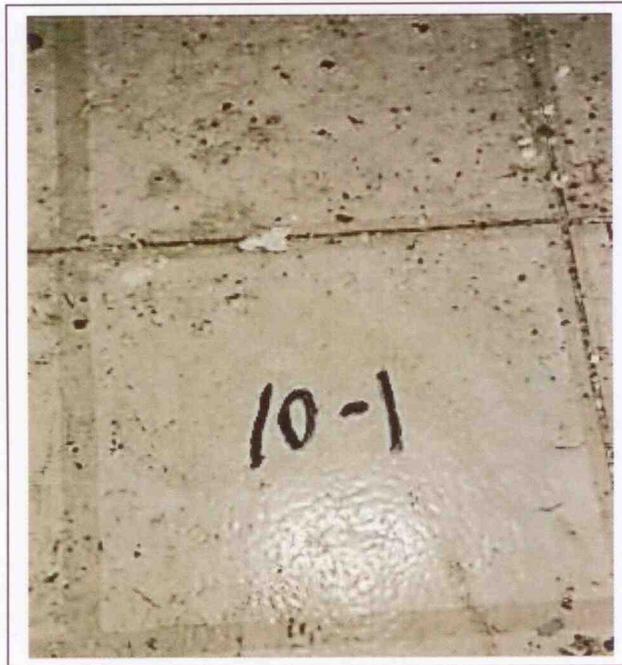
12" White sticky back floor tile

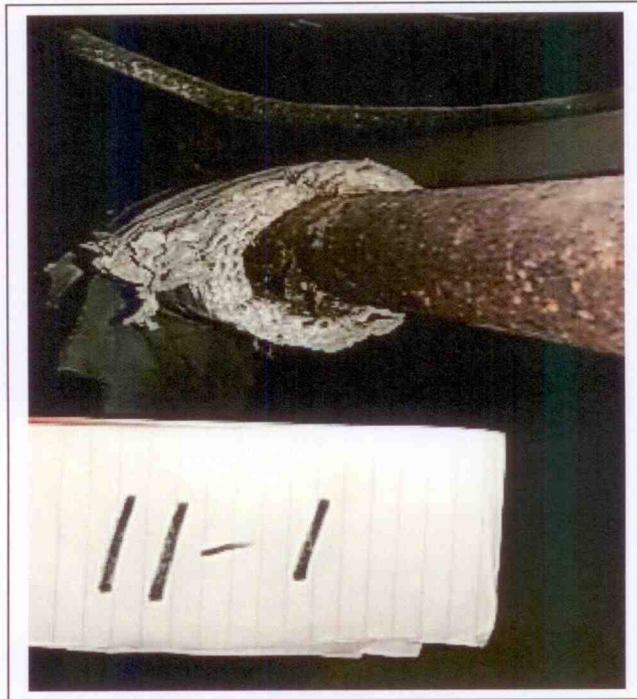
Basement	RACM	Aircell-paper pipe insulation	320 lf
Basement	RACM	Boiler insulation	130 sf
Foyer	I	Brown floor tile	225 sf

Aircell-paper pipe insulation

Location	Type ACM	Material Description	Cost for abatement (approx.)
The following asbestos-containing materials are located in the vacant residence located at 1541 West 2nd Street, Dayton, Ohio.			
Basement	RACM	Aircell-paper pipe insulation	\$6,400.00
Basement	RACM	Boiler insulation	\$2,600.00
Foyer	I	Brown floor tile	\$250.00

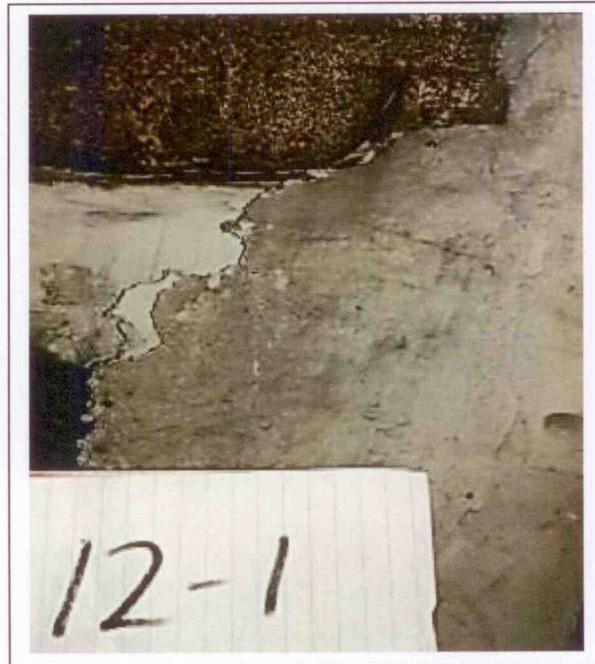
Exterior boiler insulation

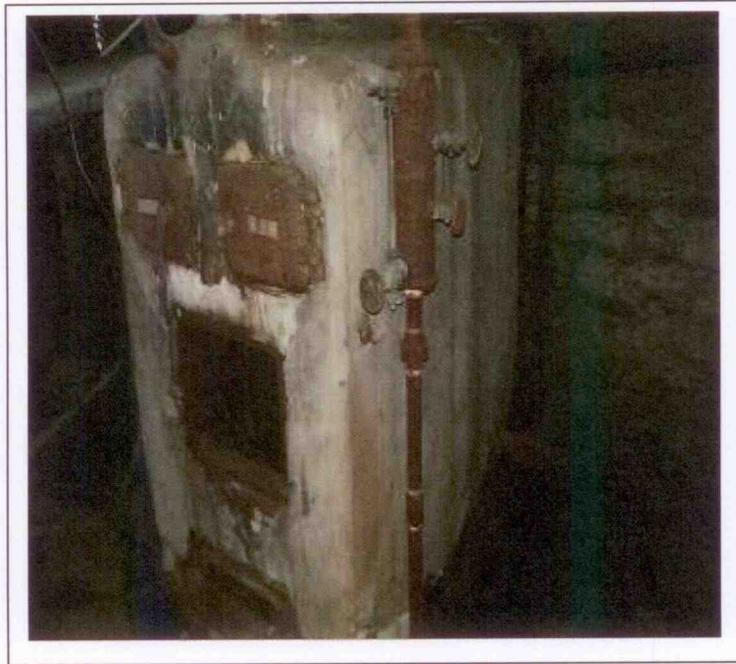
Overview of boiler

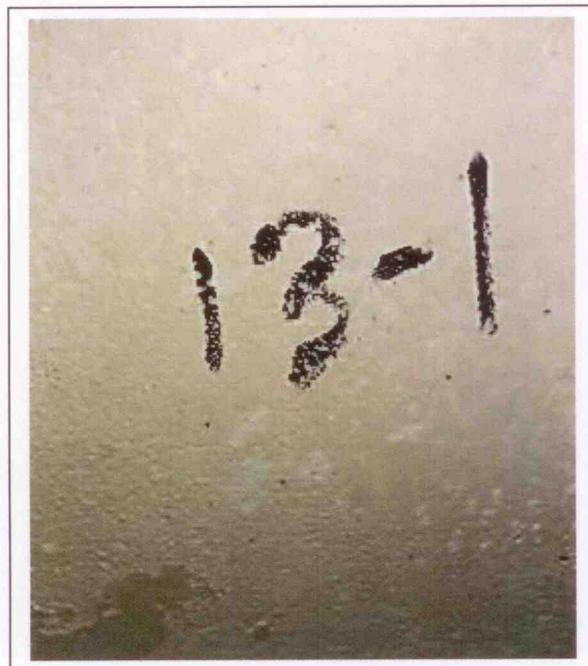
Hard wall plaster

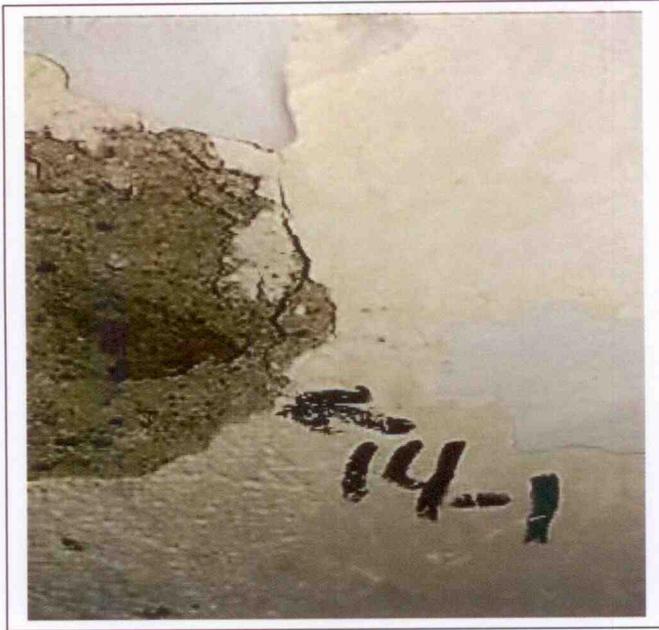
Hard ceiling plaster
