**SIERRA** ENVIRONMENTAL GROUP, INC.

**Re:** Comprehensive Pre-Demolition Asbestos Inspection  
Vacant Residence  
2315 South Smithville Road  
Dayton, Ohio 45420  
Sierra Project Number: MCLB.003

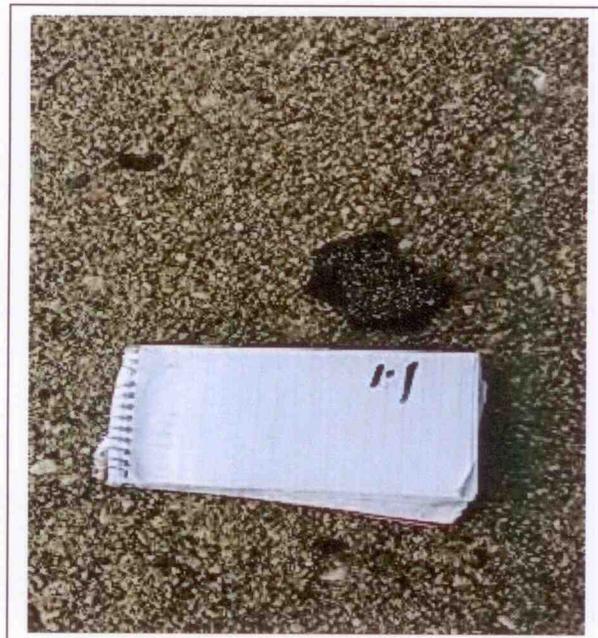
Asphalt roof shingle

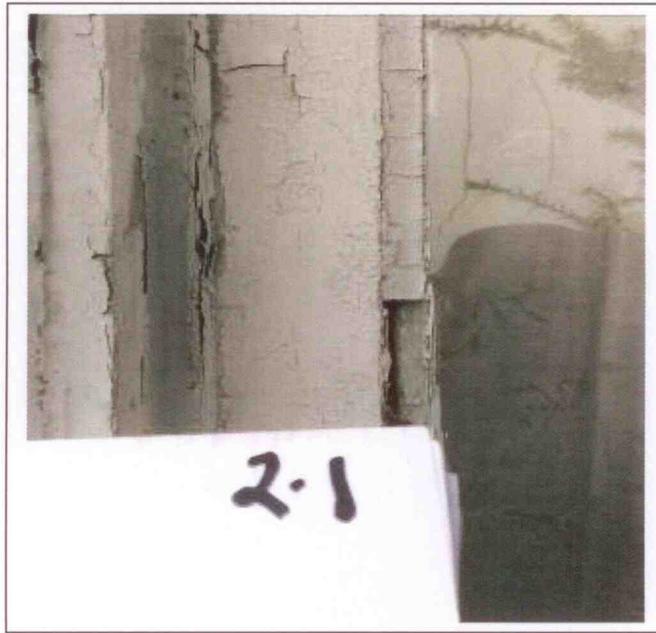
Window glaze

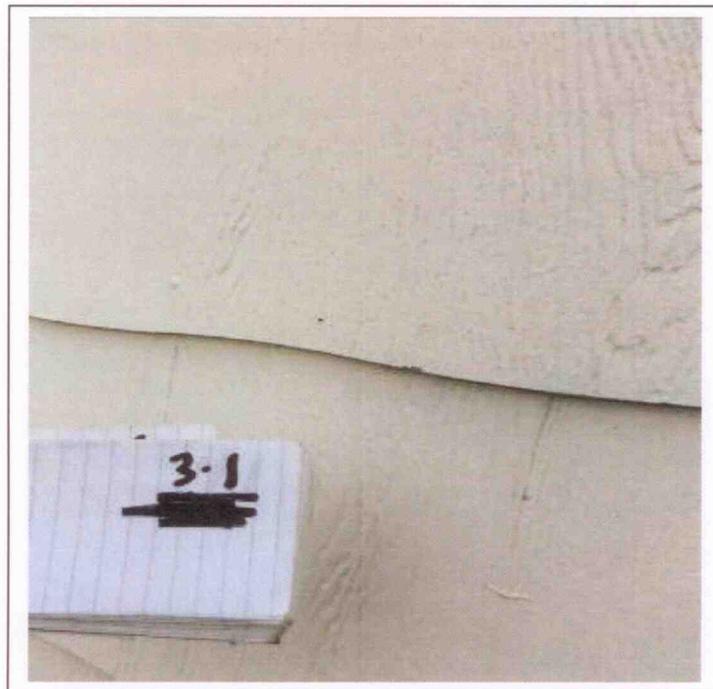
Cementitious siding

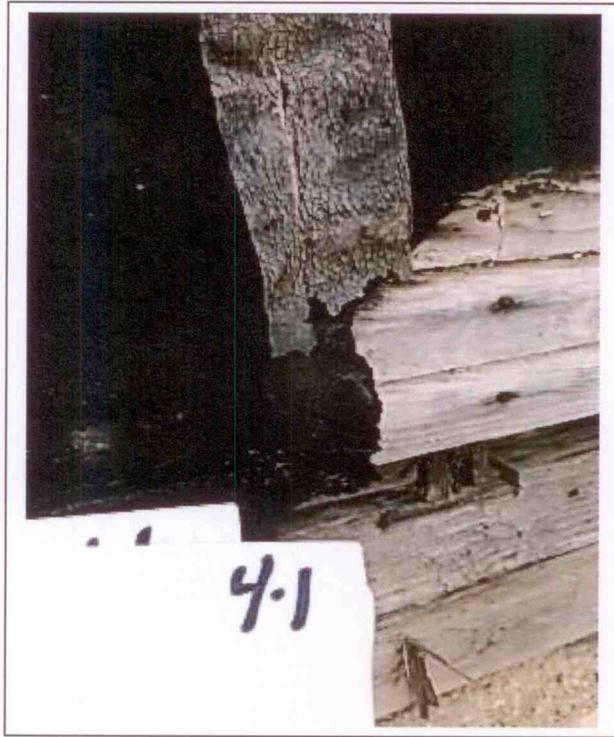
Black paper

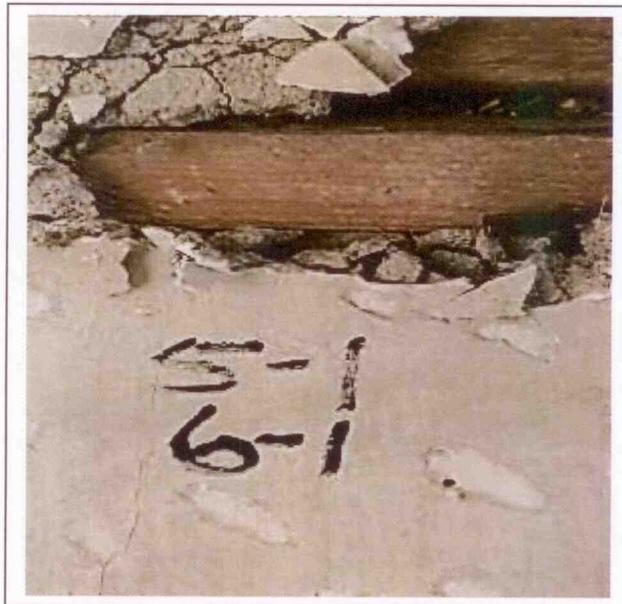
Hard wall and ceiling plaster

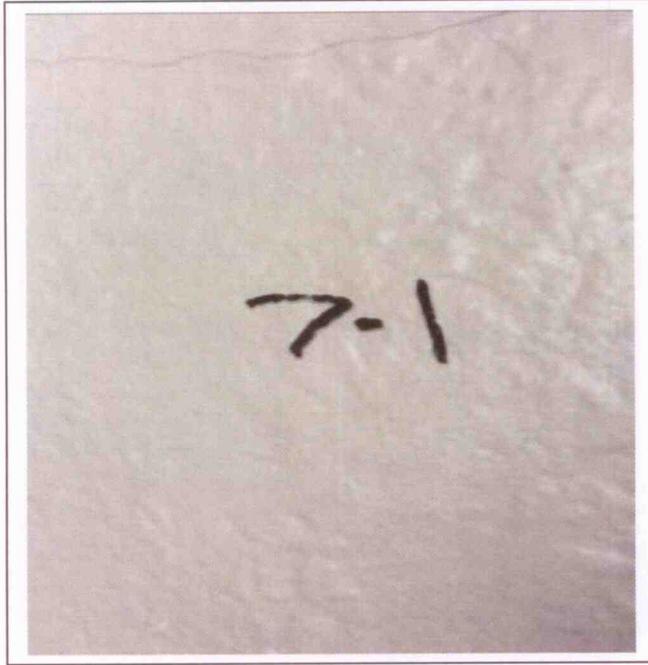
Rough white ceiling texture

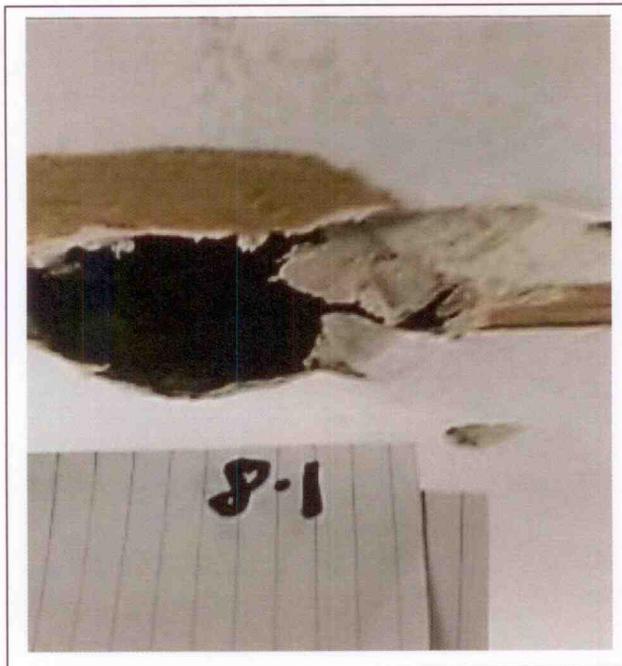
Drywall

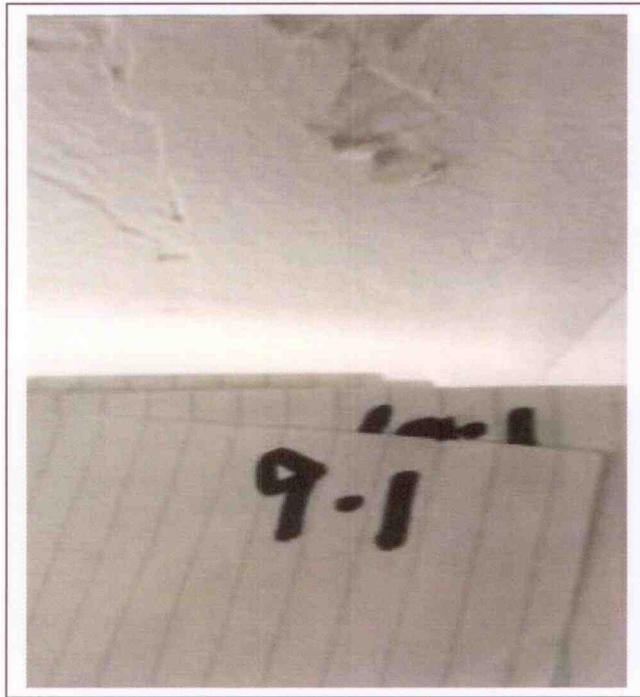
Joint compound

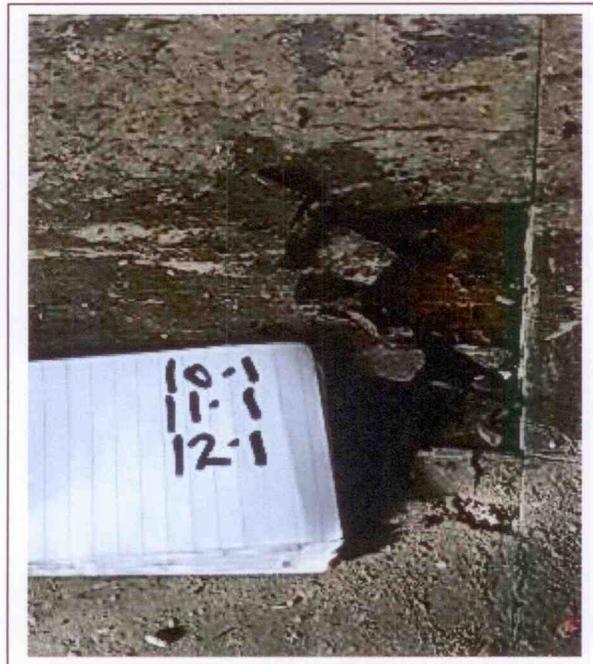
9" Brown floor tile, black mastic and tarpaper

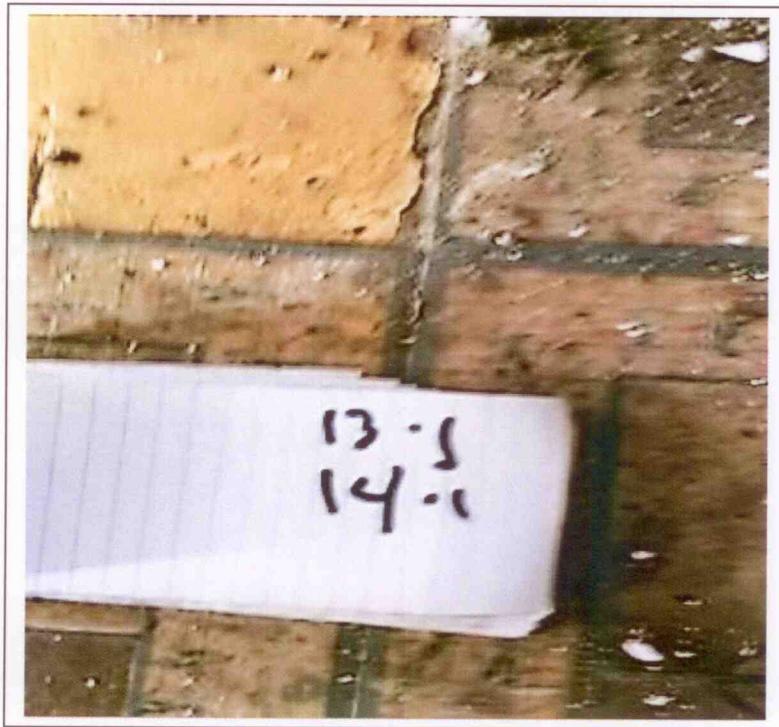
12" Tan floor tile and associated brown mastic

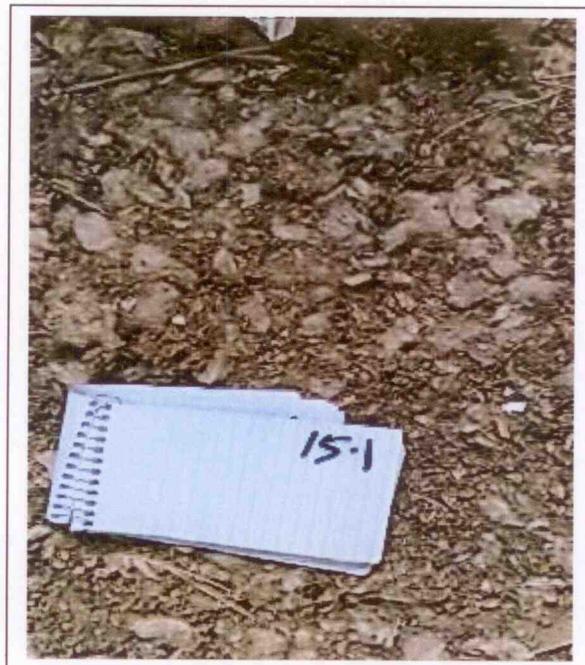
Blown-in insulation

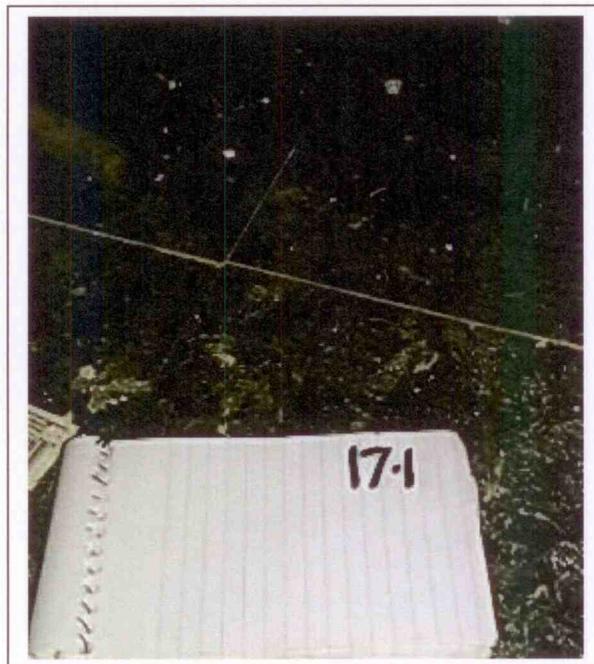
12" Green floor tile

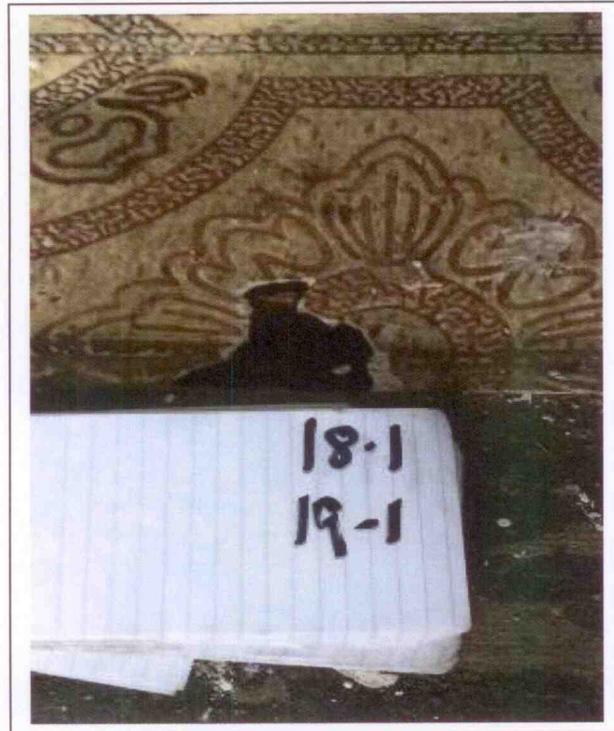
Yellow pattern linoleum and associated black mastic
