SIERRA ENVIRONMENTAL GROUP, INC.

December 14, 2015

Re: Comprehensive Pre-Demolition Asbestos Inspection
Vacant Residence
3319 Susannah Avenue
Dayton, Ohio 45414
Sierra Project Number: MCLB.003

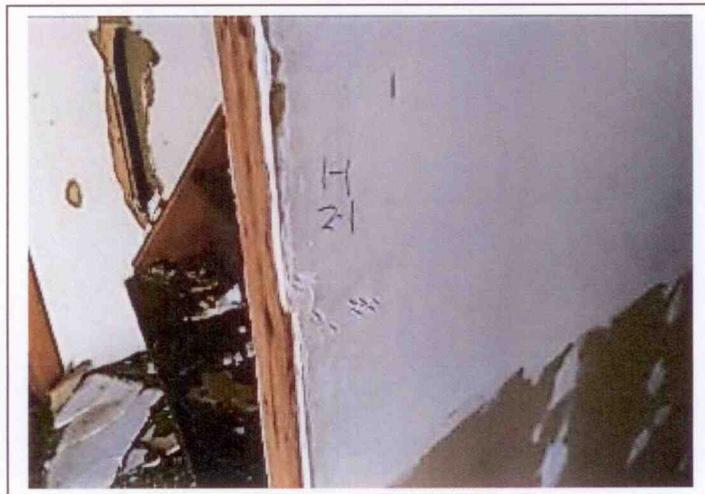
Drywall and associated joint compound

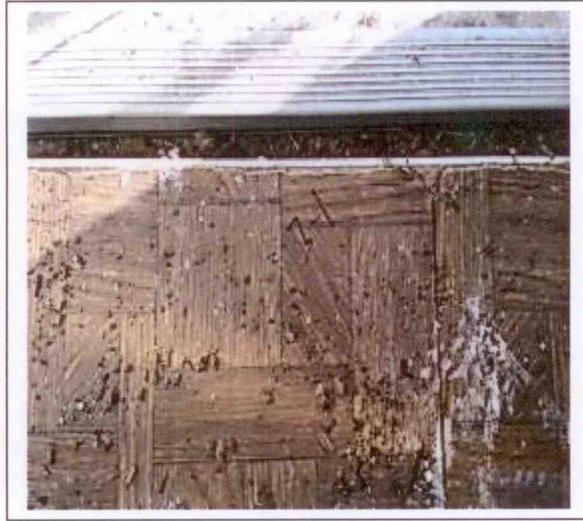
12" Brown floor tile

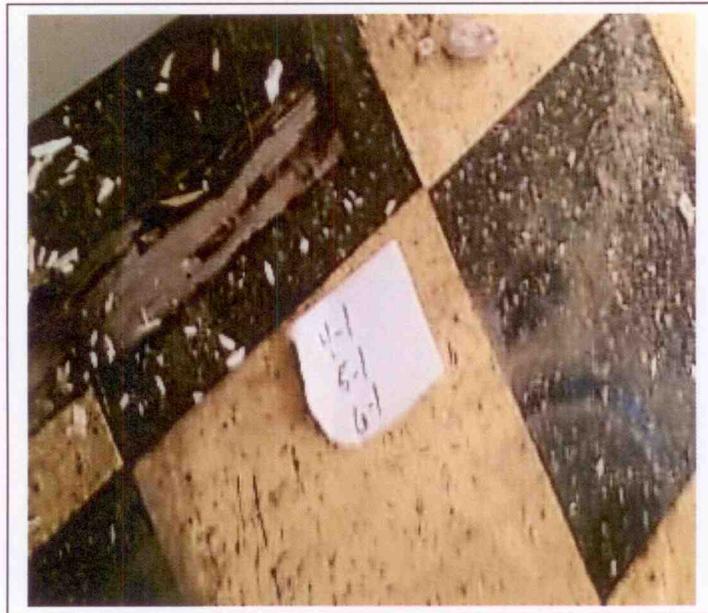
9" Black floor tile, 9" tan floor tile and associated mastic

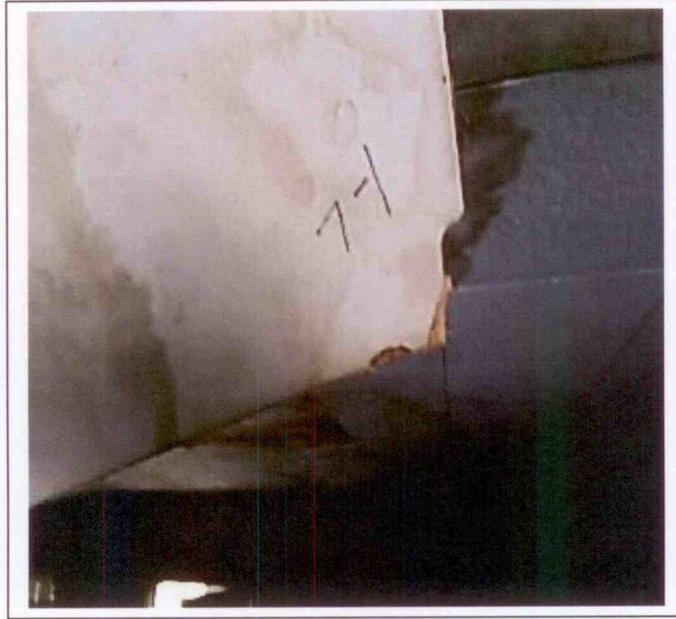
12" Ceiling tile

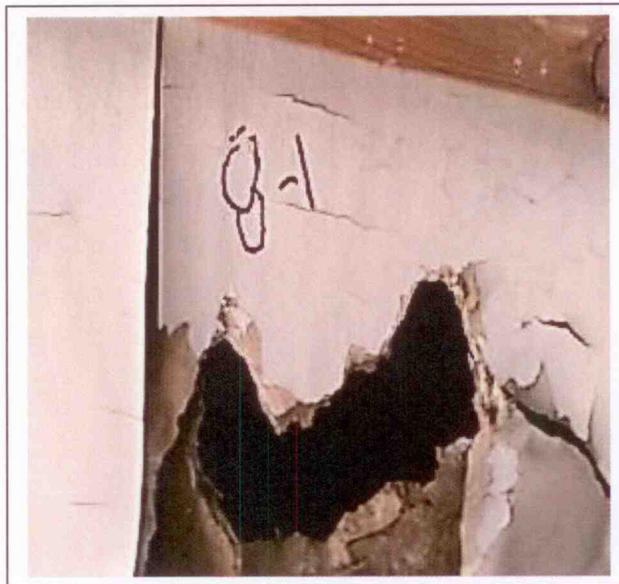
Drywall, old

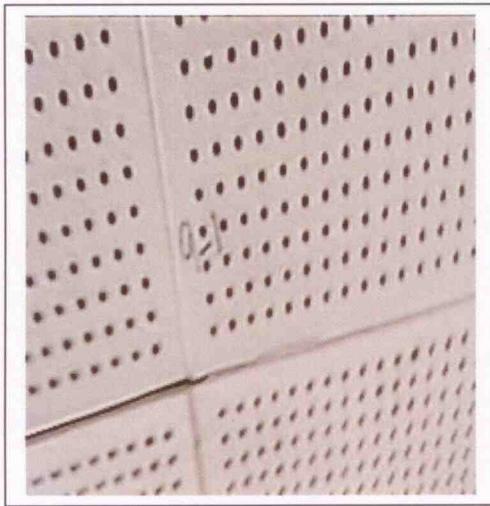
12" Ceiling tile with holes

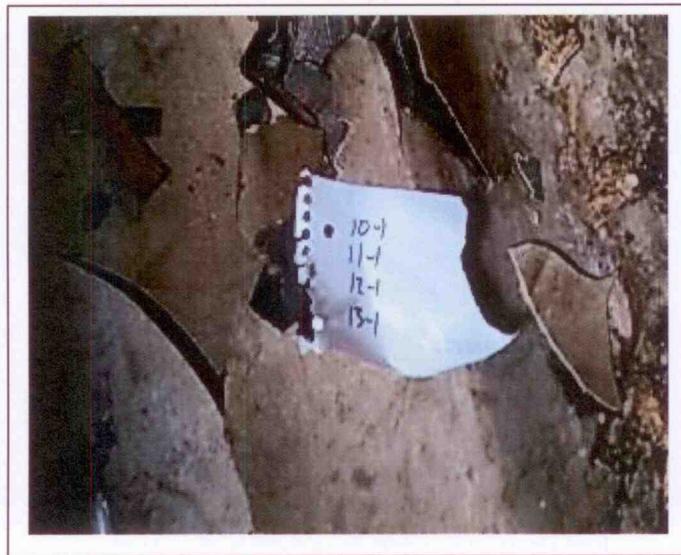
White linoleum, tan linoleum, 9" floor tile and tar paper

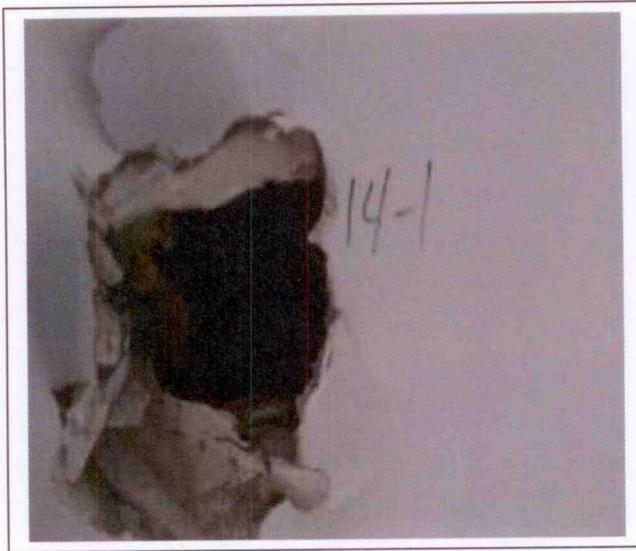
Drywall

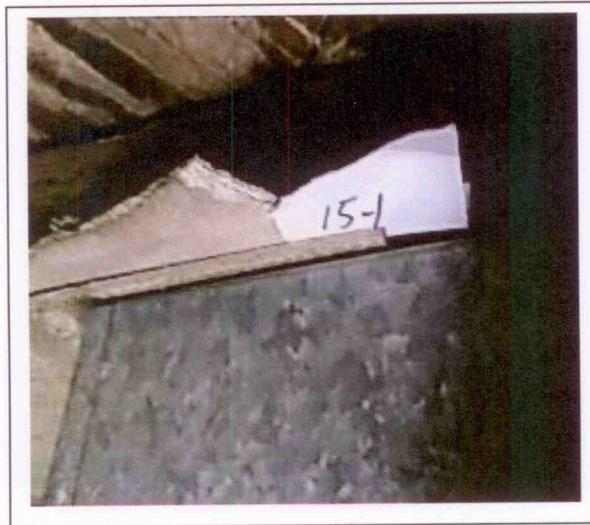
Heat shield

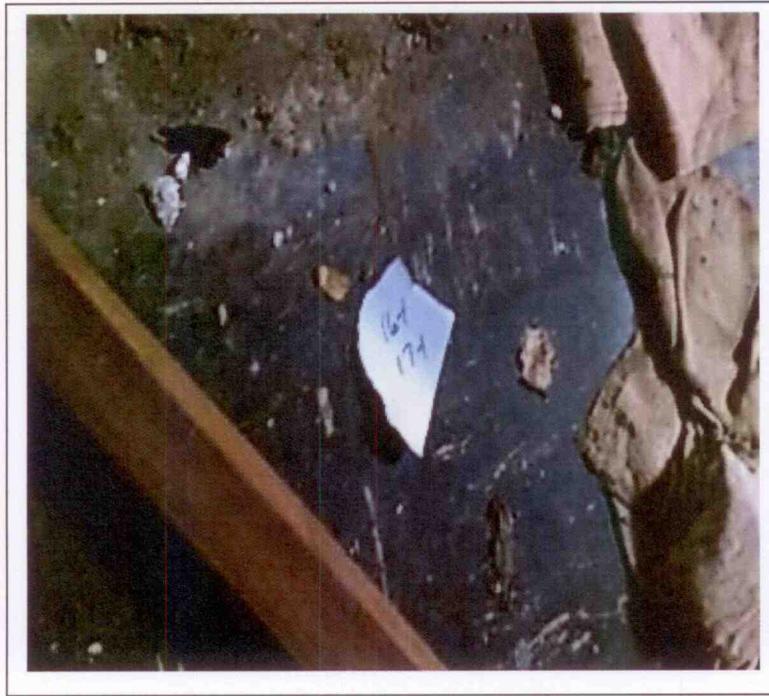
9" Black floor tile and associated mastic

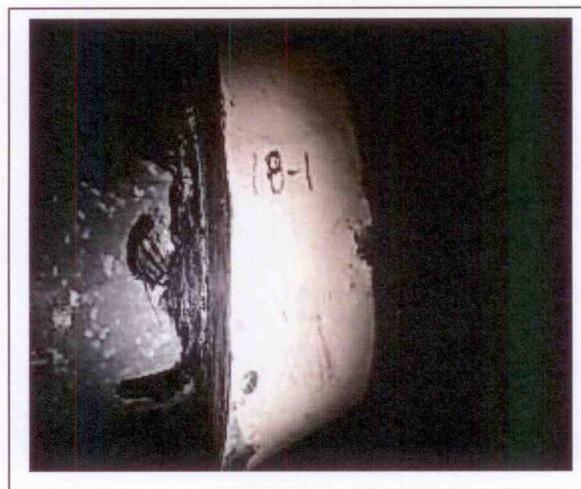
Duct insulation

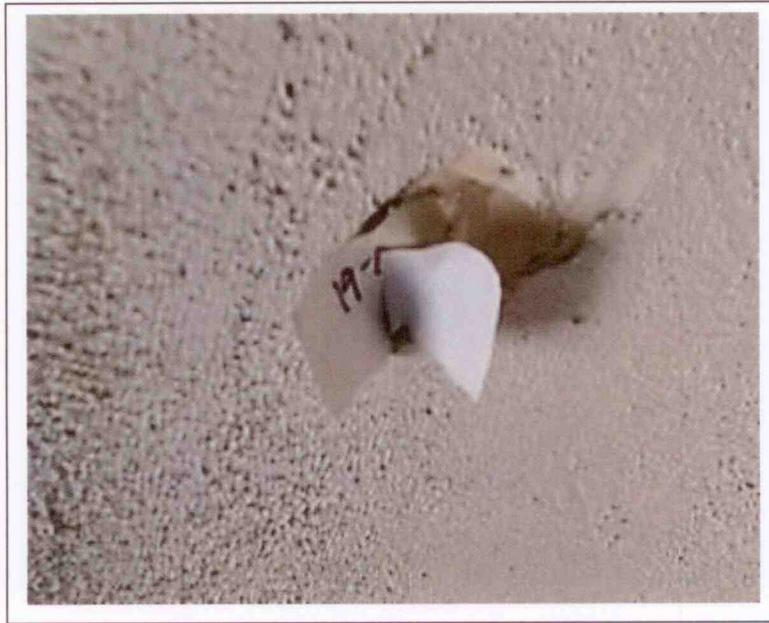
Textured ceiling, rough

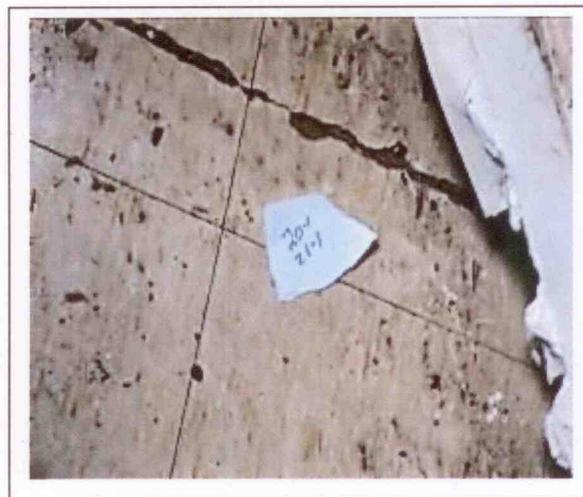
12" White floor tile and associated mastic

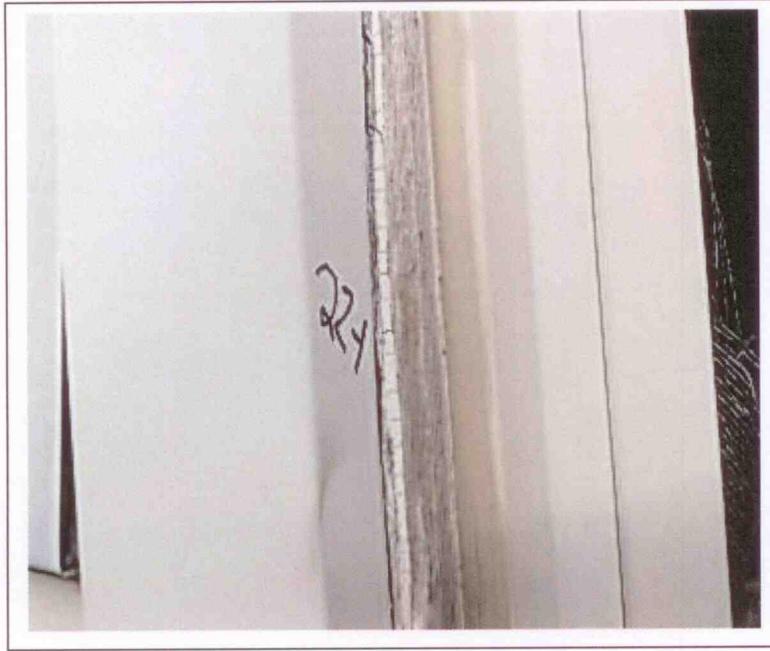
Exterior window caulk

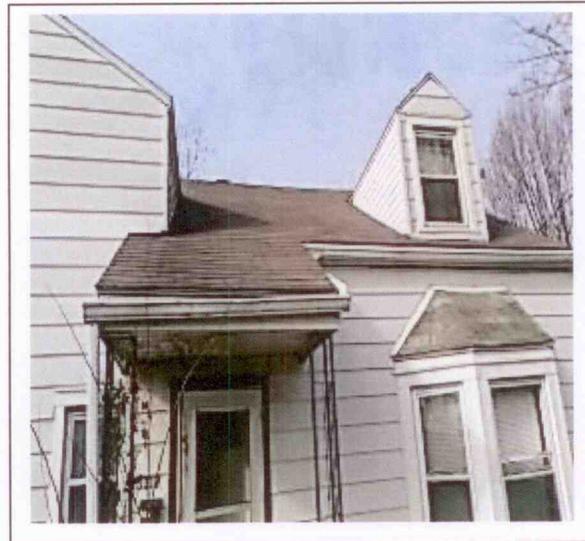
Asphalt roof shingle

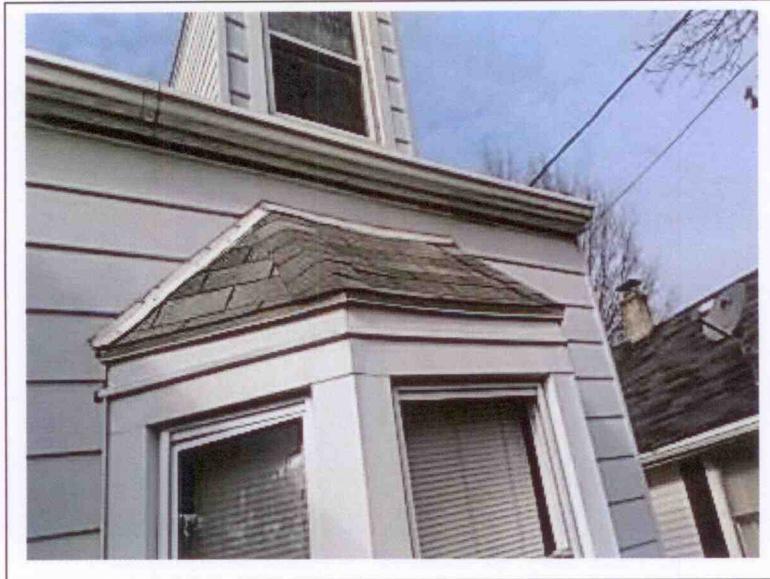
Asphalt roof shingle over bay window
