SIERRA ENVIRONMENTAL GROUP, INC.

Re: Comprehensive Pre-Demolition Asbestos Inspection
Vacant Residence
434 Burleigh Avenue
Dayton, Ohio 45417
Sierra Project Number: MCLB.003

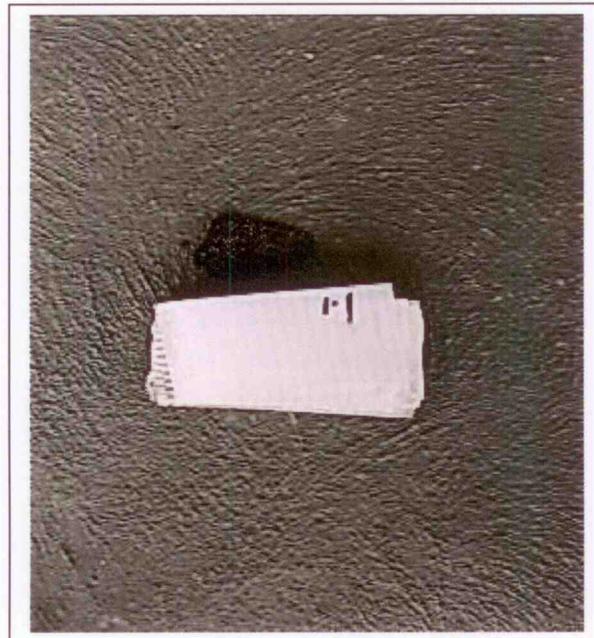
Asphalt roof shingle

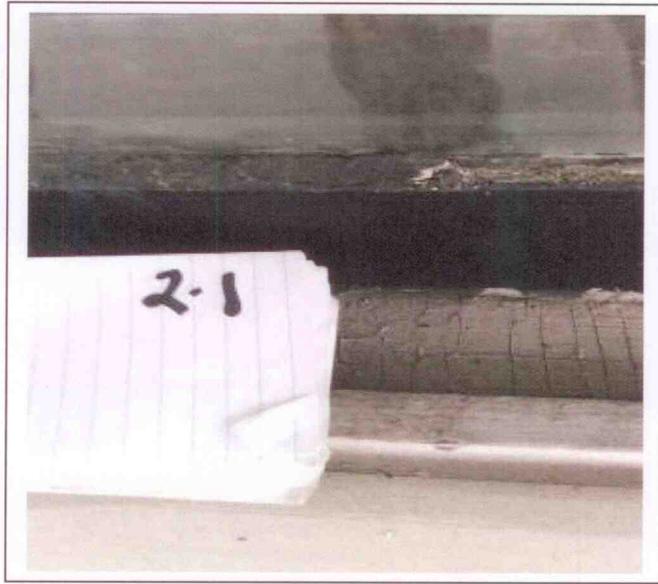
Window glaze

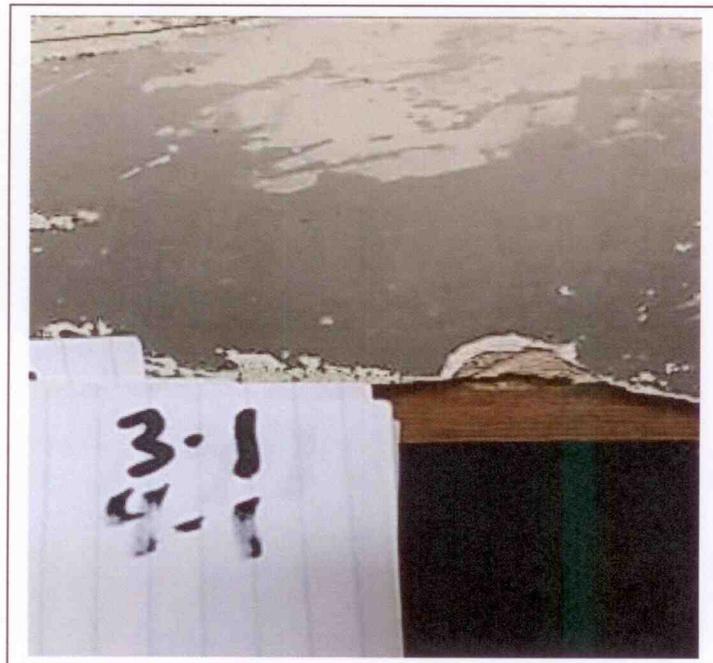
Hard wall and ceiling plaster

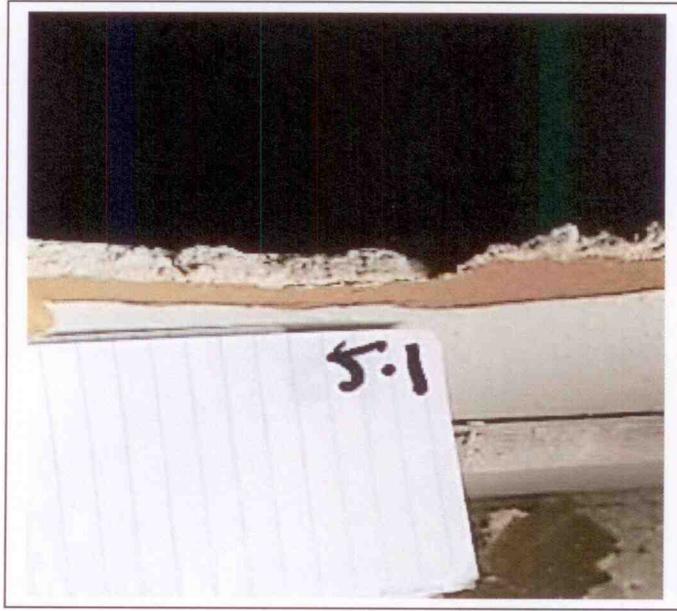
Drywall

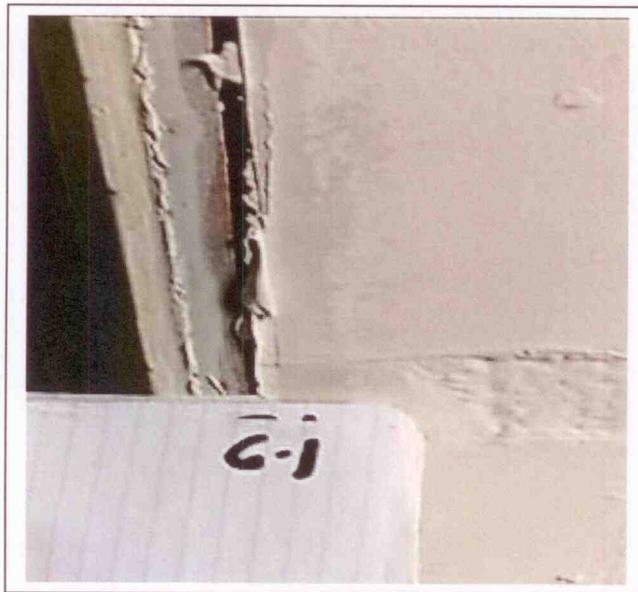
Joint compound

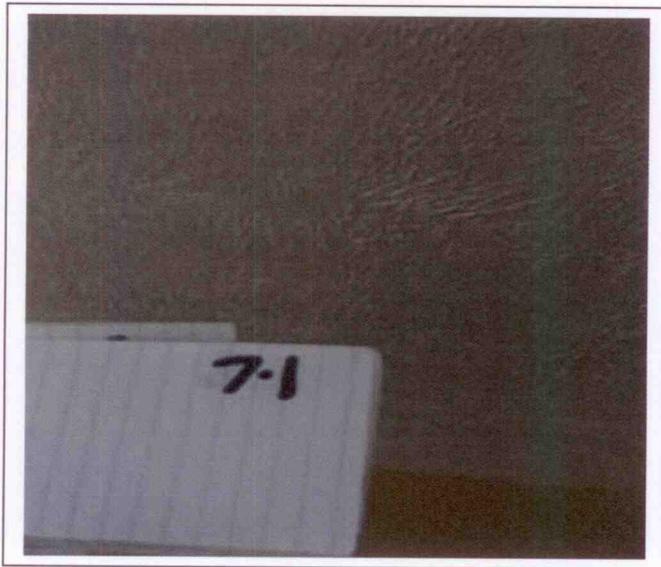
Textured ceiling, flower pattern

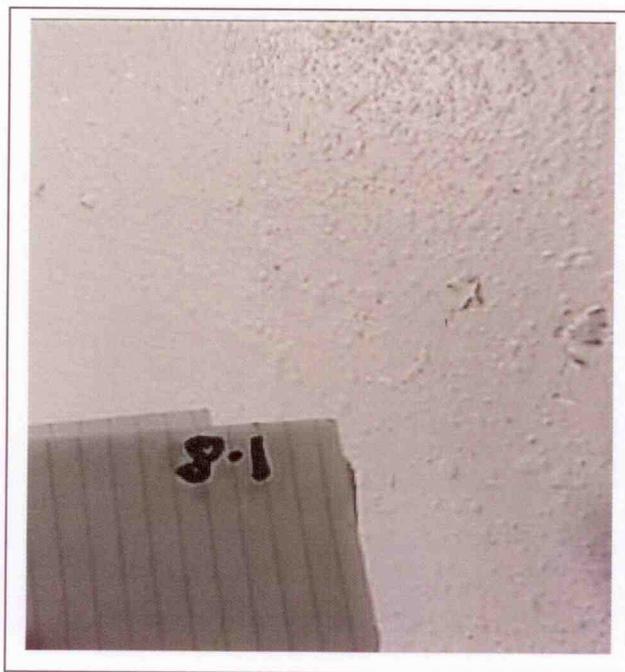
Textured wall, rough

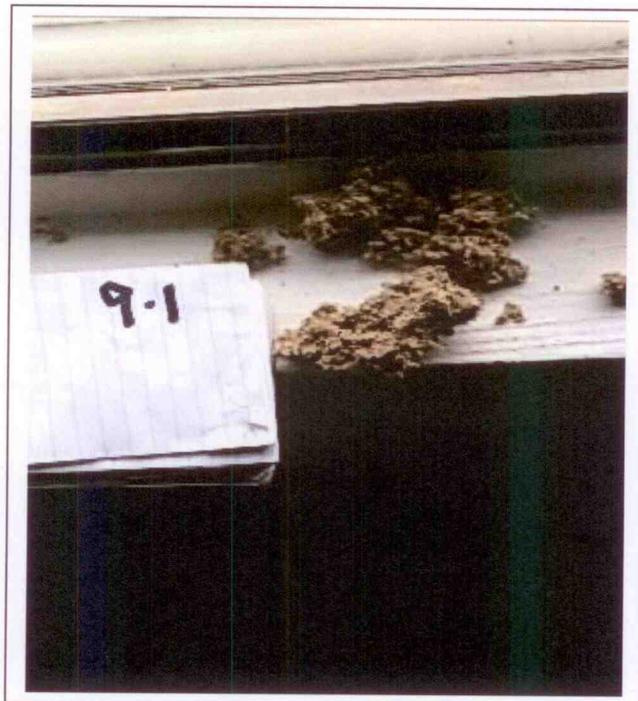
Blown-in insulation

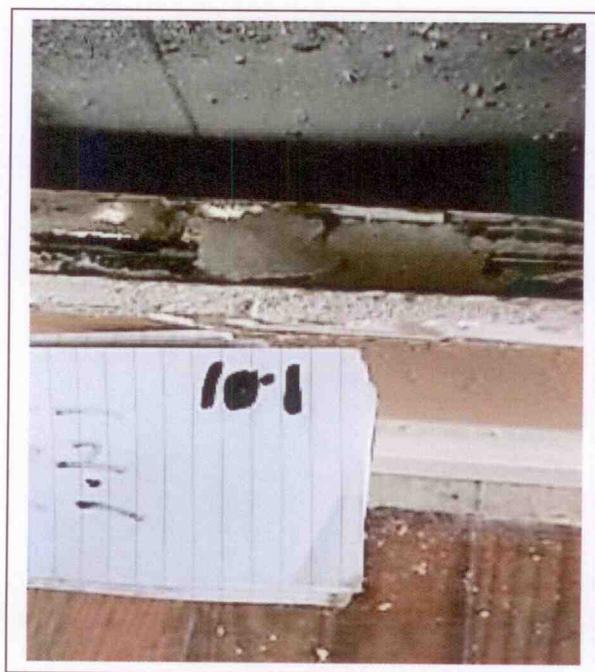
Basement	RACM	Duct insulation	20 sf
Basement to 2nd floor	RACM	Duct insulation (concealed behind hard wall and ceiling plaster)	75 sf

Duct insulation

Location	Type ACM	Material Description	Cost for abatement (approx.)
The following asbestos-containing materials are located in the vacant residence located at 434 Burleigh Avenue, Dayton.			
Basement	RACM	Duct insulation	\$400.00
Basement to 2nd floor	RACM	Duct insulation (concealed behind hard wall and ceiling plaster)	\$1,875.00
