SIERRA ENVIRONMENTAL GROUP, INC.

December 9, 2015

Re: Comprehensive Pre-Demolition Asbestos Inspection
Vacant Residences
2521-2523 North Main Street
Dayton, Ohio 45405
Sierra Project Number: MCLB.003

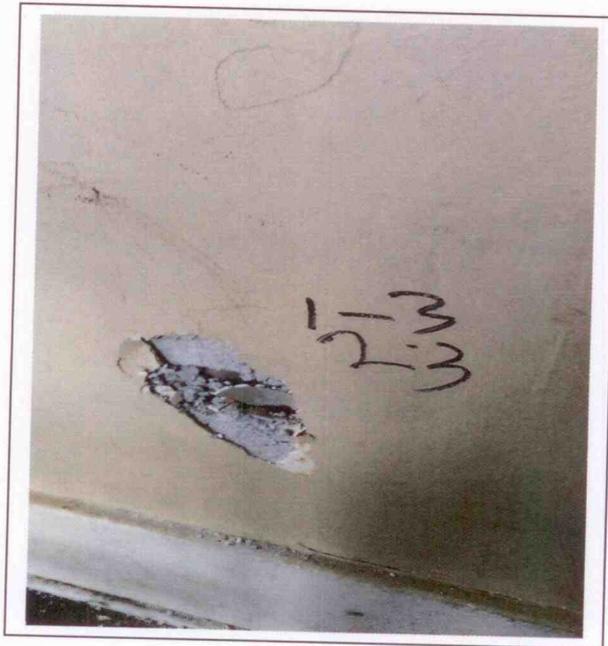
| SAMPLE DESCRIPTION (Material Type) | SAMPLE LOCATION | HOMO AREA # | SAMPLE I.D. NO. | ASBESTOS CONTENT | FRIABLE/ NONFRIABLE |
|--|---|---|---|---|---|
| Brown coat of hard wall plaster (Surfacing, >5,000 sf) | Dining room, 2521 side | 2 | 2-1 | *0.25% Chrysotile | Nonfriable |
| Brown coat of hard ceiling plaster (Surfacing, >5,000 sf) | Dining room, 2521 side | 2 | 2-2 | *0.25% Chrysotile | Nonfriable |
| Brown coat of hard wall plaster (Surfacing, >5,000 sf) | Rear bedroom, 2521 side | 2 | 2-3 | *<0.25% Chrysotile | Nonfriable |
| Brown coat of hard ceiling plaster (Surfacing, >5,000 sf) | Rear bedroom, 2521 side | 2 | 2-4 | *0.25% Chrysotile | Nonfriable |

Hard wall and ceiling plaster

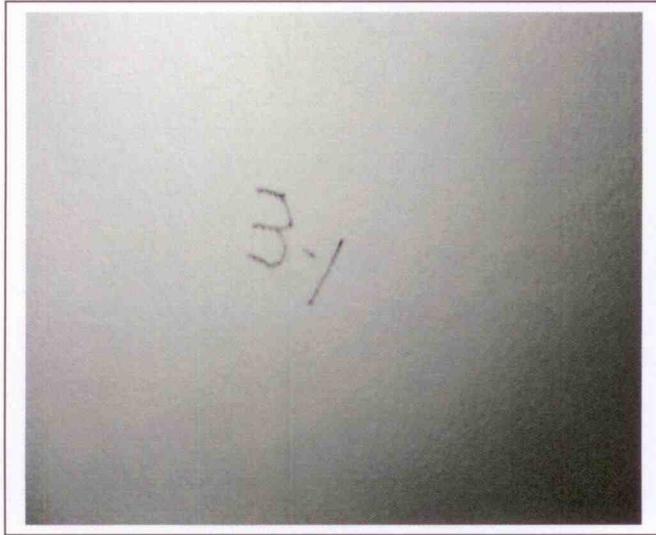
Textured ceiling

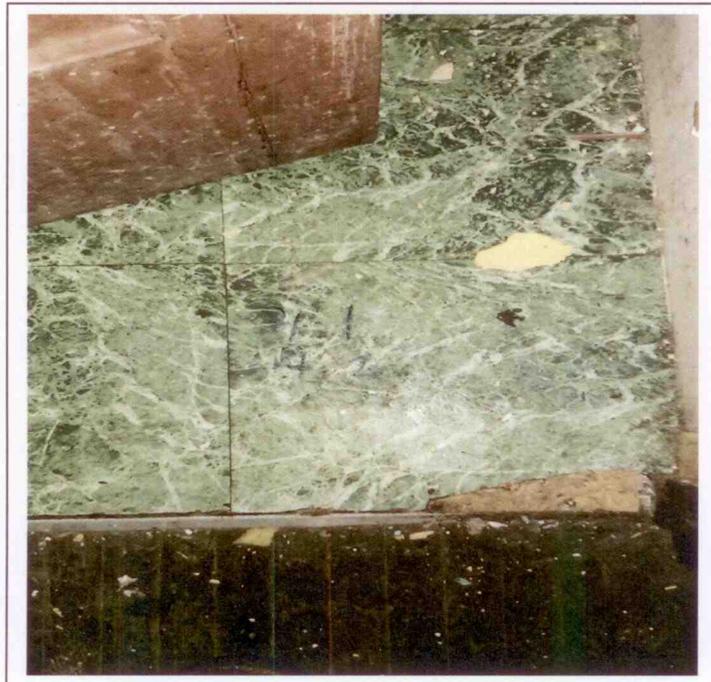
12" Green sticky back floor tile

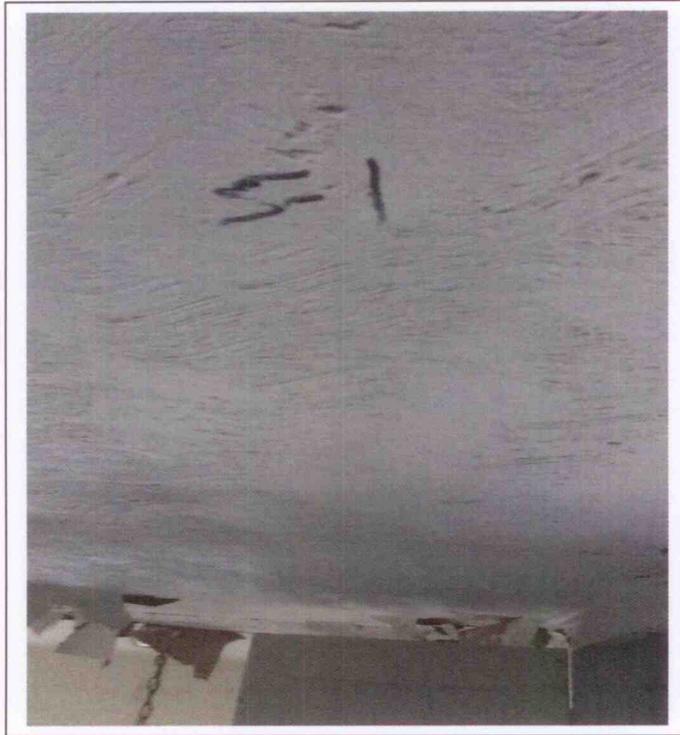
Textured ceiling, swirl pattern

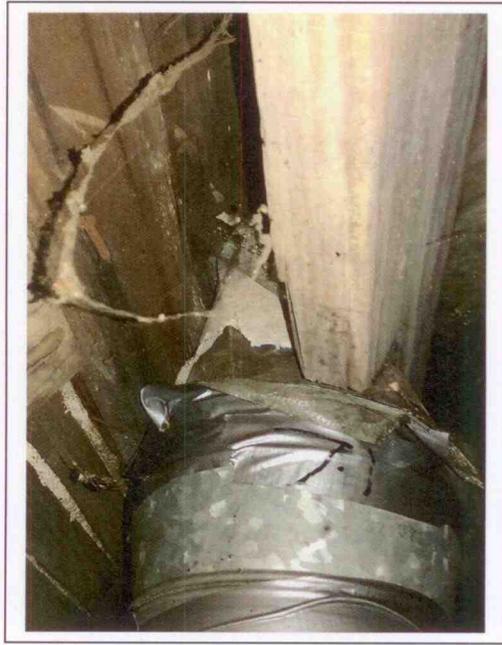
| SAMPLE DESCRIPTION (Material Type) | SAMPLE LOCATION | HOMO AREA # | SAMPLE I.D. NO. | ASBESTOS CONTENT | FRIABLE/ NONFRIABLE |
|---|---|---|---|---|---|
| Duct insulation (Thermal System Insulation) | Basement, 2521 side | 6 | 6-1 | 58% Chrysotile | Friable |

| Basement, 2521 side | RACM | Duct insulation | 10 sf |
| Basement, 2523 side | RACM | Duct insulation | 85 sf |

Duct insulation

| Location | Type ACM | Material Description | Cost for abatement (approx.) |
|---|---|---|---|
| Basement, 2521 side | RACM | Duct insulation | \$250.00 |
| Basement, 2523 side | RACM | Duct insulation | \$1,700.00 |

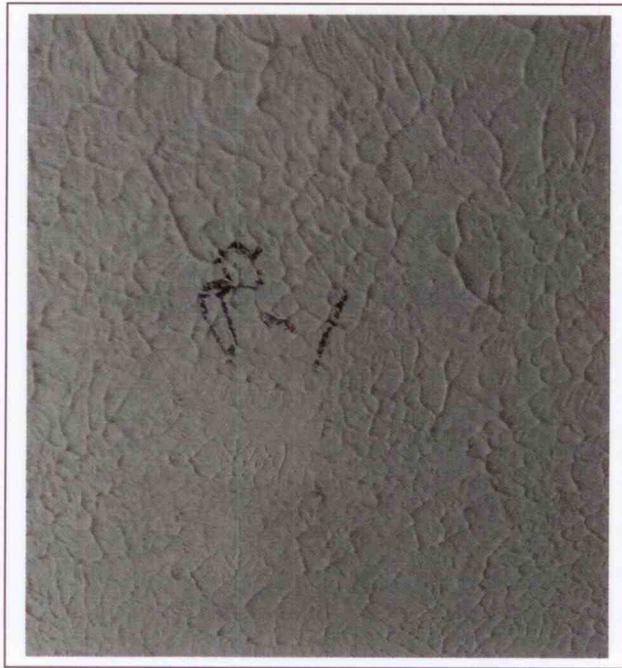
Textured ceiling

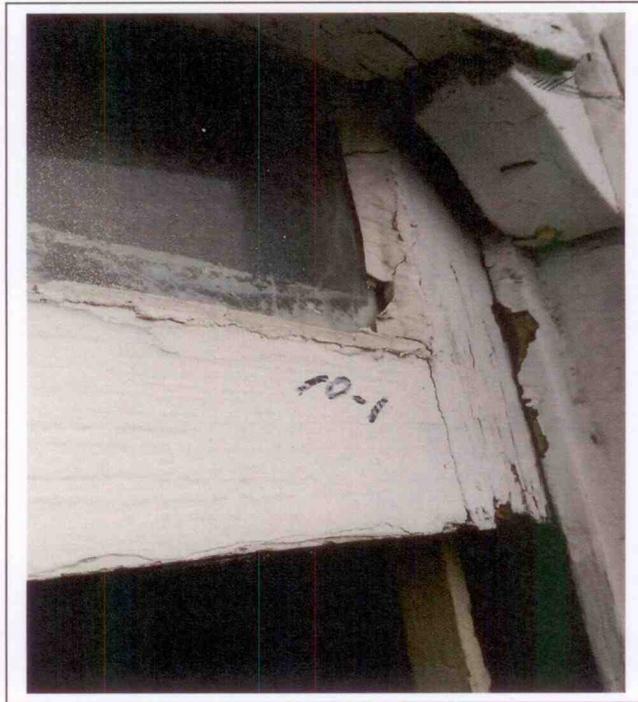
Window glaze

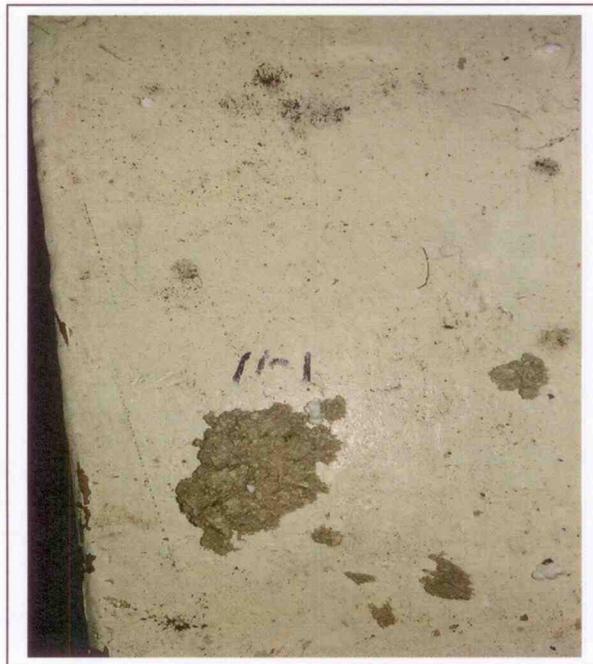
Blown-in insulation

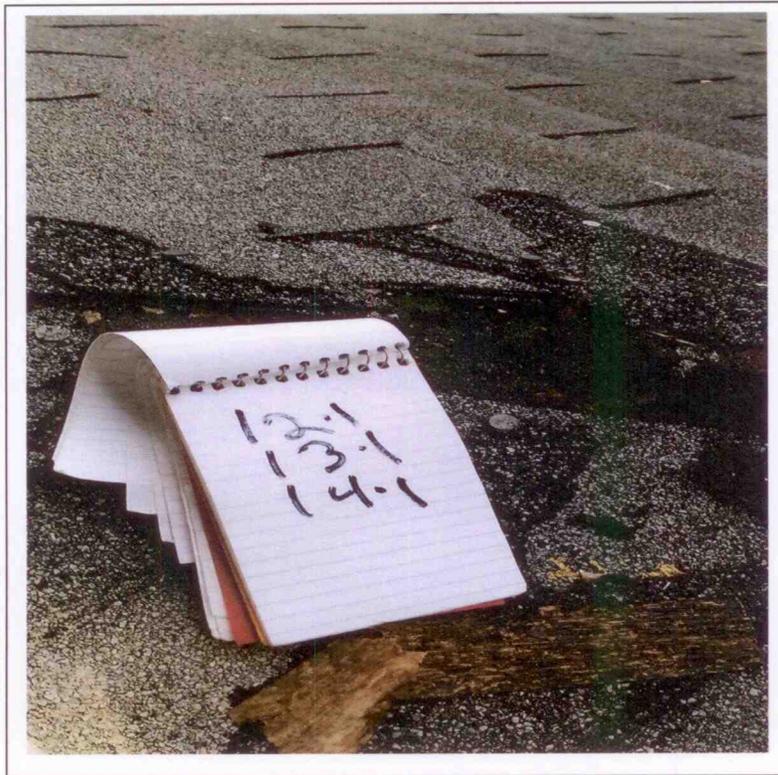
Black, green and tan asphalt roof shingles

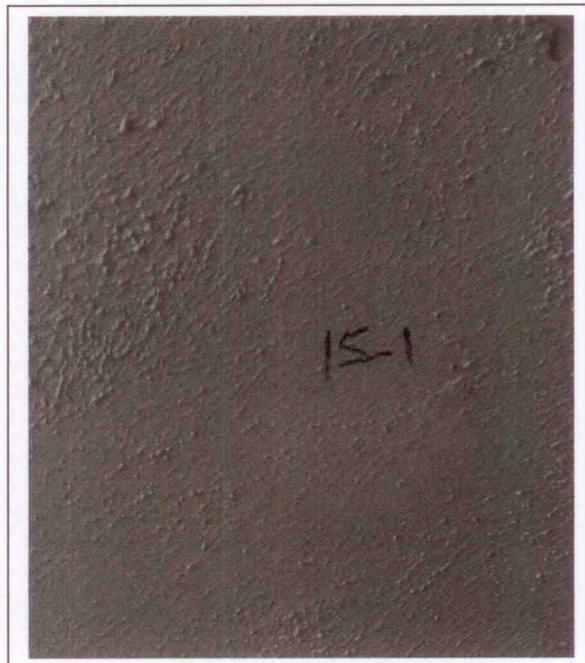
Textured ceiling

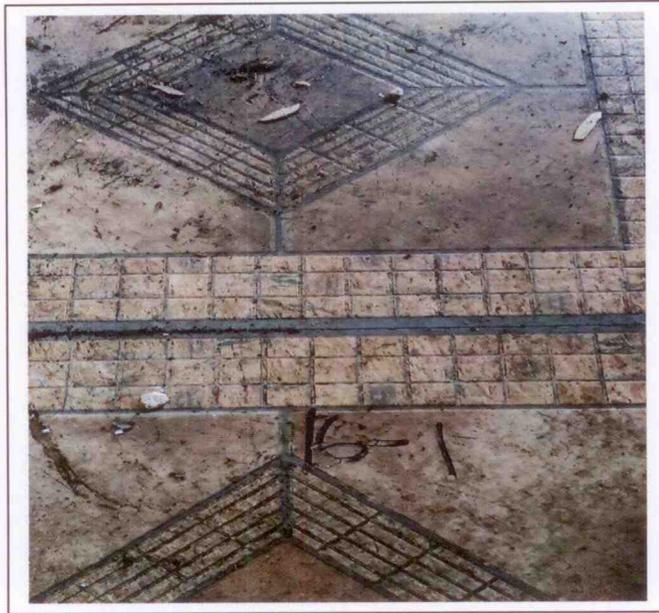
12" Diamond pattern sticky back floor tile

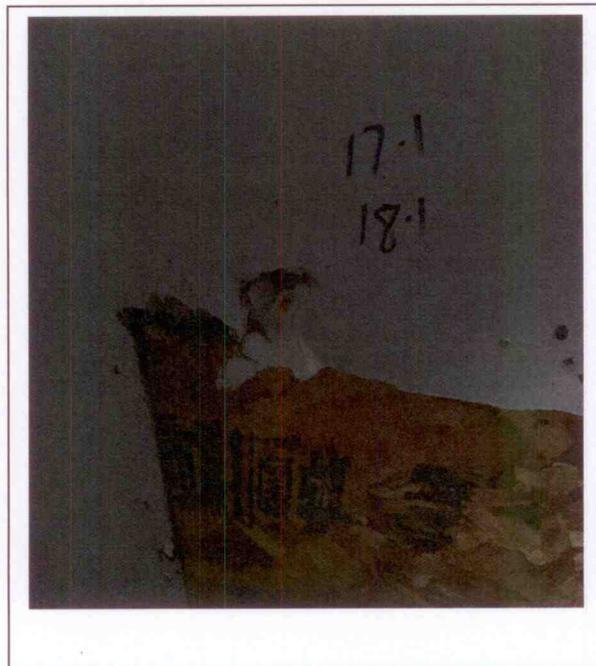
Drywall and associated joint compound

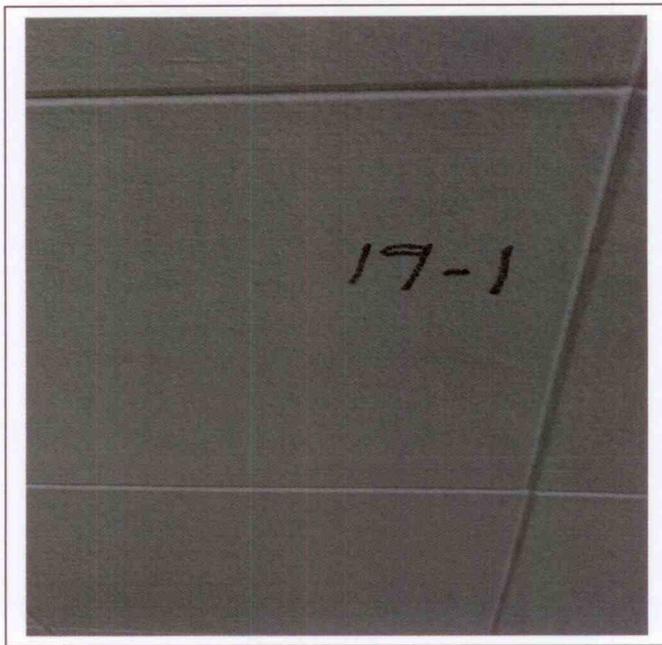
12" Ceiling tile

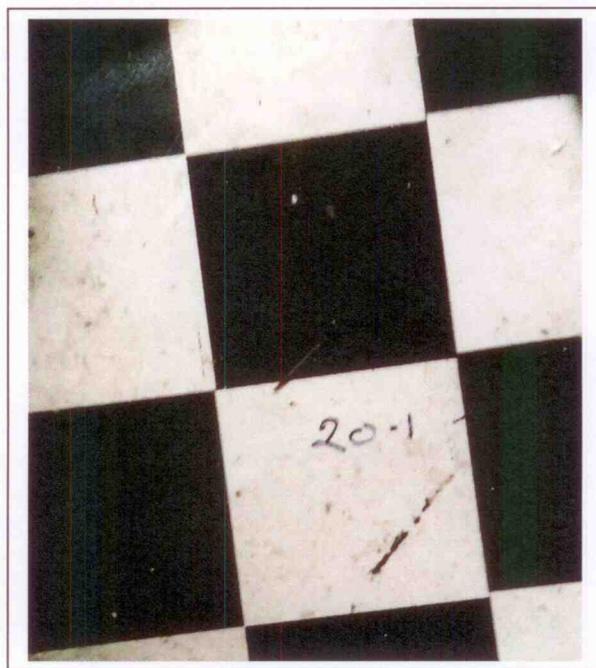
Black and white sheet flooring

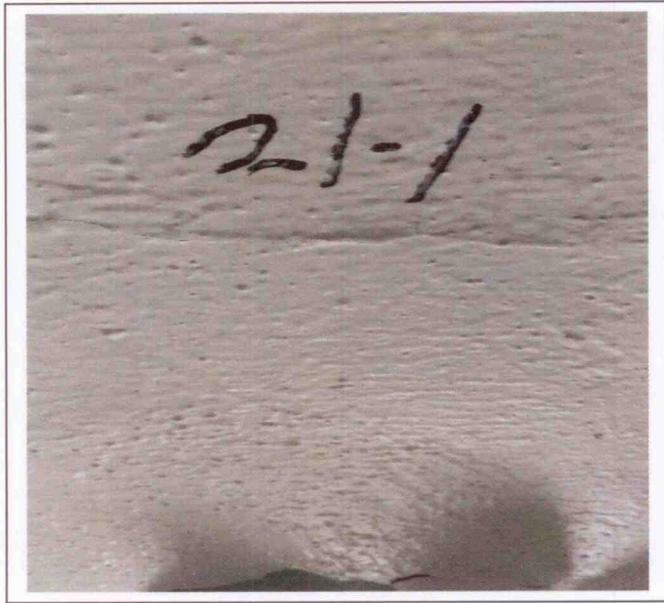
Textured wall and ceiling
