SIERRA ENVIRONMENTAL GROUP, INC.

December 11, 2015

Re: Comprehensive Pre-Demolition Asbestos Inspection
Vacant Residences
2609-2611 North Main Street
Dayton, Ohio 45405
Sierra Project Number: MCLB.003

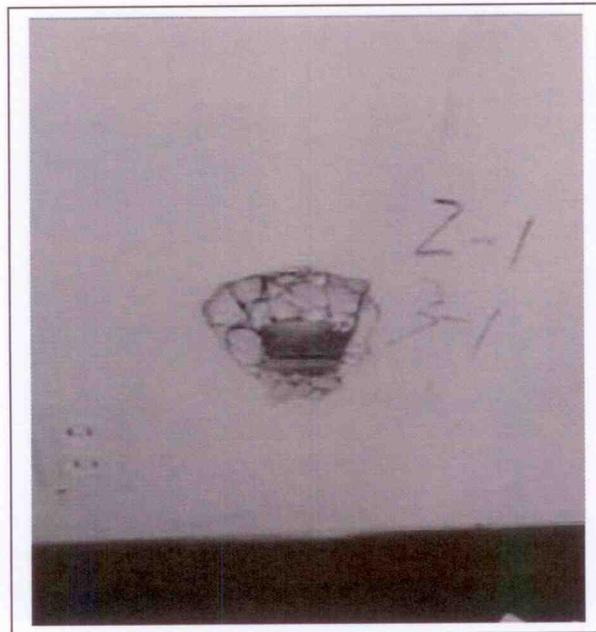
Hard wall and ceiling plaster

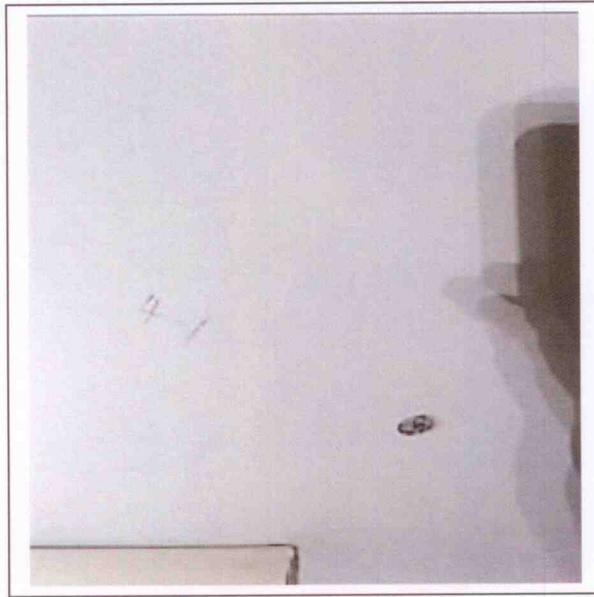
Textured ceiling

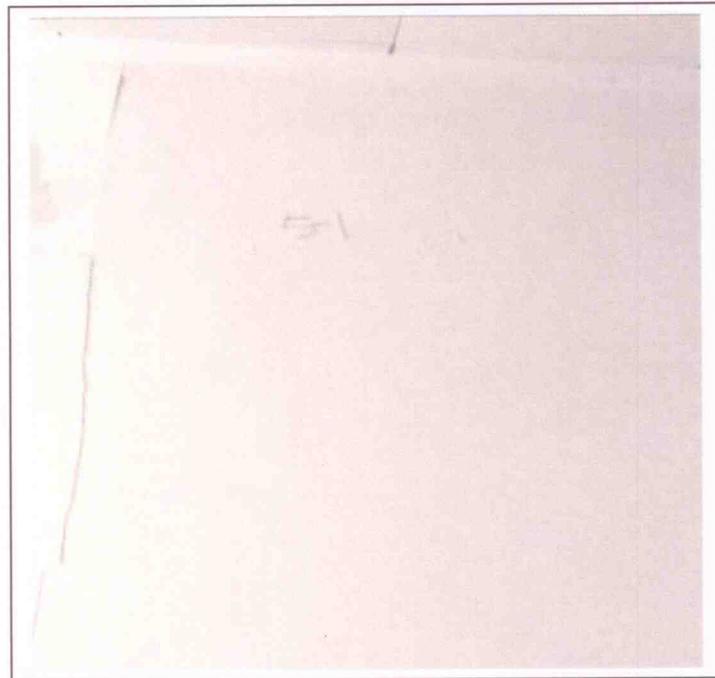
Textured wall

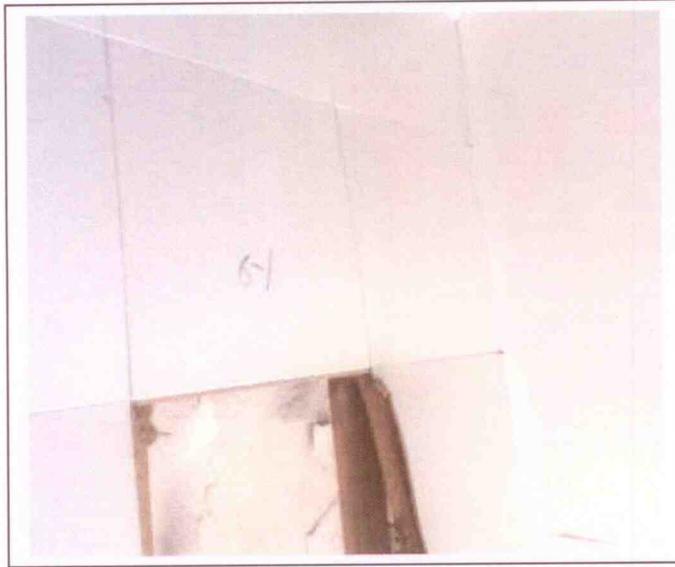
12" Ceiling tile

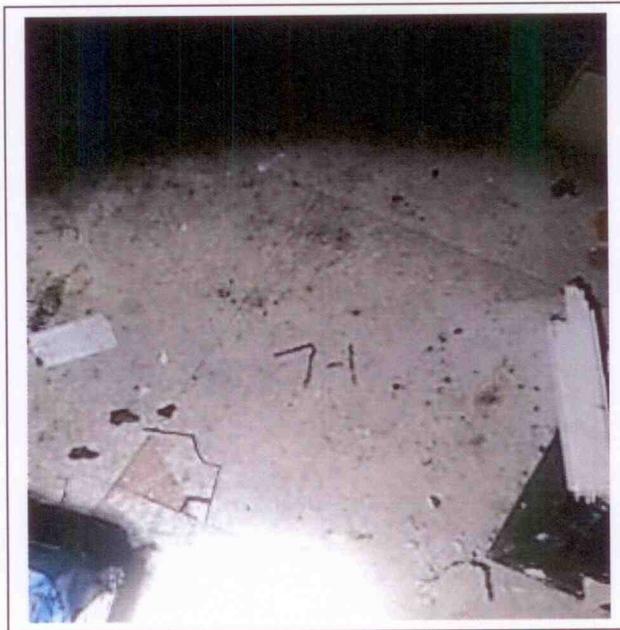
12" White sticky back floor tile

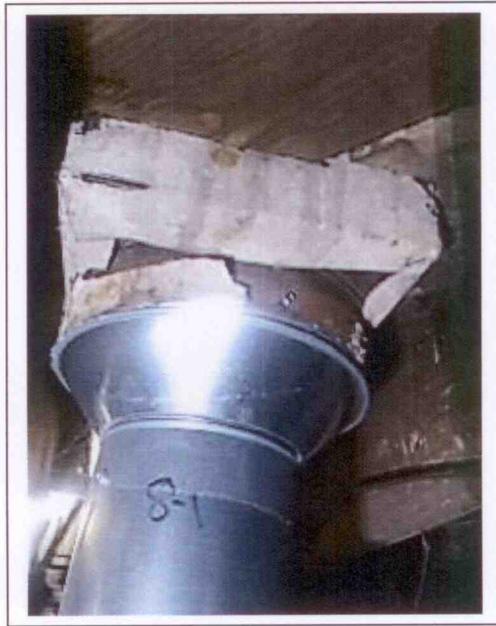
Duct insulation (Thermal System Insulation)	Basement, 2609 side	8	8-1	55% Chrysotile	Friable
Drywall, old (Miscellaneous)	Basement, 2609 side	9	9-1	None Detected	Nonfriable
Drywall, old (Miscellaneous)	Basement, 2609 side	9	9-2	None Detected	Nonfriable
Textured ceiling (Surfacing, <1,000 sf)	Bathroom, 2609 side	10	10-1	None Detected	Nonfriable
Textured ceiling (Surfacing, <1,000 sf)	Bathroom, 2609 side	10	10-2	None Detected	Nonfriable
Textured ceiling (Surfacing, <1,000 sf)	Bathroom, 2609 side	10	10-3	None Detected	Nonfriable
Textured ceiling (Surfacing, <1,000 sf)	Living room, 2611 side	11	11-1	None Detected	Nonfriable
Textured ceiling (Surfacing, <1,000 sf)	Dining room, 2611 side	11	11-2	None Detected	Nonfriable

Location	Type ACM	Material Description	Amt. of Material (approx.)
The following asbestos-containing materials are located in the vacant residences located at 2609-2611 North Main Street, Dayton.			
Basement, 2609 side	RACM	Duct insulation	20 sf
Basement to 2nd floor, 2609 side	RACM	Duct insulation (concealed behind hard wall and ceiling plaster)	100 sf
Basement, 2611 side	RACM	Duct insulation	10 sf
Basement to 2nd floor, 2611 side	RACM	Duct insulation (concealed behind hard wall and ceiling plaster)	100 sf

Duct insulation

Location	Type ACM	Material Description	Cost for abatement (approx.)
The following asbestos-containing materials are located in the vacant residences located at 2609-2611 North Main Street, Dayton.			
Basement, 2609 side	RACM	Duct insulation	\$400.00
Basement to 2nd floor, 2609 side	RACM	Duct insulation (concealed behind hard wall and ceiling plaster)	\$2,500.00
Basement, 2611 side	RACM	Duct insulation	\$400.00
Basement to 2nd floor, 2611 side	RACM	Duct insulation (concealed behind hard wall and ceiling plaster)	\$2,500.00

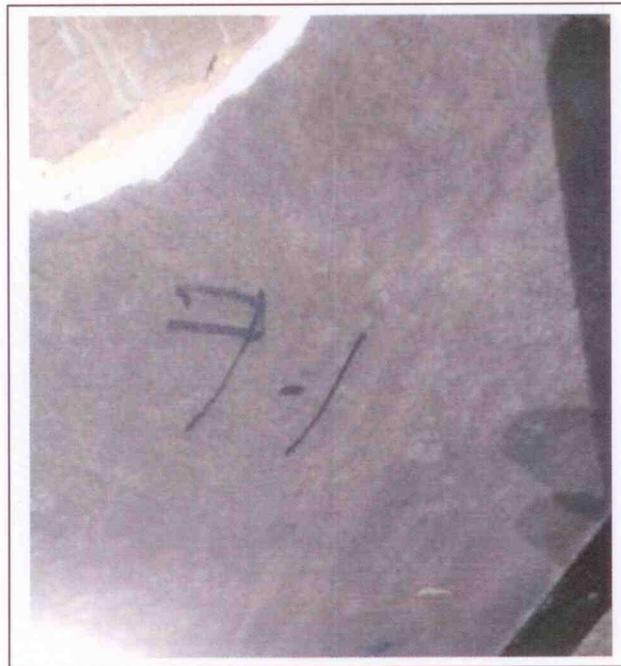
Drywall, old

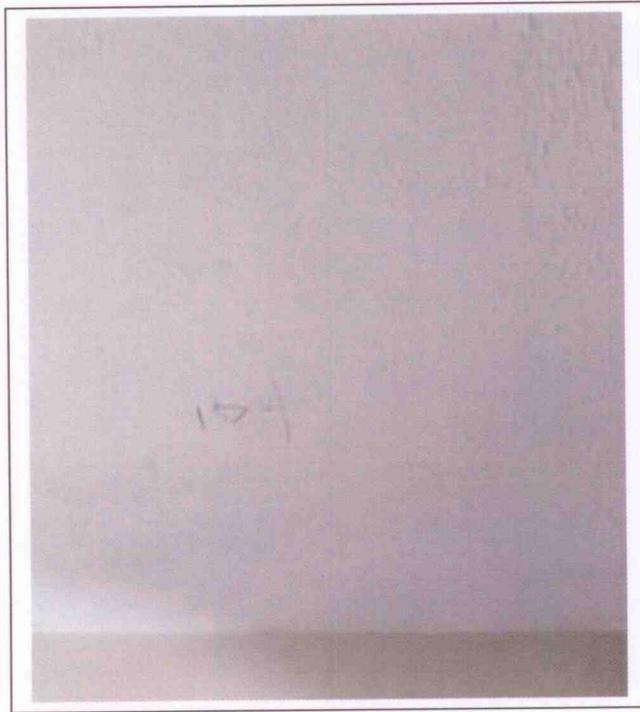
Textured ceiling

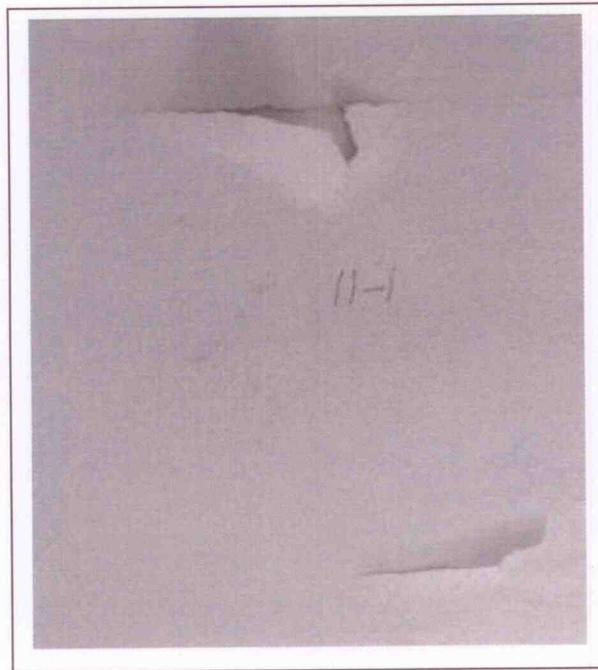
Textured ceiling

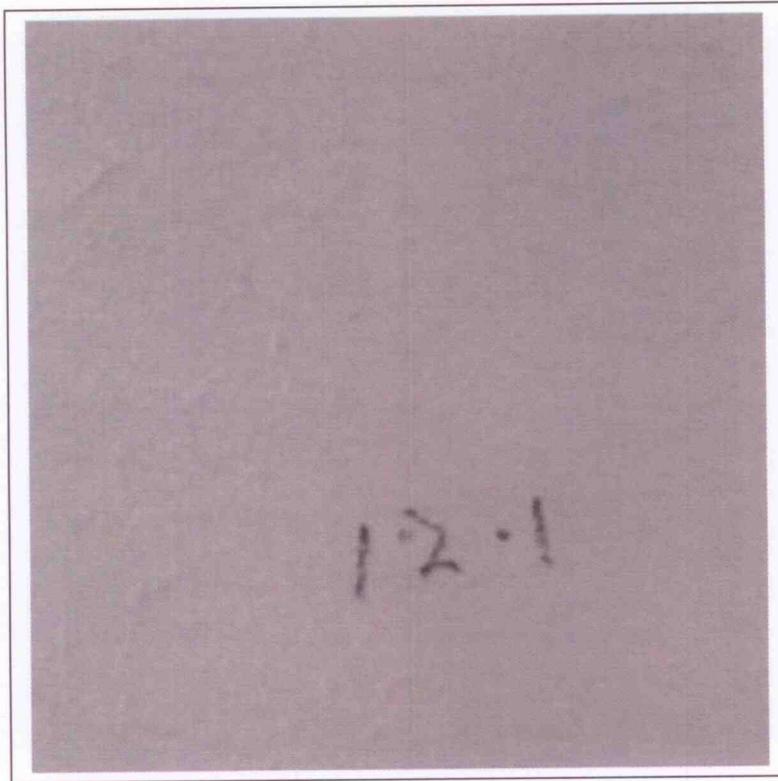
Textured wall and ceiling

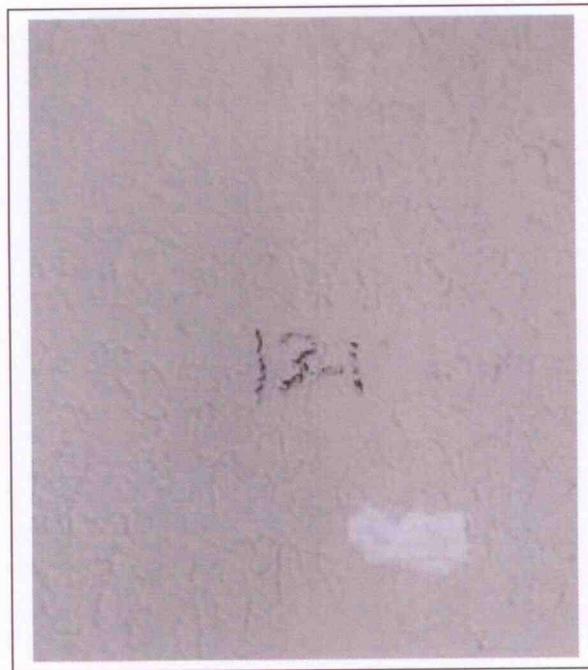
Textured wall and ceiling

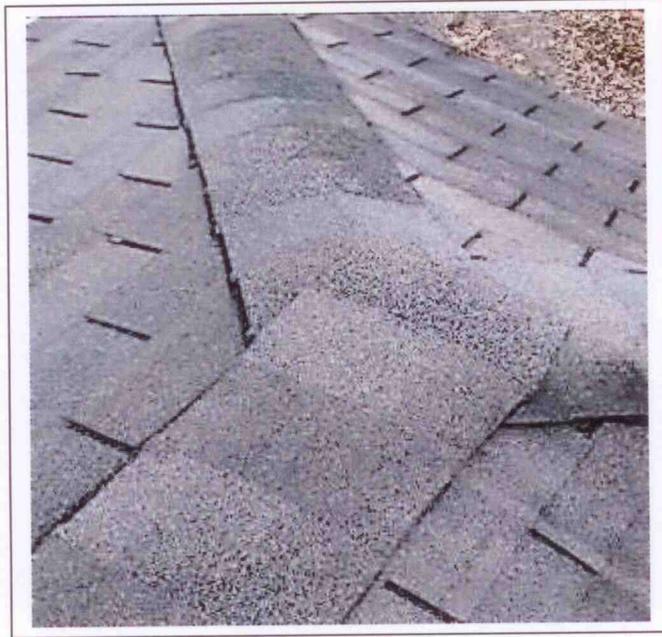
Black asphalt roof shingles
