December 14, 2015

**Re:** Comprehensive Pre-Demolition Asbestos Inspection  
Vacant Residences  
2613-2615 North Main Street  
Dayton, Ohio 45405  
Sierra Project Number: MCLB.003

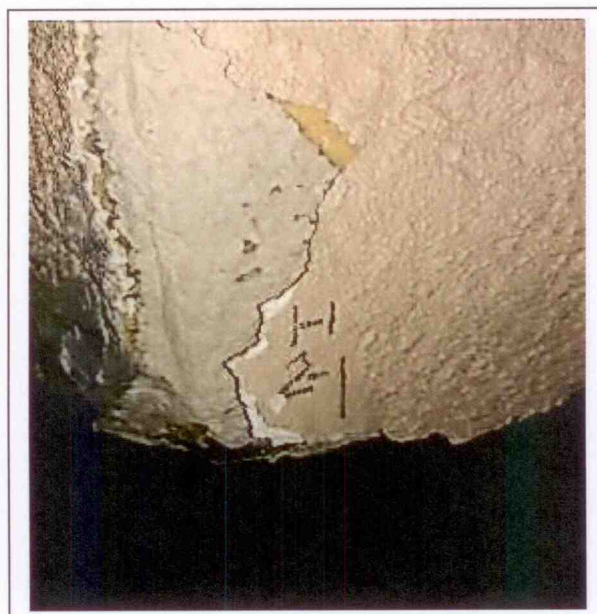
| <b>SAMPLE DESCRIPTION<br/>(Material Type)</b> | <b>SAMPLE LOCATION</b> | <b>HOMO AREA #</b> | <b>SAMPLE I.D. NO.</b> | <b>ASBESTOS CONTENT</b> | <b>FRIABLE/<br/>NONFRIABLE</b> |
|---|---|---|---|---|---|
| Bottom coat of exterior stucco<br>(Surfacing, <1,000 sf) | Exterior | 2 | 2-1 | *0.25% Chrysotile | Nonfriable |
| Bottom coat of exterior stucco<br>(Surfacing, <1,000 sf) | Exterior | 2 | 2-2 | *0.25% Chrysotile | Nonfriable |
| Bottom coat of exterior stucco<br>(Surfacing, <1,000 sf) | Exterior | 2 | 2-3 | *0.25% Chrysotile | Nonfriable |

Exterior stucco, two coats

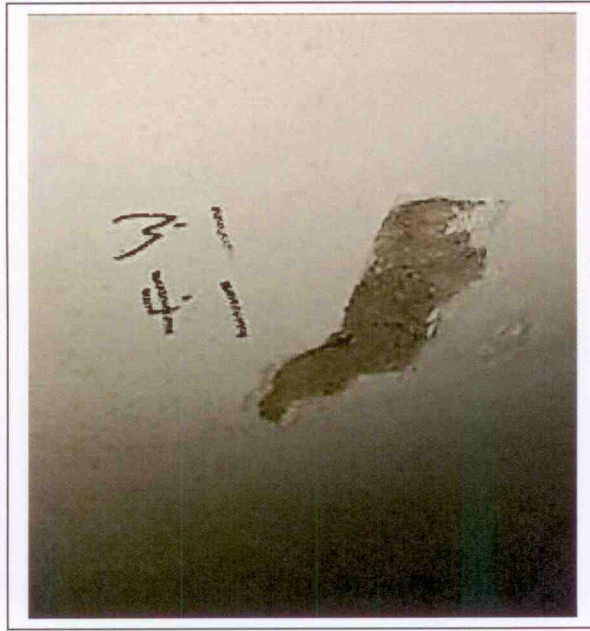
Hard wall and ceiling plaster

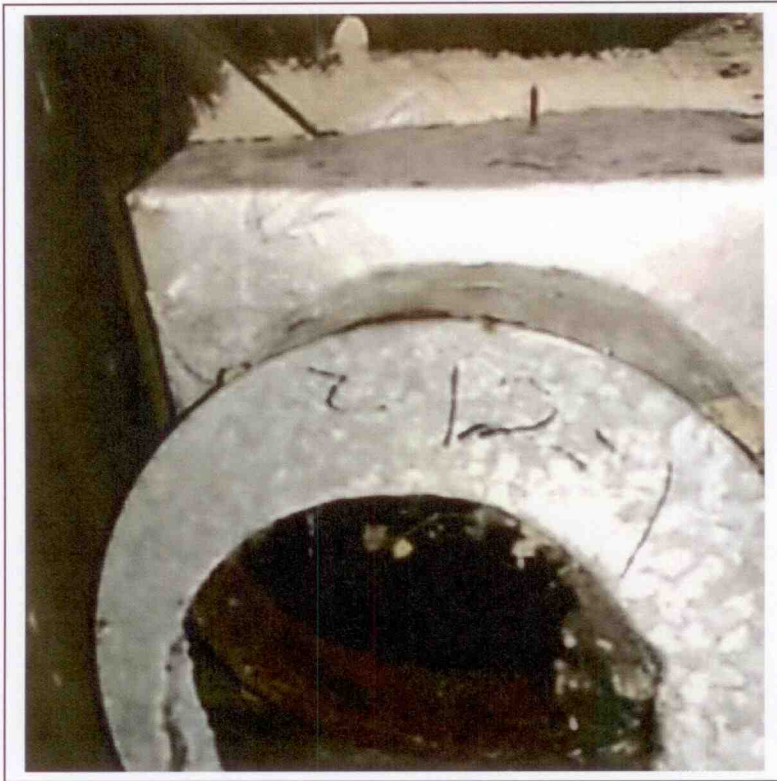
| <b>SAMPLE DESCRIPTION<br/>(Material Type)</b> | <b>SAMPLE LOCATION</b> | <b>HOMO AREA #</b> | <b>SAMPLE I.D. NO.</b> | <b>ASBESTOS CONTENT</b> | <b>FRIABLE/<br/>NONFRIABLE</b> |
|---|---|---|---|---|---|
| Duct insulation<br>(Thermal System Insulation) | Basement, 2613 side | 12 | 12-1 | 55% Chrysotile | Friable |

| Location | Type<br>ACM | Material<br>Description | Amt. of<br>Material<br>(approx.) |
|---|---|---|---|
| Basement, 2613 side | RACM | Duct insulation | 15 sf |
| Basement to 2nd floor,<br>2613 side | RACM | Duct insulation<br>(concealed behind hard wall and ceiling plaster) | 75 sf |

Duct insulation

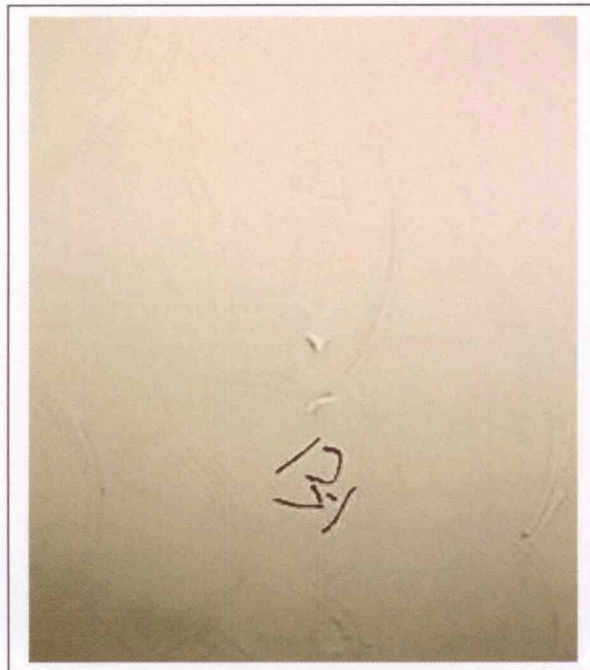
| <b>SAMPLE DESCRIPTION<br/>(Material Type)</b> | <b>SAMPLE LOCATION</b> | <b>HOMO AREA #</b> | <b>SAMPLE I.D. NO.</b> | <b>ASBESTOS CONTENT</b> | <b>FRIABLE/<br/>NONFRIABLE</b> |
|---|---|---|---|---|---|
| Textured ceiling, swirl<br>(Surfacing, <1,000 sf) | Bedroom 1, 2613 side | 13 | 13-1 | *0.25% Chrysotile | Nonfriable |

Textured ceiling, swirl pattern

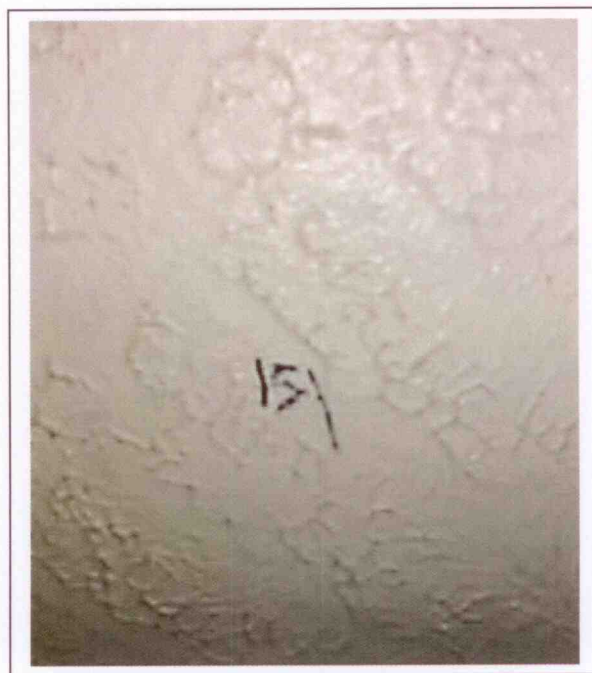
| <b>SAMPLE DESCRIPTION<br/>(Material Type)</b> | <b>SAMPLE LOCATION</b> | <b>HOMO AREA #</b> | <b>SAMPLE I.D. NO.</b> | <b>ASBESTOS CONTENT</b> | <b>FRIABLE/<br/>NONFRIABLE</b> |
|---|---|---|---|---|---|
| Textured ceiling<br>(Surfacing, <1,000 sf) | Bathroom, 2613 side | 15 | 15-1 | *0.50% Chrysotile | Nonfriable |

Textured ceiling

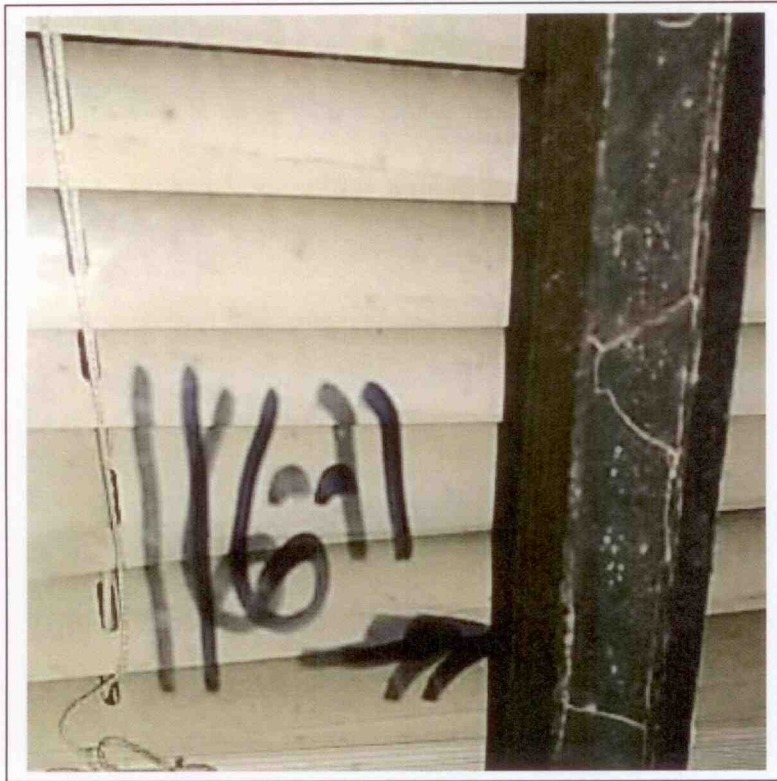
| <b>SAMPLE DESCRIPTION<br/>(Material Type)</b> | <b>SAMPLE LOCATION</b> | <b>HOMO AREA #</b> | <b>SAMPLE I.D. NO.</b> | <b>ASBESTOS CONTENT</b> | <b>FRIABLE/<br/>NONFRIABLE</b> |
|---|---|---|---|---|---|
| Window glaze<br>(Miscellaneous) | Exterior | 16 | 16-1 | *<0.25% Chrysotile | Friable |
| Window glaze<br>(Miscellaneous) | Exterior | 16 | 16-2 | *0.25% Chrysotile | Friable |

Exterior window glaze
