SIERRA ENVIRONMENTAL GROUP, INC.

December 8, 2015

Re: Comprehensive Pre-Demolition Asbestos Inspection
Vacant Residences
1308-1310 Kumler Avenue
Dayton, Ohio 45406
Sierra Project Number: MCLB.002

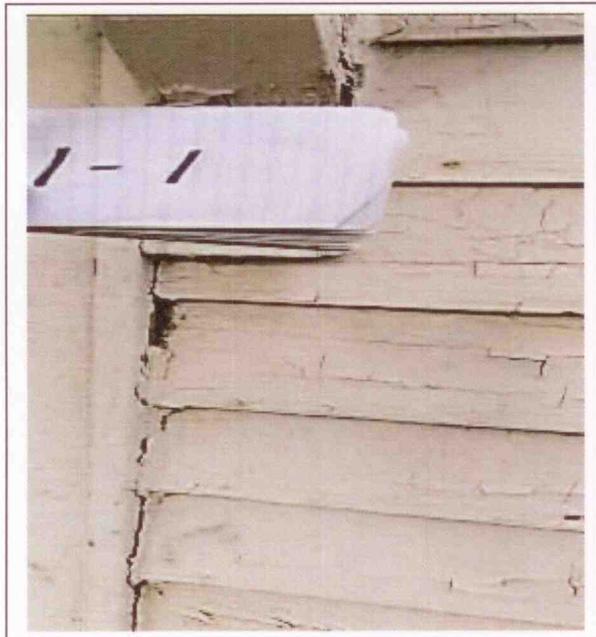
Door caulk

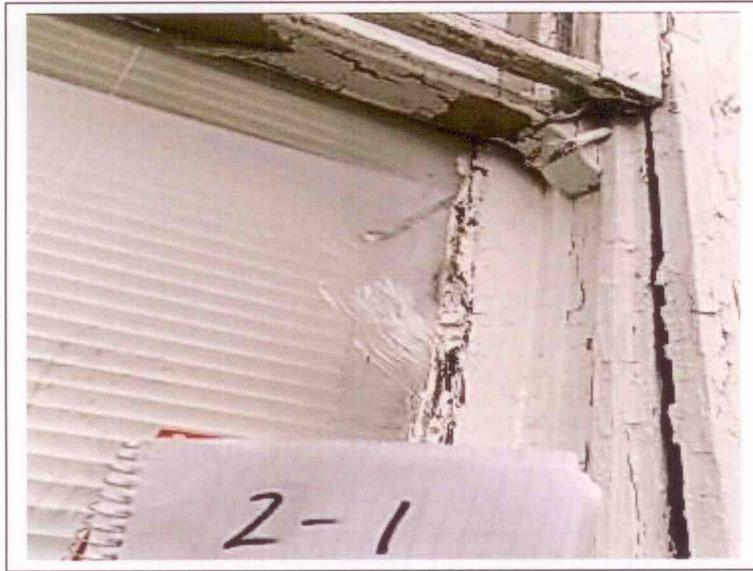
Window glaze

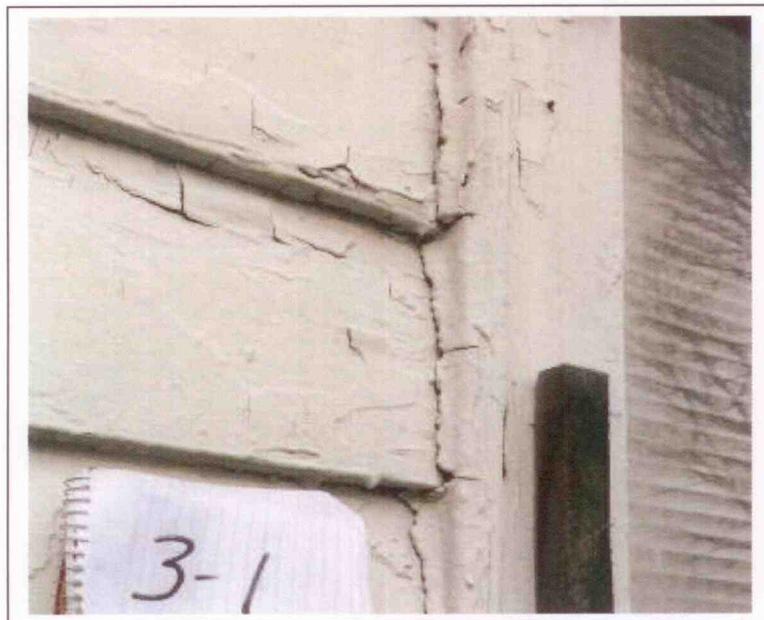
Window caulk

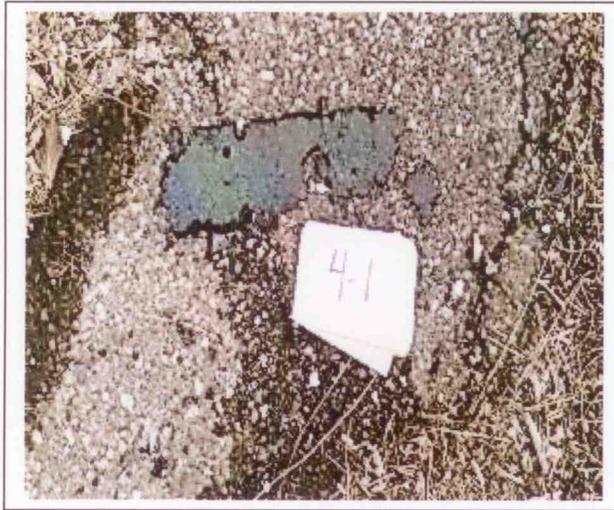
Asphalt roof shingle

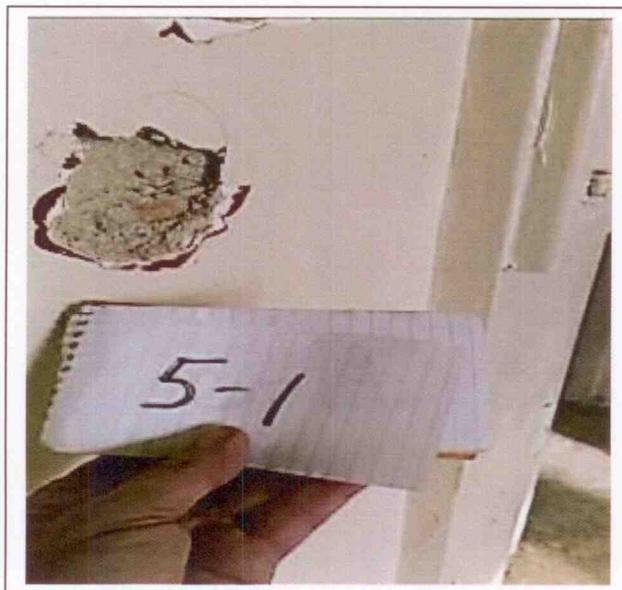
Skim coat

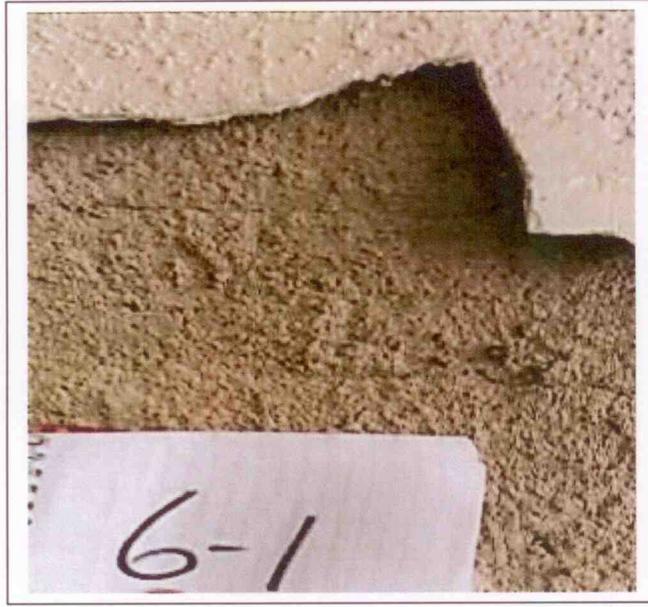
Hard wall and ceiling plaster

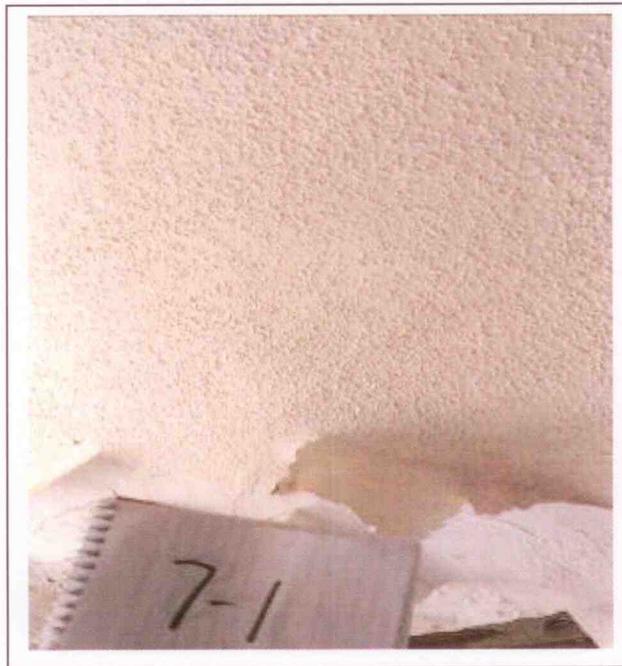
Rough white ceiling texture

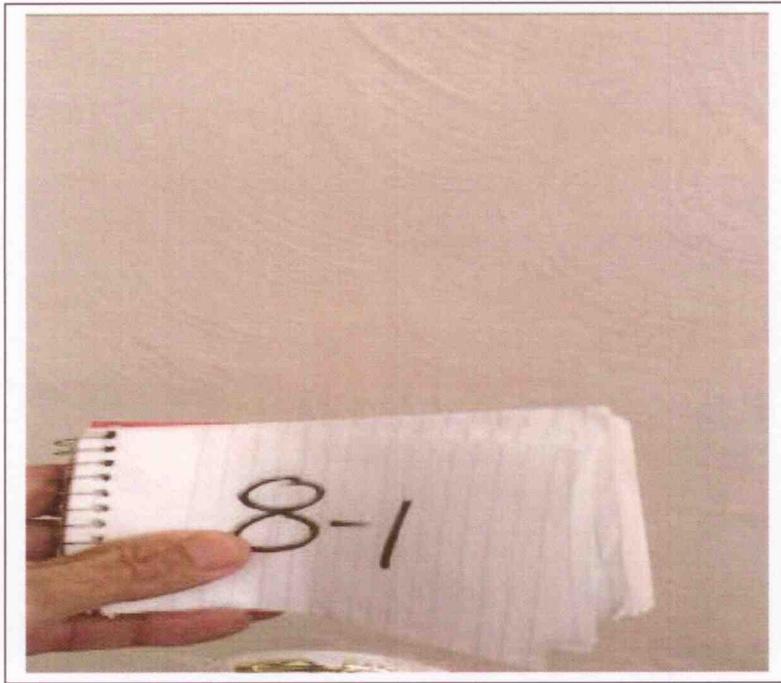
Swirl textured ceiling

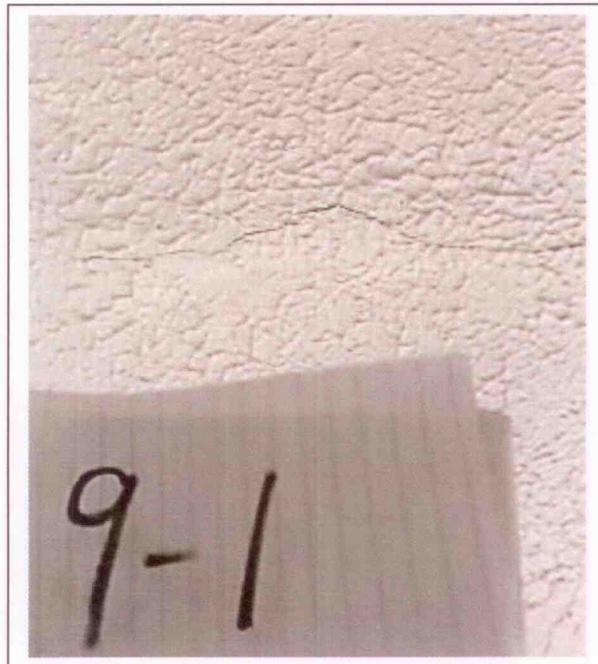
Ripple textured ceiling

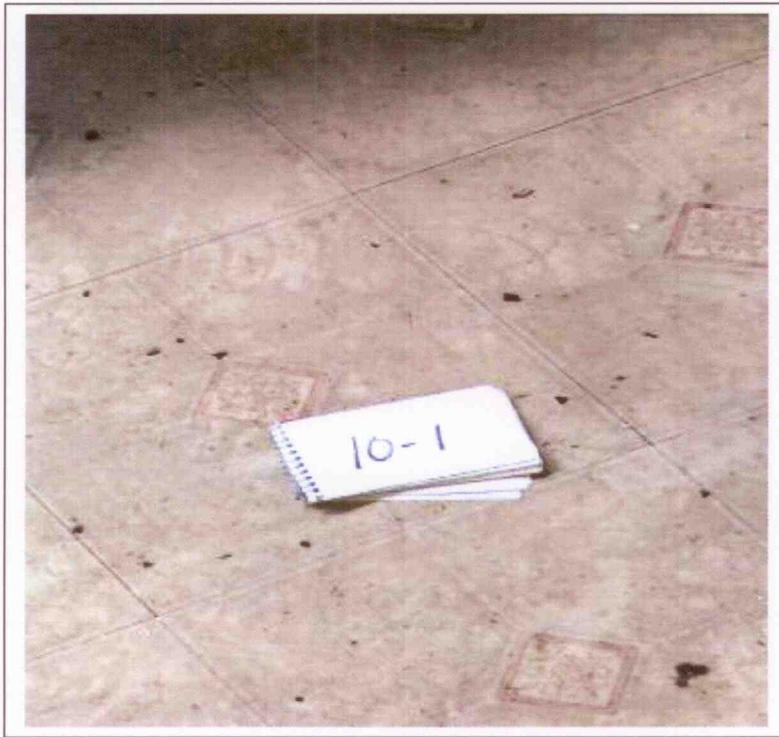
12" Tan sticky back floor tile

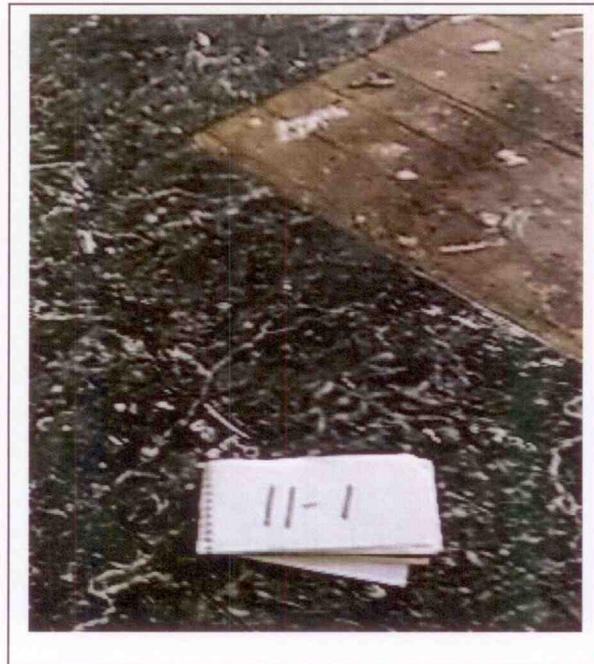
12" Grey sticky back tile

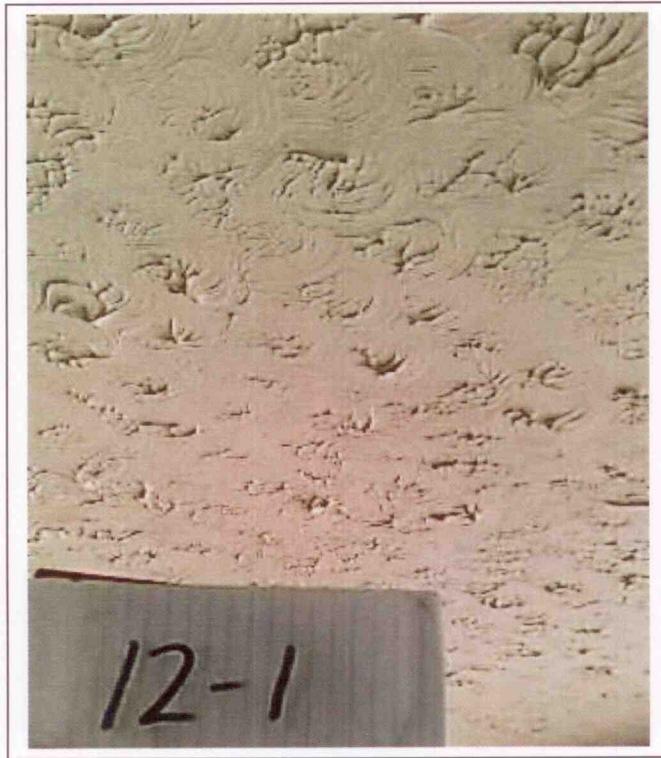
Lumpy textured ceiling

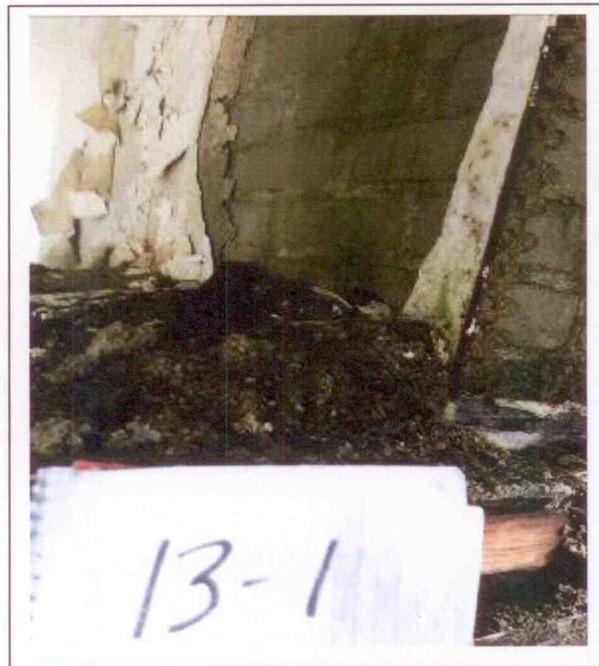
Blown-in insulation

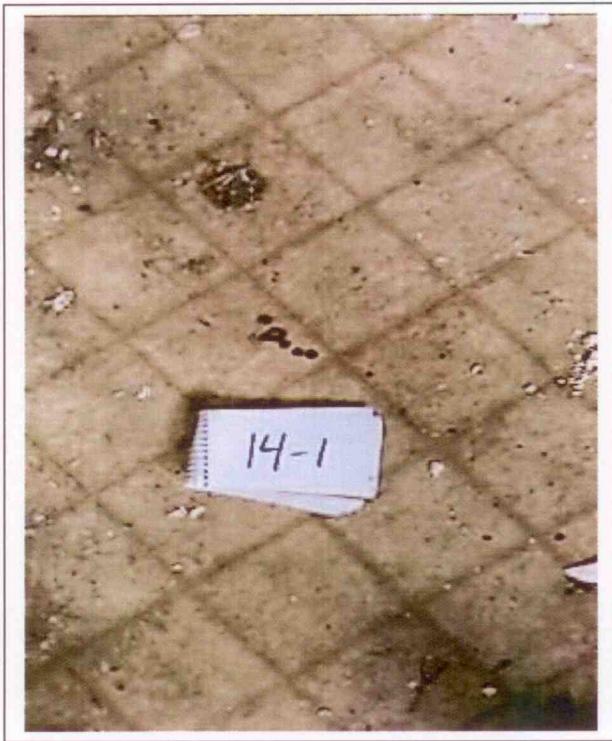
Tan square pattern linoleum

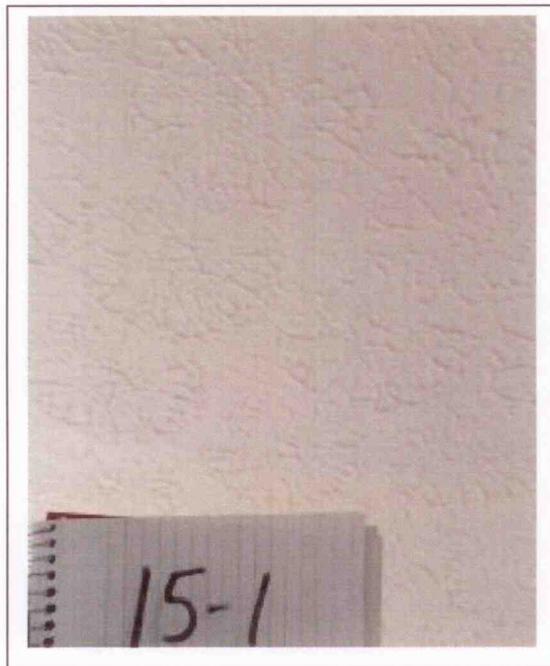
Flower pattern textured ceiling

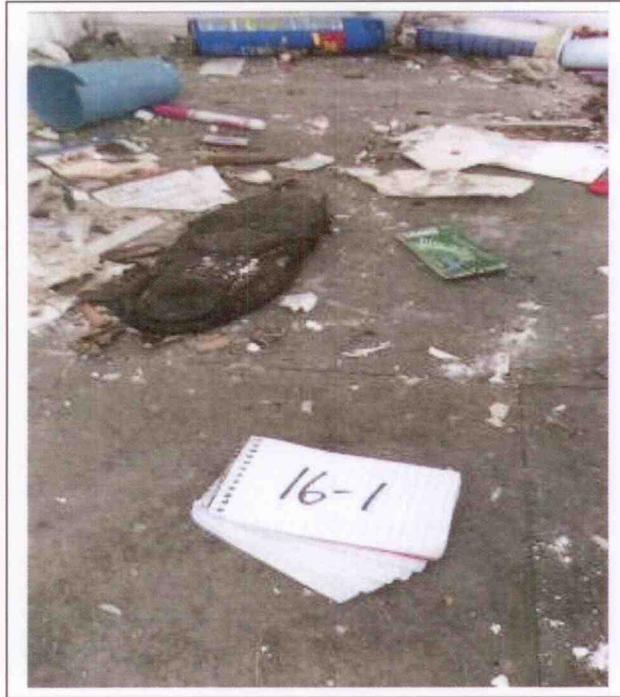
12" Grey pattern sticky-back tile

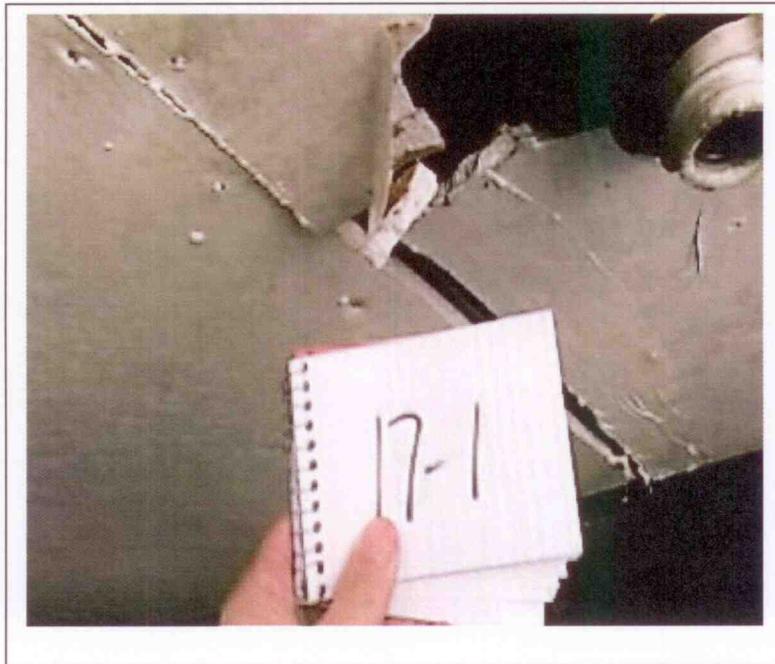
Drywall

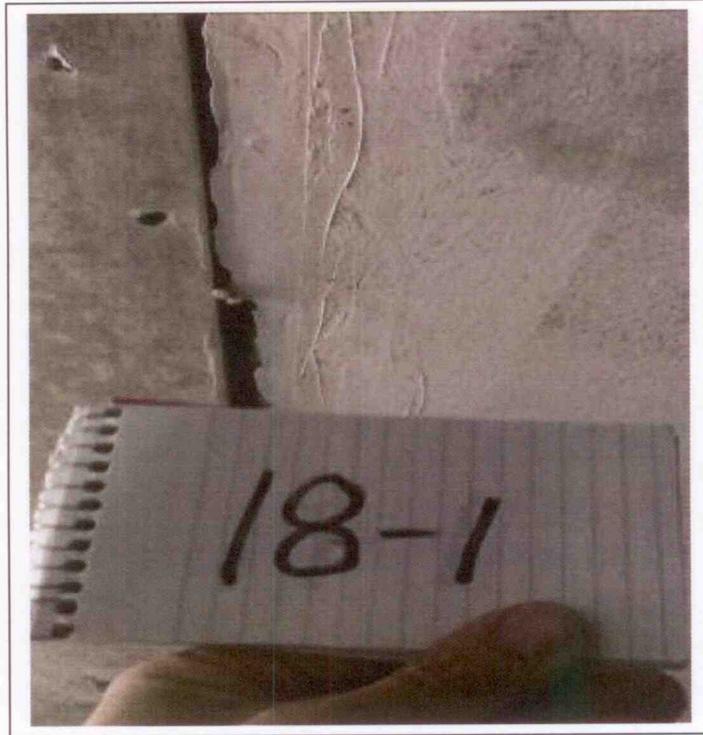
Joint compound

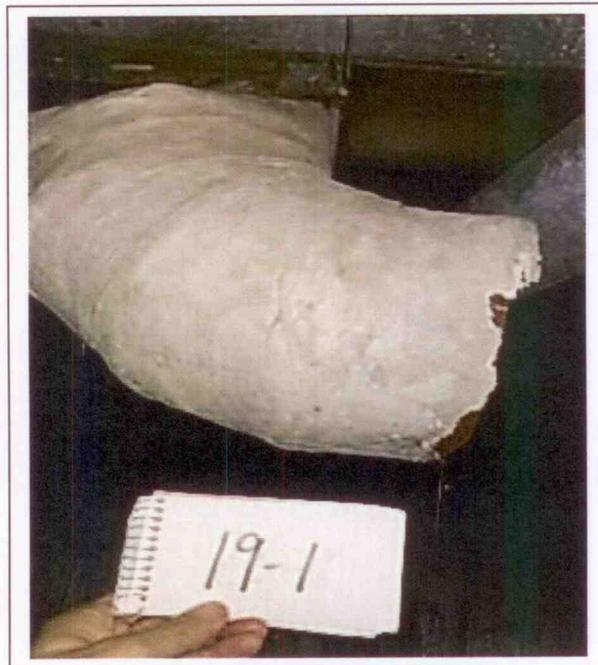
SAMPLE DESCRIPTION (Material Type)	SAMPLE LOCATION	HOMO AREA #	SAMPLE I.D. NO.	ASBESTOS CONTENT	FRIABLE/ NONFRIABLE
Duct insulation (Thermal System Insulation)	Basement	19	19-1	55% Chrysotile	Friable

Duct insulation
