SIERRA ENVIRONMENTAL GROUP, INC.

Re: Comprehensive Pre-Demolition Asbestos Inspection
Vacant Residences
2060-2062 Ravenwood Avenue
Dayton, Ohio 45406
Sierra Project Number: MCLB.002

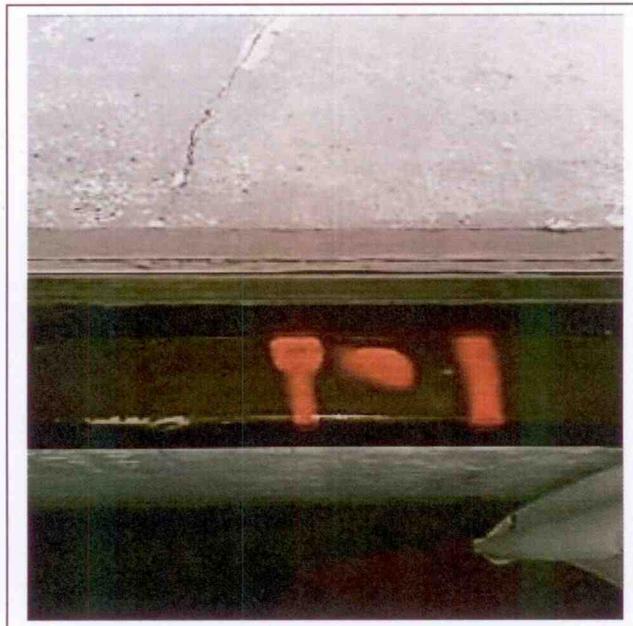
Window glaze

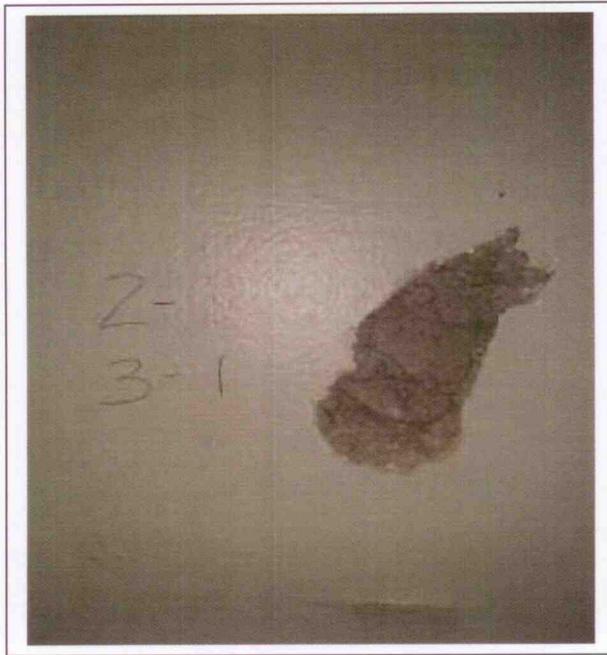
Hard wall and ceiling plaster

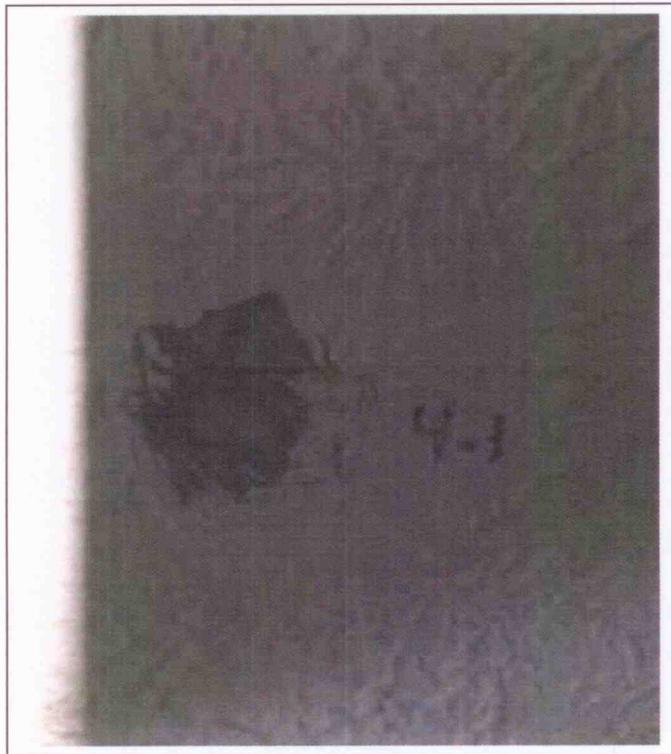
Textured wall

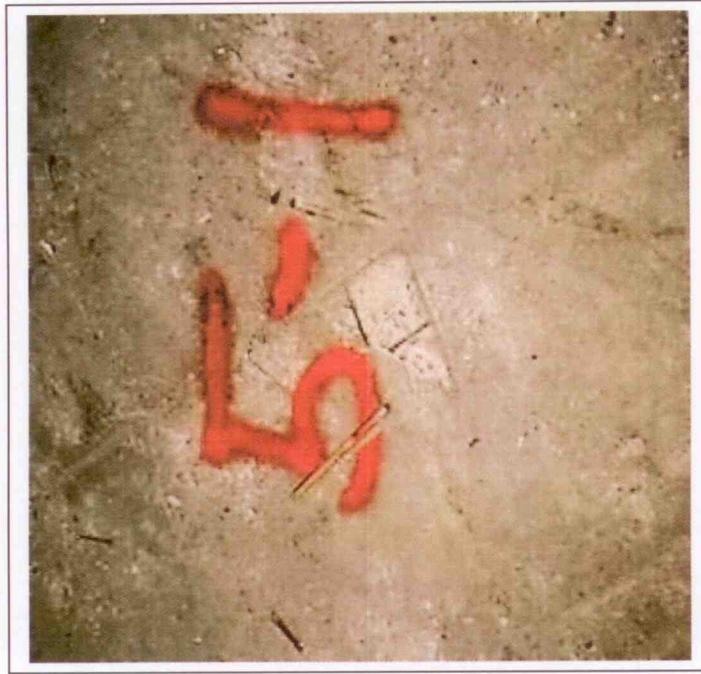
12" Tan sticky back floor tile

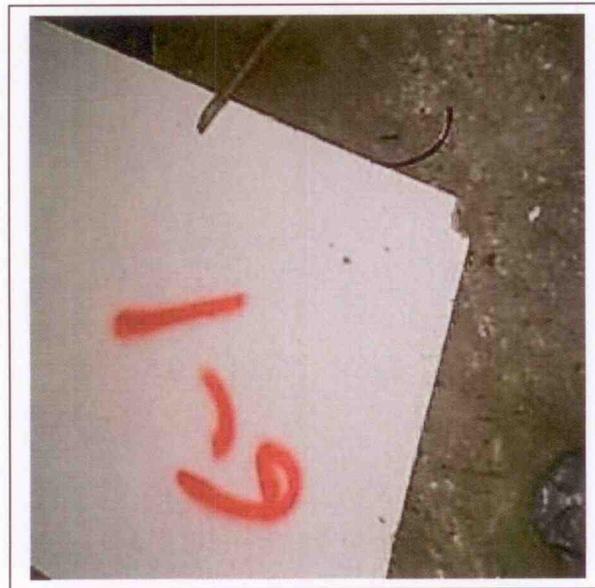
2'x4' Suspended ceiling tile with holes and fissures

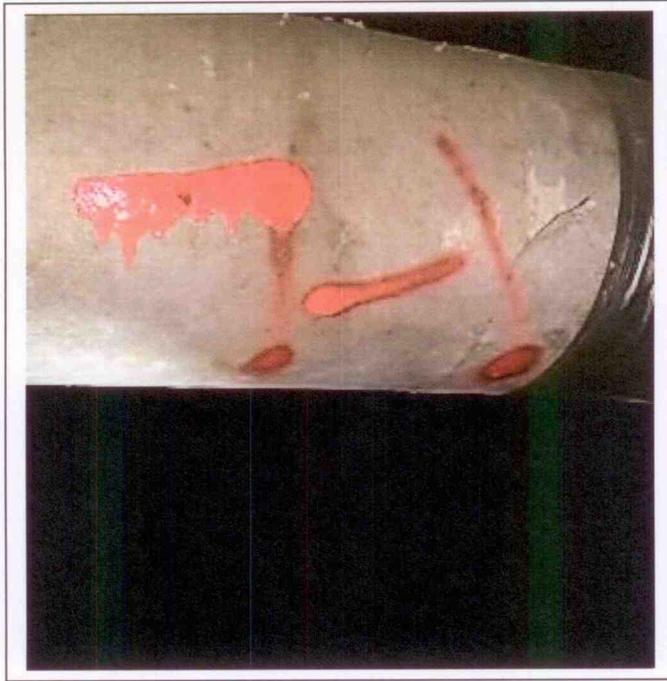
Duct insulation

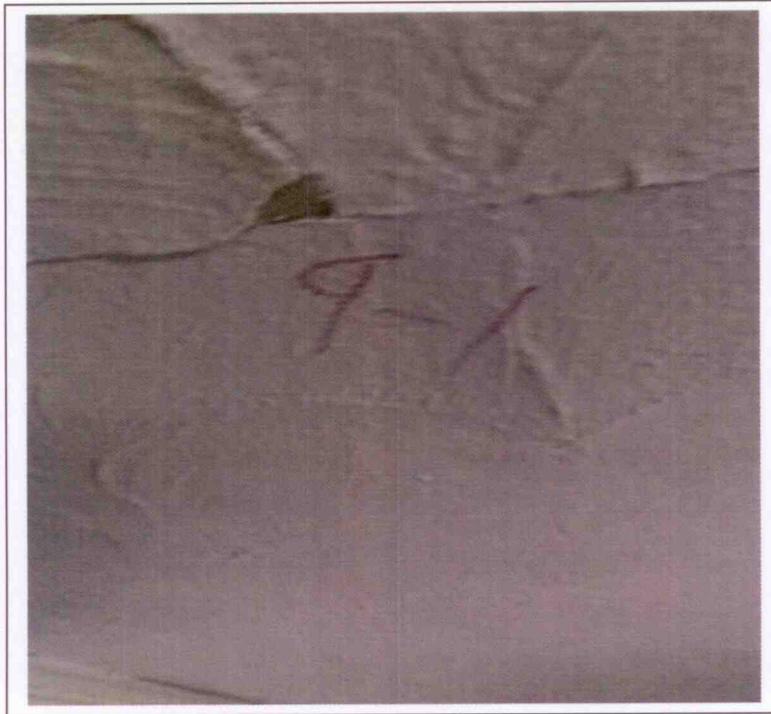
Textured ceiling

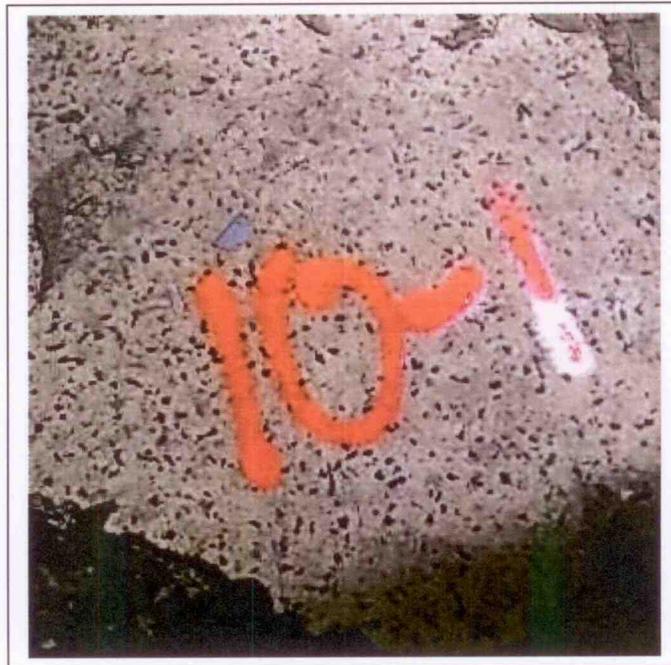
Multi-colored linoleum

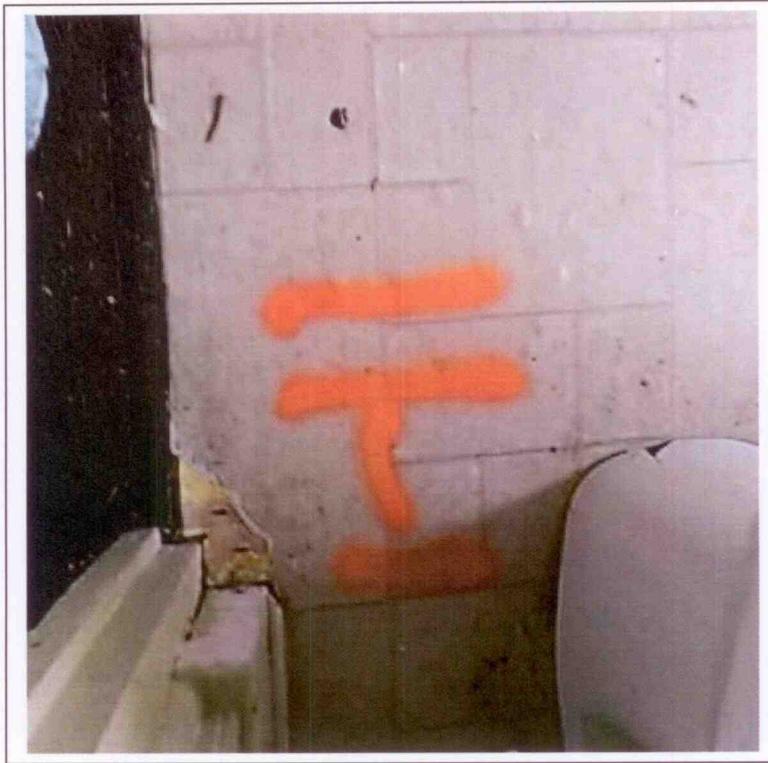
Tan linoleum

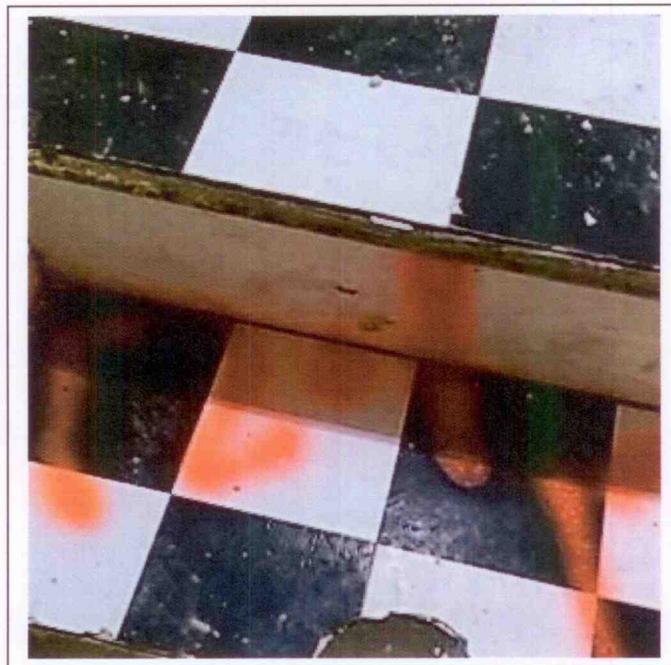
Black and white sheet flooring

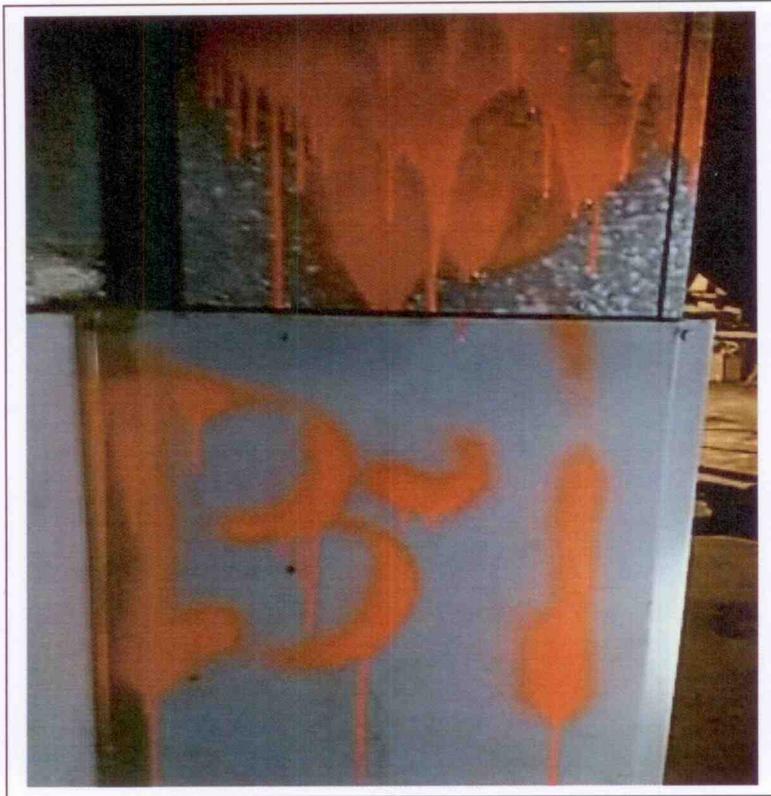
Heat shield

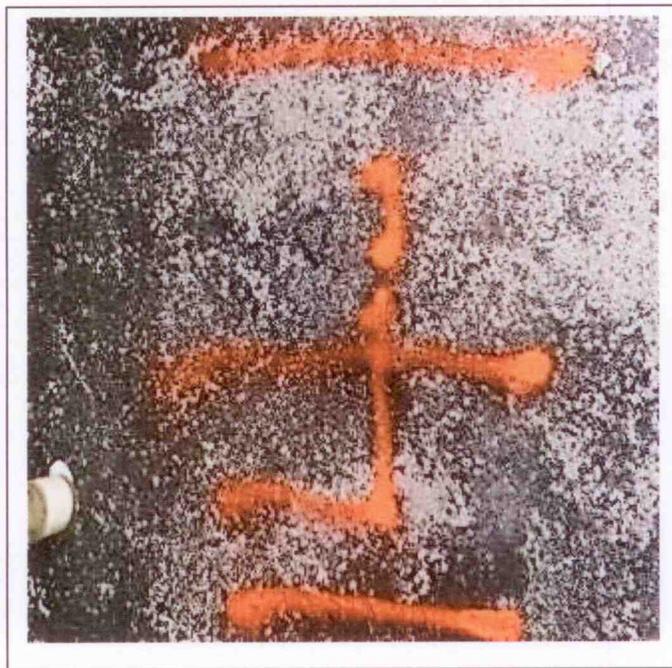
Black and grey asphalt roof shingles
