SIERRA ENVIRONMENTAL GROUP, INC.

Re: Comprehensive Pre-Demolition Asbestos Inspection
Vacant Residences
2119 West Third Street
Dayton, Ohio 45417
Sierra Project Number: MCLB.002

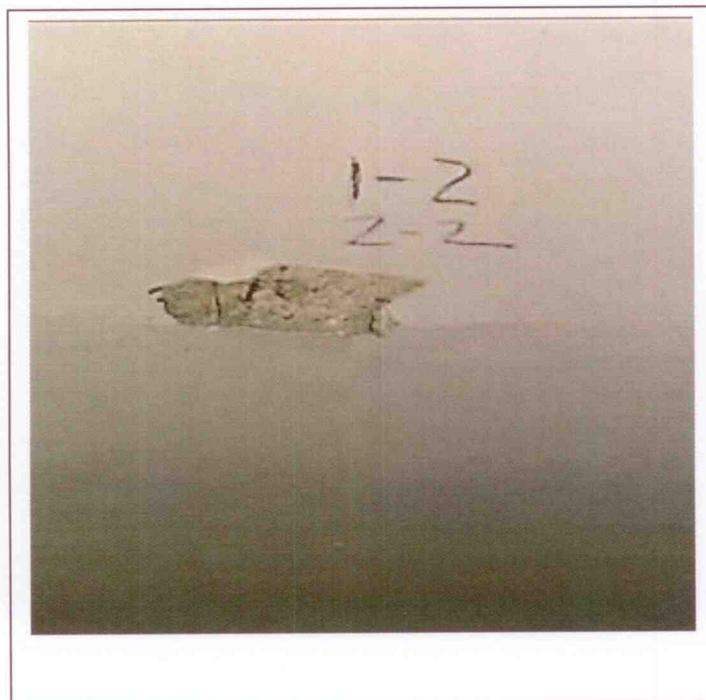
Hard wall and ceiling plaster

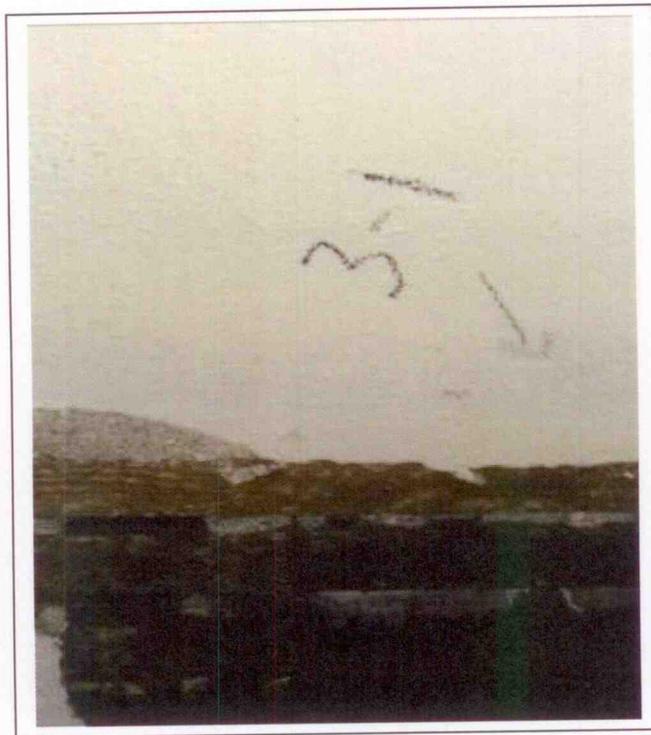
Location	Type ACM	Material Description	Amt. of Material (approx.)
The following asbestos-containing materials are located in the vacant residences located at 2119 West Third Street, Dayton, Ohio.			
Basement	RACM	Duct insulation	45 sf
Basement to 2nd floor	RACM	Duct insulation (concealed behind hard wall and ceiling plaster)	100 sf

Duct insulation

Location	Type ACM	Material Description	Cost for abatement (approx.)
The following asbestos-containing materials are located in the vacant residences located at 2119 West Third Street, Dayton, Ohio.			
Basement	RACM	Duct insulation	\$900.00
Basement to 2nd floor	RACM	Duct insulation (concealed behind hard wall)	\$2,500.00

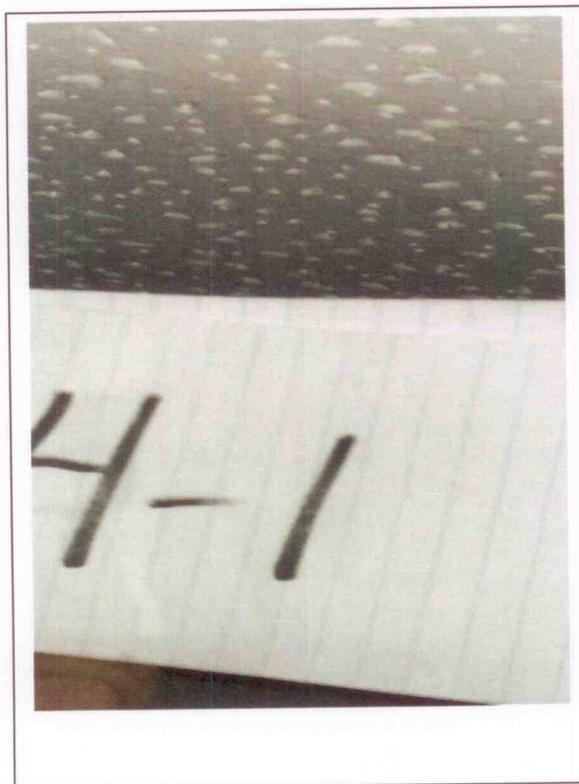
2'x4' Suspended ceiling tile with holes and gouges

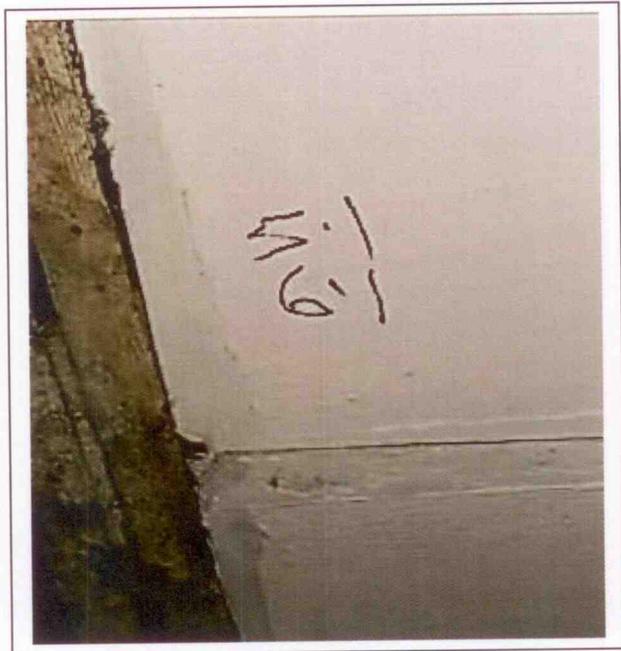
Drywall and associated joint compound

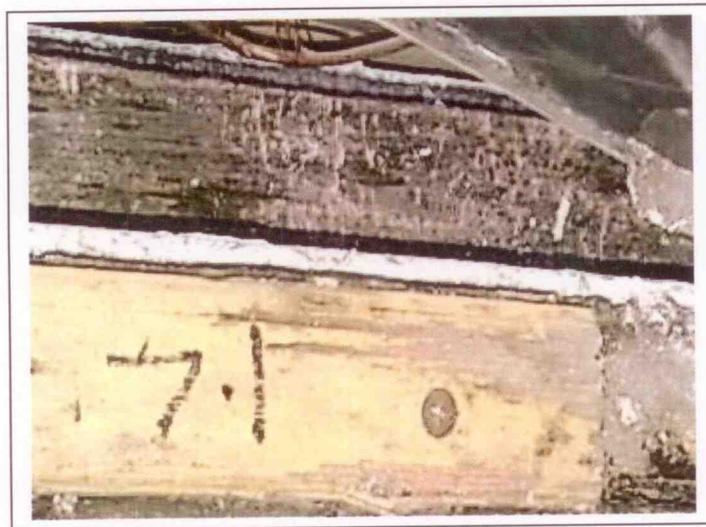
Window glaze

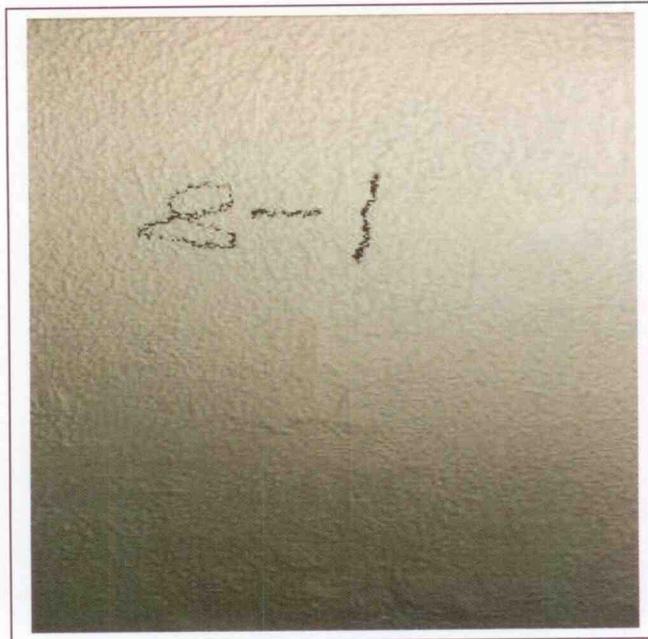
Textured wall and ceiling

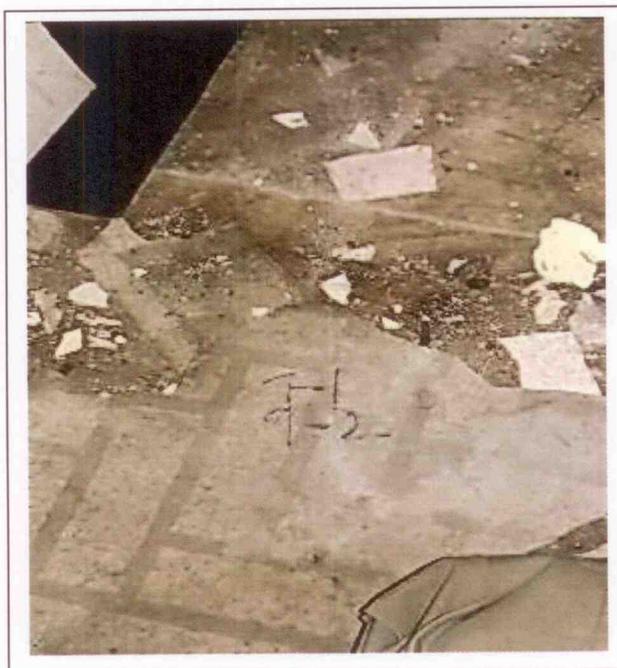
12" Tan sticky back floor tile

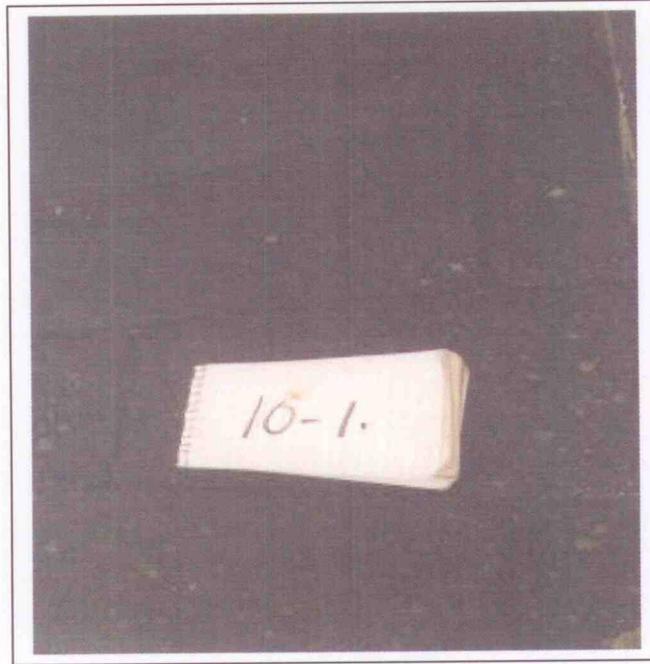
Black asphalt roof shingle

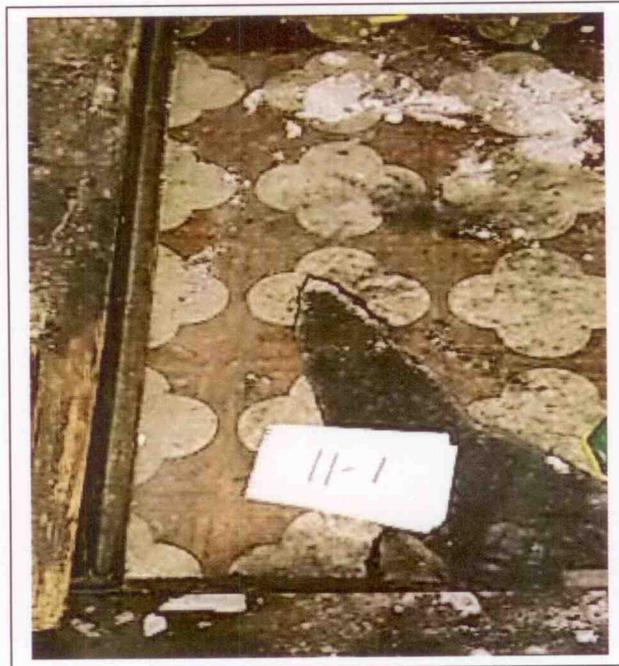
Tan linoleum
