**SIERRA** ENVIRONMENTAL GROUP, INC.

December 8, 2015

**Re:** Comprehensive Pre-Demolition Asbestos Inspection  
Vacant Residence – Fire Damage  
5054 Coulson Drive  
Dayton, Ohio 45417  
Sierra Project Number: MCLB.002

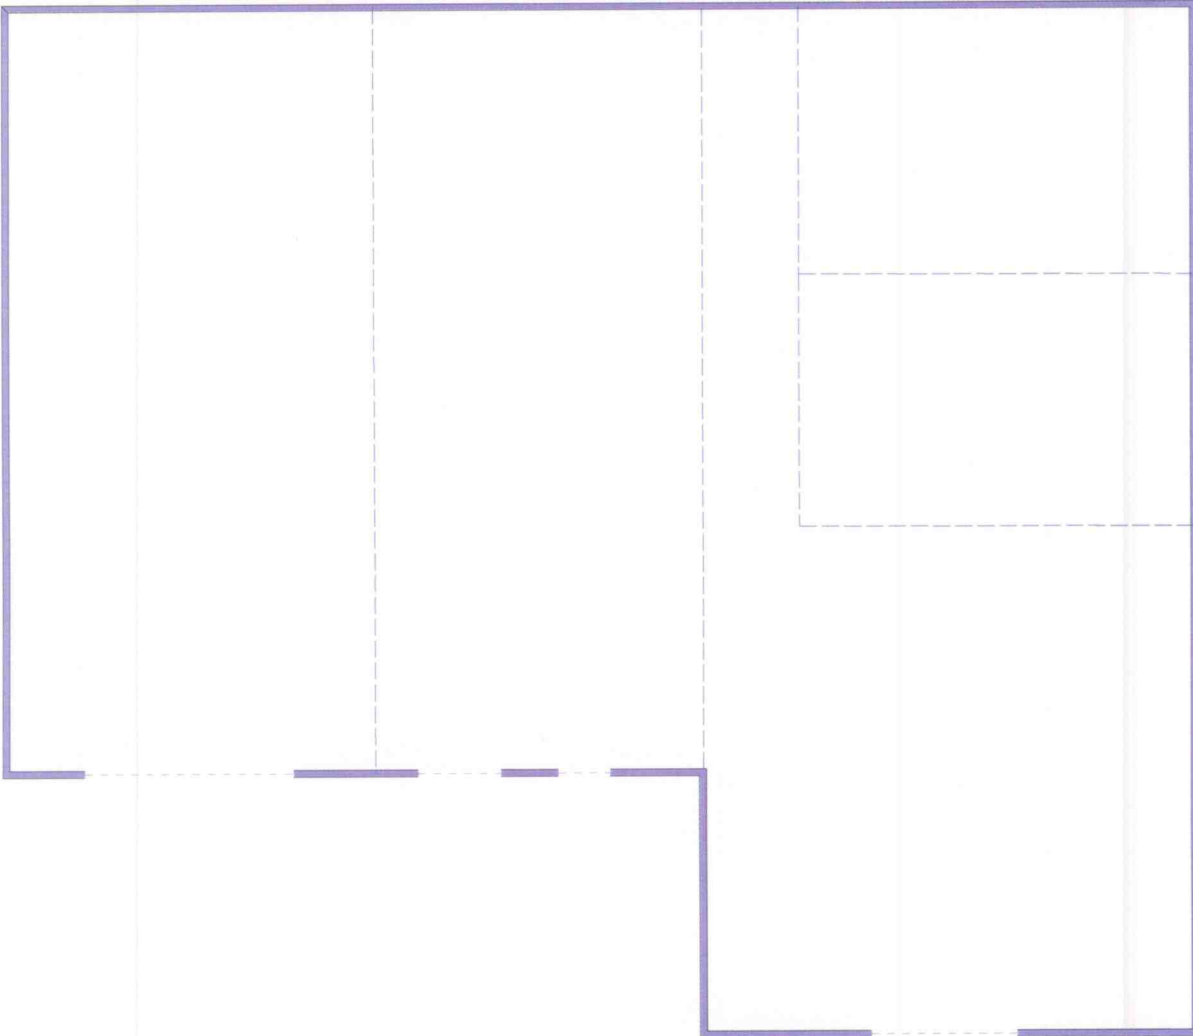
5054 COULSON DRIVE  
FIRST FLOOR  
STRUCTURE UNSAFE DUE  
TO FIRE DAMAGE

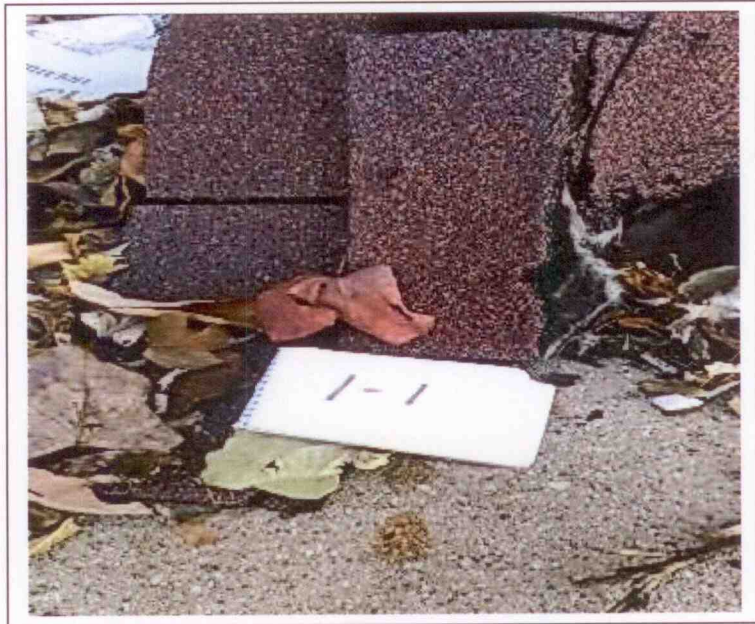
Roofing shingle

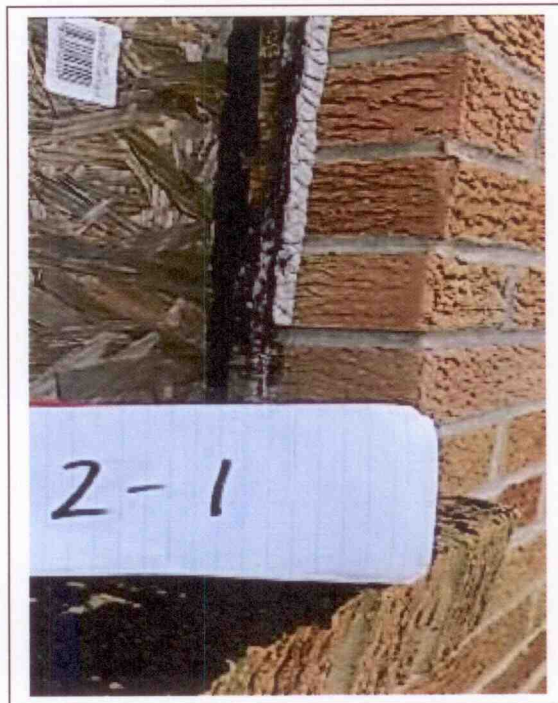
Location	Type ACM	Material Description	Amt. of Material (approx.)
<b>The following asbestos-containing materials are located in the vacant residence located at 5054 Coulson Drive, Dayton, Ohio.</b>			
Exterior	II	Window caulk	6 windows
Exterior	II	Door caulk	1 door

Window caulk

Location	Type ACM	Material Description	Cost for abatement (approx.)
<b>The following asbestos-containing materials are located in the vacant residence located at 5054 Coulson Drive, Dayton, Ohio.</b>			
Exterior	II	Window caulk	\$900.00
Exterior	II	Door caulk	\$200.00

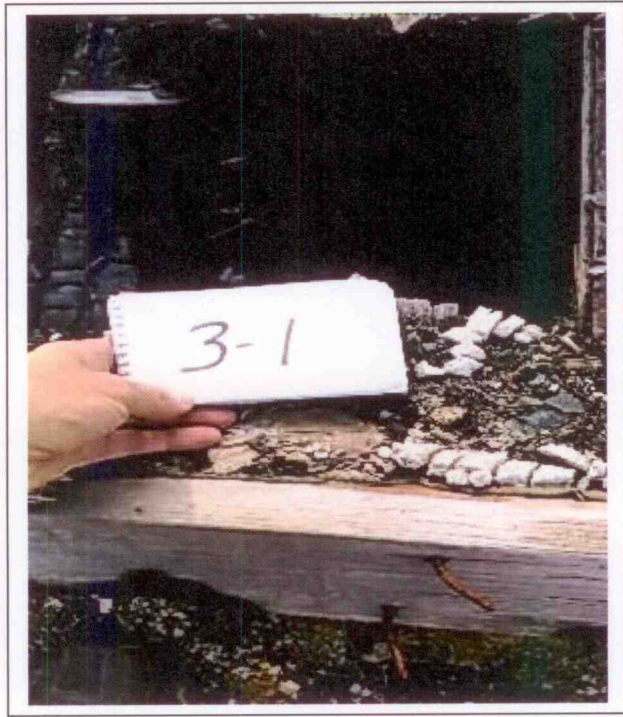
Dry wall

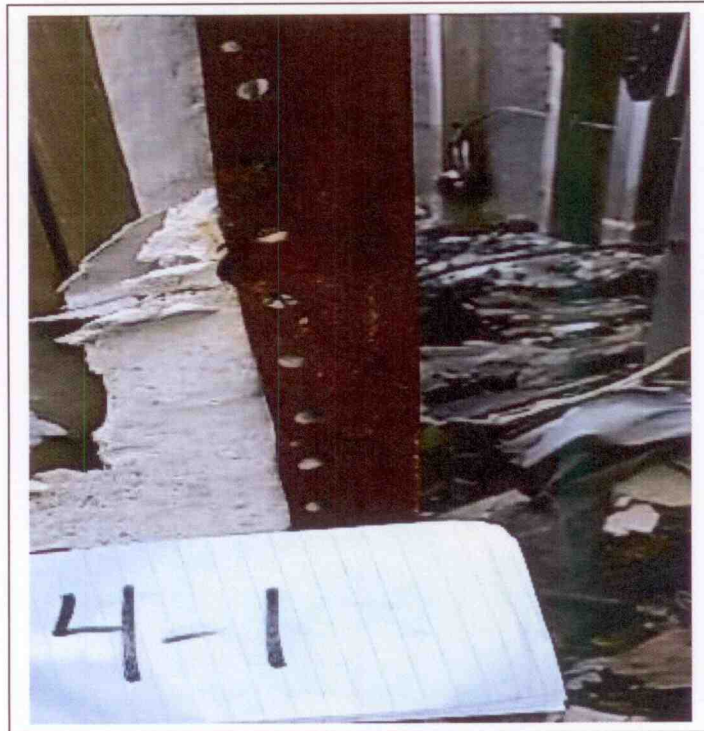
Joint compound

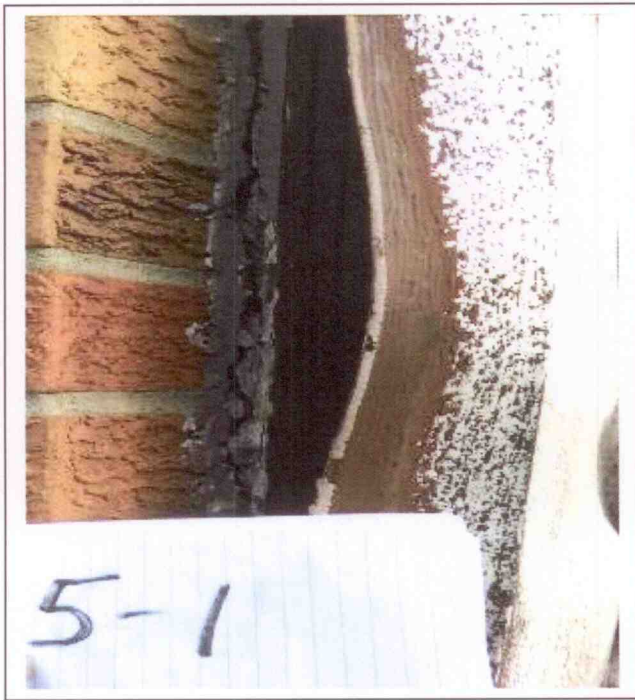
Door caulk (Miscellaneous)	Exterior	5	5-2	None Detected	Friable

Door caulk
