Turn-Key Environmental Consultants, Inc.

March 24, 2016

RE: Comprehensive Pre-Demolition Asbestos Survey, NOP TK-27, Vacant Residence, 2912 N. Main St., Dayton, OH, TKEC Project #TK-27A

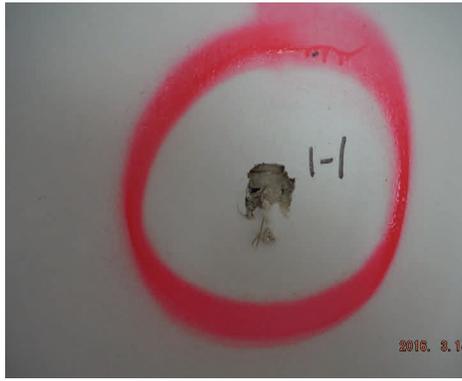
Sample 1-1 Plaster/Skim Coat

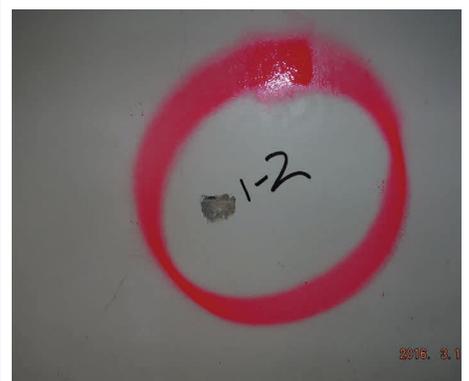
Sample 1-2 Plaster/Skim Coat

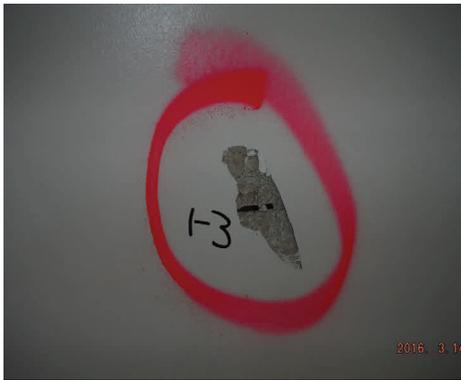
Sample 1-3 Plaster/Skim Coat

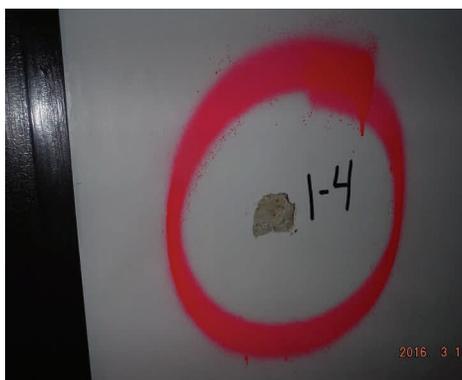
Sample 1-4 Plaster/Skim Coat

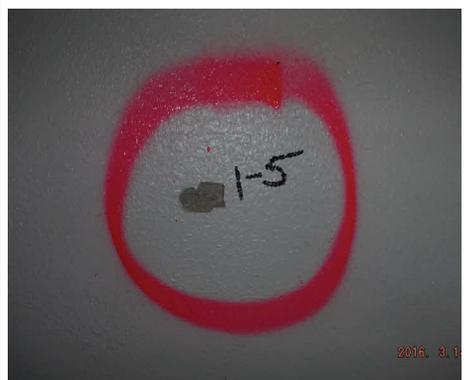
Sample 1-5 Plaster/Skim Coat

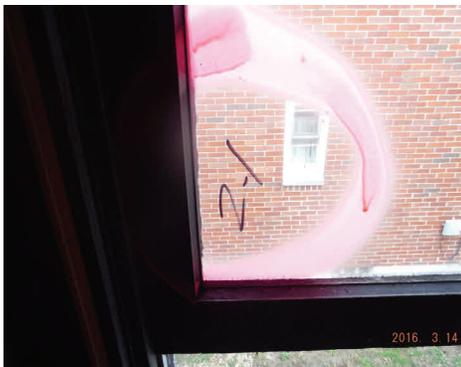
Sample 2-1 Window Glaze

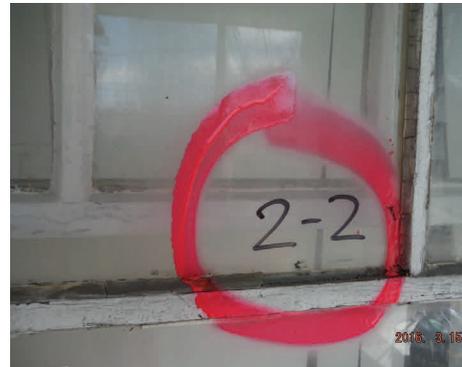
Sample 2-2 Window Glaze

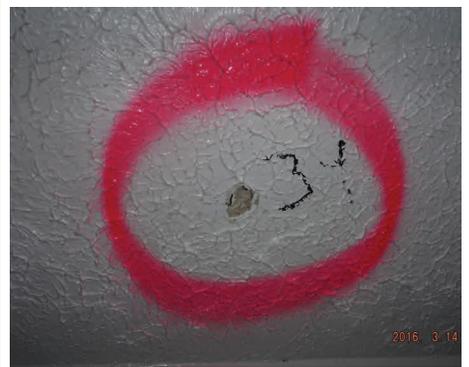
Sample 3-1 Textured Ceiling

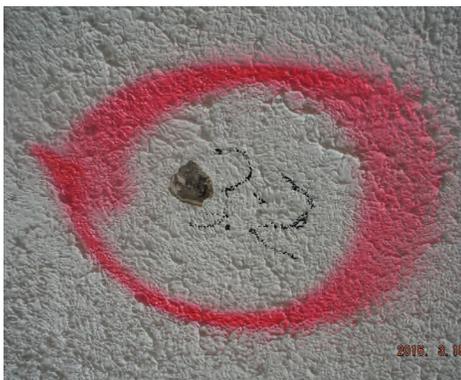
Sample 3-2 Textured Ceiling

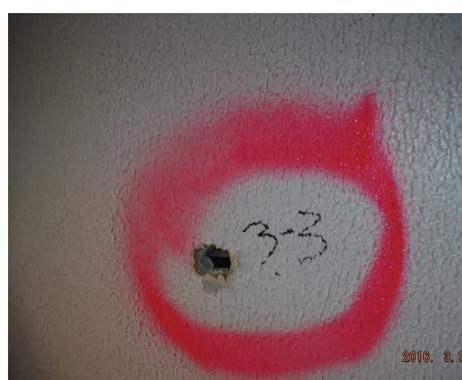
Sample 3-3 Textured Ceiling

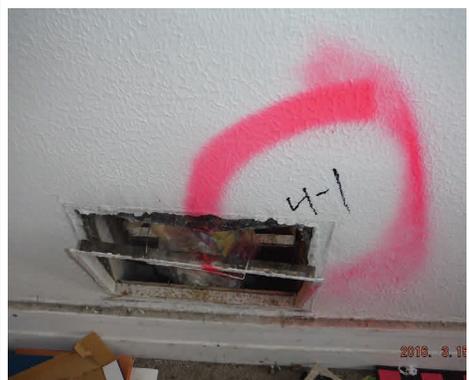
Two (2) samples of duct wrap taken from a heating vent in bedrooms 1 and 2 were determined to contain 65% chrysotile each.

Two (2) samples of duct wrap taken from a heating vent in bedrooms 1 and 2 were determined to contain 65% chrysotile each. This Category II Friable material will need to be abated prior to demolishing the structure.

Sample 4-1 Duct Wrap

1. Prior to any outside contractor(s) working at the subject structure, the contractor(s) must be notified of the presence of the building materials identified as containing asbestos.
2. Trained workers and supervisors certified by the Ohio Department of Health must be used to remove the identified asbestos-containing building materials using special procedures and protective equipment to ensure that workers are not overexposed to airborne asbestos.
3. Advance notification must be provided to the Regional Air Pollution Control Agency (RAPCA) and the Ohio Department of Health at least ten (10) working days prior to the start of abatement activities.

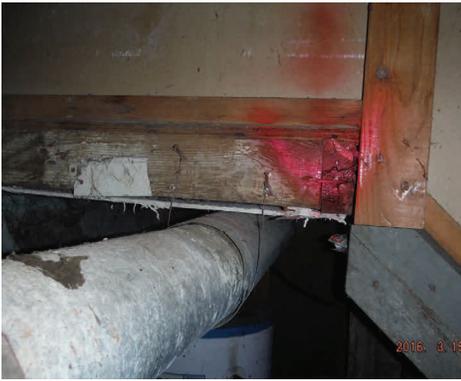
Sample 4-2 Duct Wrap

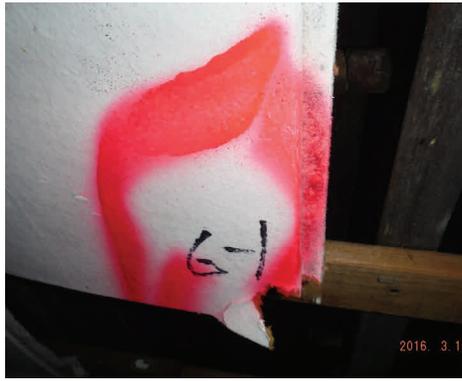
Sample 6-1 12" Ceiling Tile

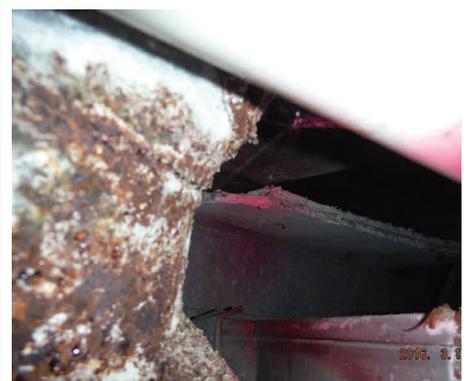
One (1) sample of millboard taken in the basement, above the furnace, was determined to contain 55% chrysotile.

One (1) sample of millboard taken in the basement, above the furnace, was determined to contain 55% chrysotile. This Category II Friable material will need to be abated prior to demolishing the structure.

Sample 7-1 Millboard
