RE: Comprehensive Pre-Demolition Asbestos Survey, NOP TK-7amended, Vacant Residence, 2824 Boulder Ave., Dayton, OH, TKEC Project #TK-7aA

On August 13, 2015, Mr. Joseph Saunders (Ohio Department of Health Certified Asbestos Hazard Evaluation Specialist # ES34837) of Turn-Key Environmental Consultants, Inc. (TKEC) performed a comprehensive pre-demolition asbestos inspection of the vacant residence located at 2824 Boulder Ave. in Dayton, Ohio. Fourteen (14) samples of suspect materials were collected from the residential structure. The samples were shipped overnight to an accredited laboratory for analysis. Some of the samples were comprised of layers which resulted in the analysis of a total of twenty (20) samples. Laboratory analysis indicated that three (3) samples contained 1% or greater asbestos. Two (2) samples of floor tile/mastic 9" were determined to contain greater than 1% asbestos. One sample of sink undercoating was determined to contain greater than 1% asbestos. These materials do not have to be abated as these materials are Category 1 Non-Friable materials.

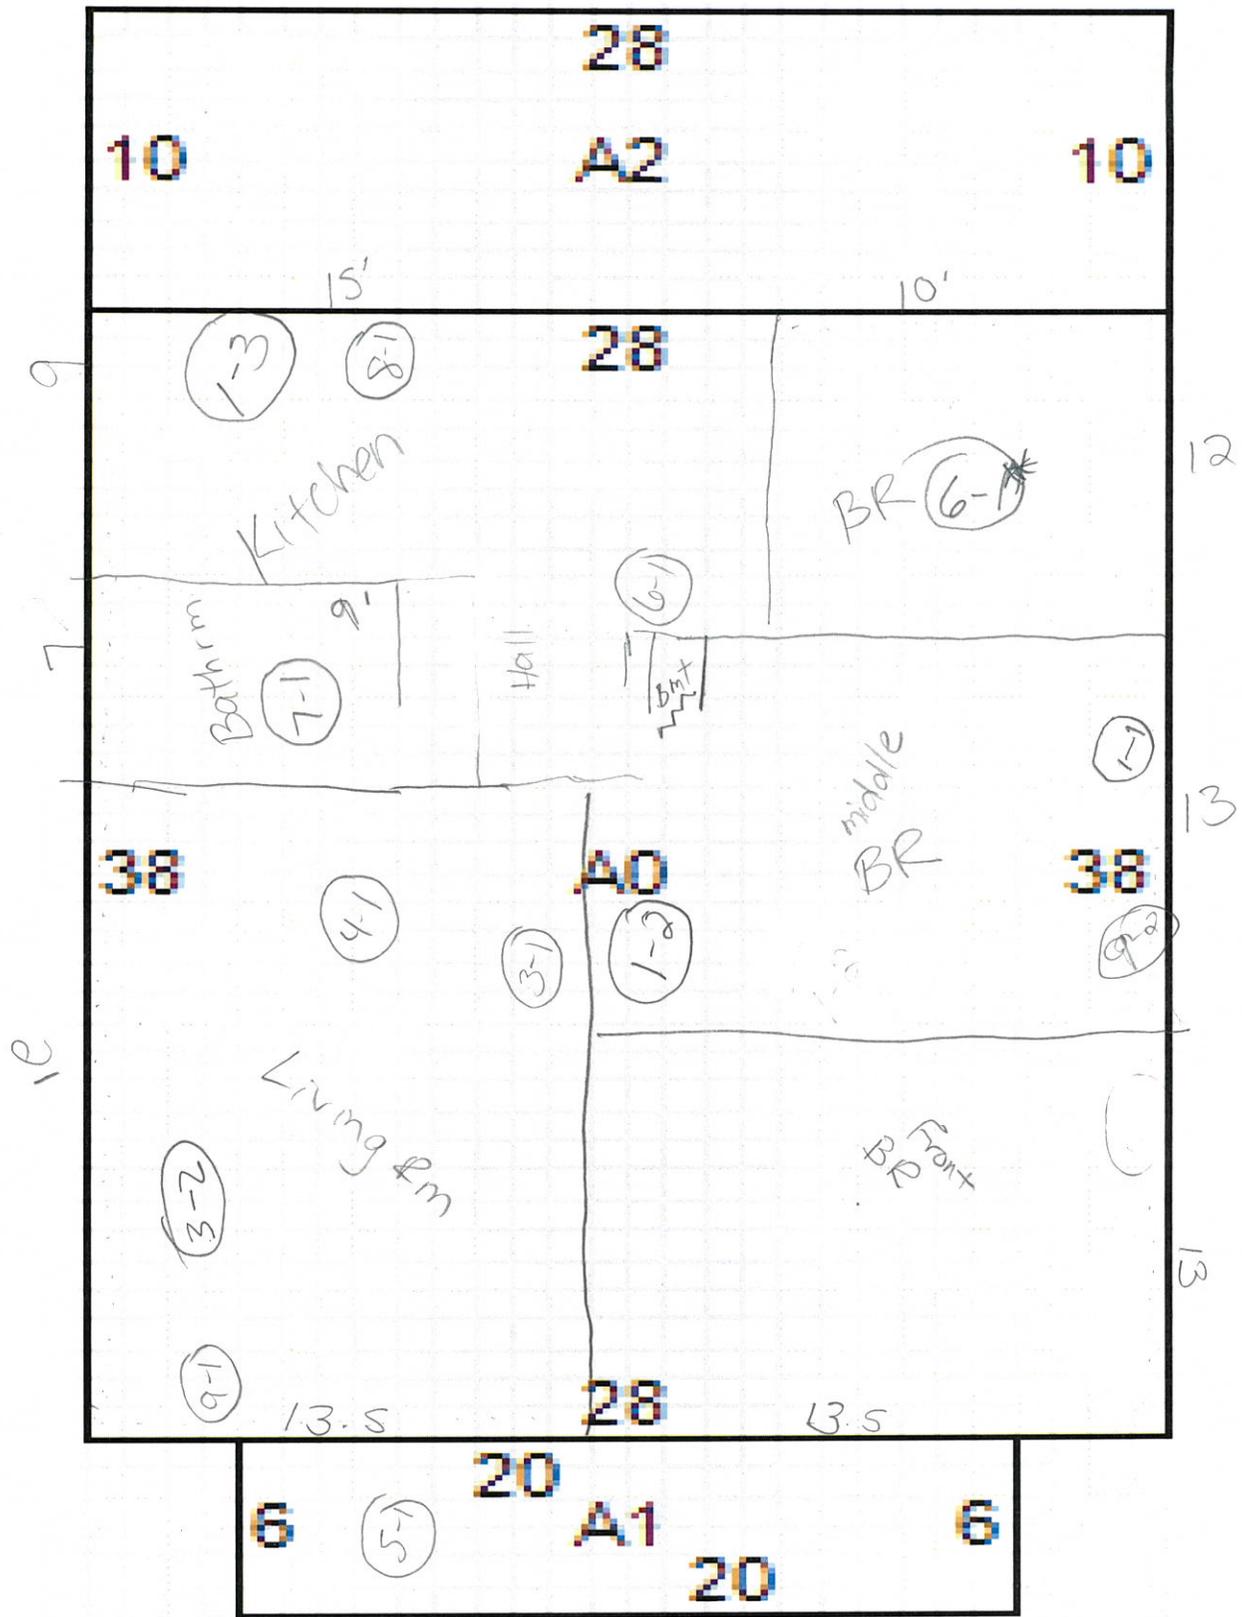
Floor Main
2824 Boulder Ave.
TK-7aA

1-1 Approximate
Sample Location
1-1* Asbestos > 1%

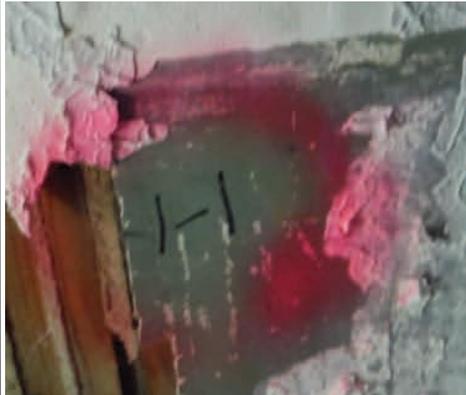
SanAir ID / Description	Stereoscopic Appearance	Components		Asbestos Fibers
		% Fibrous	% Non-Fibrous	
1-1 / 15025202-001 Plaster & Skim Coat Ceiling Middle Bedroom, Plaster	Grey Non-Fibrous Homogeneous	100%	Other	None Detected

1-1 / 15025202-001 Plaster & Skim Coat Ceiling Middle Bedroom, Skim Coat	White Non-Fibrous Homogeneous	100%	Other	None Detected
--	-------------------------------------	------	-------	---------------

Sample 1-1 Plaster/Skim Coat

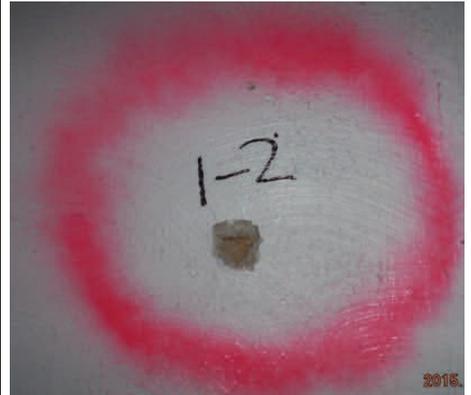
SanAir ID / Description	Stereoscopic Appearance	Components		Asbestos Fibers
		% Fibrous	% Non-Fibrous	
1-2 / 15025202-002 Plaster & Skim Coat Wall Middle Bedroom, Plaster	Grey Non-Fibrous Homogeneous	100%	Other	None Detected

1-2 / 15025202-002 Plaster & Skim Coat Wall Middle Bedroom, Skim Coat	White Non-Fibrous Homogeneous	100%	Other	None Detected
---	-------------------------------------	------	-------	---------------

Sample 1-2 Plaster/Skim Coat

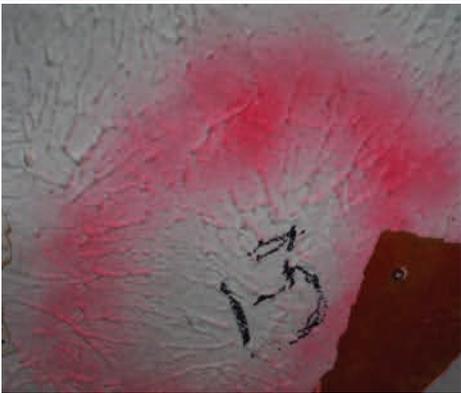
SanAir ID / Description	Stereoscopic Appearance	Components		Asbestos Fibers
		% Fibrous	% Non-Fibrous	
1-3 / 15025202-003 Plaster & Skim Coat Ceiling Kitchen, Plaster	White Non-Fibrous Homogeneous	100%	Other	None Detected

1-3 / 15025202-003 Plaster & Skim Coat Ceiling Kitchen, Skim Coat	Tan Non-Fibrous Homogeneous	100%	Other	None Detected
---	-----------------------------------	------	-------	---------------

Sample 1-3, Plaster/Skim Coat

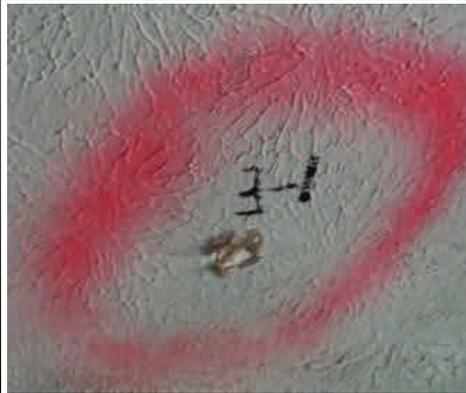
SanAir ID / Description	Stereoscopic Appearance	Components		Asbestos Fibers
		% Fibrous	% Non-Fibrous	
3-1 / 15025202-005 Drywall & Joint Compound Ceiling Living Room, Drywall	White Non-Fibrous Homogeneous	2% Cellulose	98% Other	None Detected

3-1 / 15025202-005 Drywall & Joint Compound Ceiling Living Room, Joint Compound	White Non-Fibrous Homogeneous	100%	Other	None Detected
---	-------------------------------------	------	-------	---------------

Sample 3-1, Drywall/Joint Compound

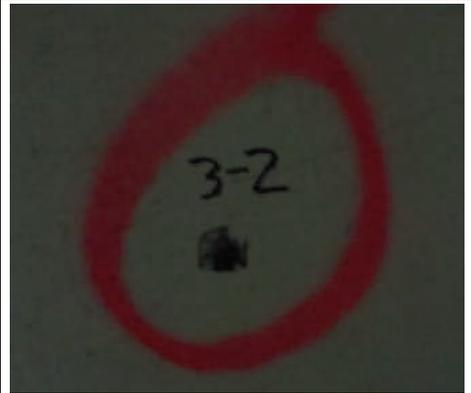
SanAir ID / Description	Stereoscopic Appearance	Components		Asbestos Fibers
		% Fibrous	% Non-Fibrous	
3-2 / 15025202-006 Drywall & Joint Compound, Drywall	White Non-Fibrous Homogeneous	2% Cellulose	98% Other	None Detected
3-2 / 15025202-006 Drywall & Joint Compound, Joint Compound	White Non-Fibrous Homogeneous		100% Other	None Detected

Sample 3-2, Drywall/Joint Compound

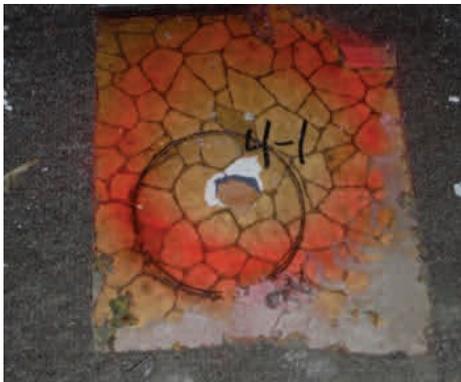
SanAir ID / Description	Stereoscopic Appearance	Components		Asbestos Fibers
		% Fibrous	% Non-Fibrous	
4-1 / 15025202-007 Linoleum Flooring Living Room (21'x12')	Yellow Non-Fibrous Homogeneous	20% Cellulose	80% Other	None Detected

Sample 4-1, Linoleum

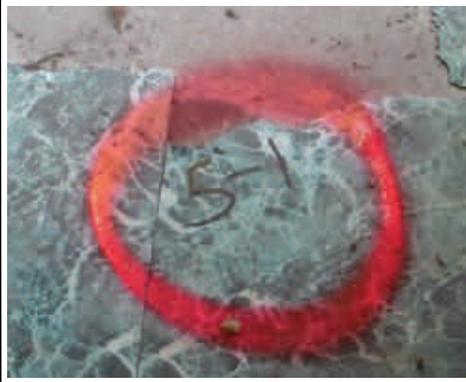
SanAir ID / Description	Stereoscopic Appearance	Components		Asbestos Fibers
		% Fibrous	% Non-Fibrous	
5-1 / 15025202-008 12" Floor Tile Front Entryway & Kitchen 6x20 & 9x15	Green Non-Fibrous Homogeneous		100% Other	None Detected

Sample 5-1, 12" Floor Tile/Mastic

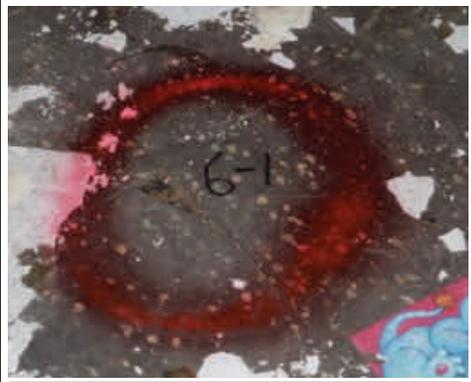
Laboratory analysis indicated that three (3) samples contained 1% or greater asbestos. Two (2) samples of floor tile/mastic 9” were determined to contain greater than 1% asbestos. One sample of sink undercoating was determined to contain greater than 1% asbestos. These materials do not have to be abated as these materials are Category 1 Non-Friable materials.

- **Floor Tile/Mastic 9”, [Rear Bedrooms], [Fair], [120 SF]**
- **Sink Undercoating, [Kitchen], [Good], [3 SF]**

SanAir ID / Description	Stereoscopic Appearance	Components		Asbestos Fibers
		% Fibrous	% Non-Fibrous	
6-1 / 15025202-009 9" Floor Tile Back BR (12x10), Floor Tile	Brown Non-Fibrous Homogeneous		95% Other	5% Chrysotile
6-1 / 15025202-009 9" Floor Tile Back BR (12x10), Mastic	Black Non-Fibrous Homogeneous		98% Other	2% Chrysotile

Sample 6-1, 9" Floor Tile/Mastic

<u>Material</u>	<u>Estimated Quantity</u>	<u>Estimated Unit Costs</u>	<u>Estimated Costs</u>
Floor Tile/Mastic 9”	120 SF	\$2.00/SF	\$240.00
Sink Undercoating	3 SF	\$50.00 LS	\$50.00

1. Prior to any outside contractor(s) working at the subject structure, the contractor(s) must be notified of the presence of the building materials identified as containing asbestos.
2. Trained workers and supervisors certified by the Ohio Department of Health must be used to remove the identified asbestos-containing building materials using special procedures and protective equipment to ensure that workers are not overexposed to airborne asbestos.
3. Advance notification must be provided to the Regional Air Pollution Control Agency (RAPCA) and the Ohio Department of Health at least ten (10) working days prior to the start of abatement activities.
4. The fact that asbestos containing materials were observed in or on the building should be noted on the demolition notification form along with the name and certification number

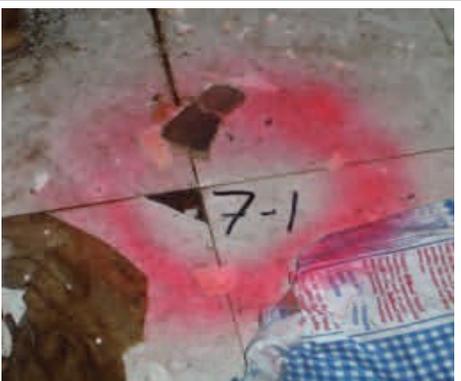
SanAir ID / Description	Stereoscopic Appearance	Components		Asbestos Fibers
		% Fibrous	% Non-Fibrous	
7-1 / 15025202-010 12" Floor Tile Bathroom (7x9)	Cream Non-Fibrous Homogeneous		100% Other	None Detected

Sample 7-1, 12" Floor Tile/Mastic

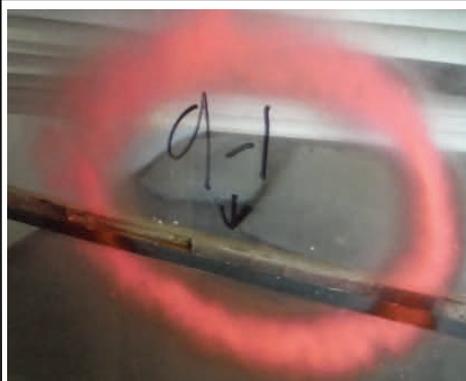
SanAir ID / Description	Stereoscopic Appearance	Components		Asbestos Fibers
		% Fibrous	% Non-Fibrous	
9-1 / 15025202-012 Window Glaze Living Room Windows	Various Non-Fibrous Homogeneous		100% Other	None Detected

Sample 9-1 Window Glazing

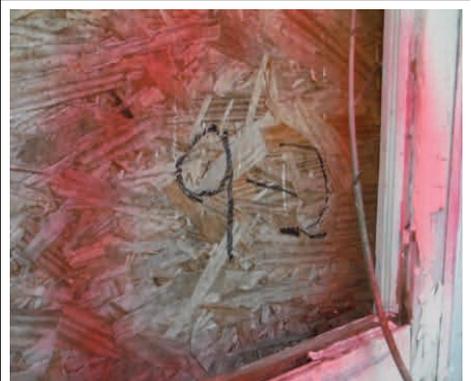
SanAir ID / Description	Stereoscopic Appearance	Components		Asbestos Fibers
		% Fibrous	% Non-Fibrous	
9-2 / 15025202-013 Window Glaze Bedroom Window	White Non-Fibrous Homogeneous		100% Other	None Detected

Sample 9-2 Window Glazing
