RE: Comprehensive Pre-Demolition Asbestos Survey, NOP TK-7amended, Vacant Residence, 2216 Harding Ave., Dayton, OH, TKEC Project #TK-7aB

EXECUTIVE SUMMARY

Floor 1
2216 Harding Ave.
TK-7aB

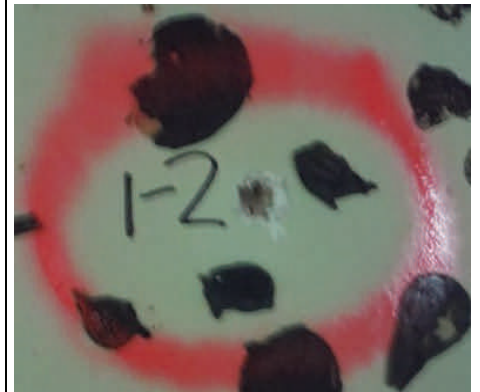
Sample 1-2 Drywall/Joint Compound

SanAir ID / Description	Stereoscopic Appearance	% Fibrous	Components		Asbestos Fibers
			% Non-Fibrous		
1-2 / 15026328-002 Drywall Living Room - 1st Floor - Wall, Joint Compound	Beige Non-Fibrous Heterogeneous		100%	Other	< 0.25% Chrysotile

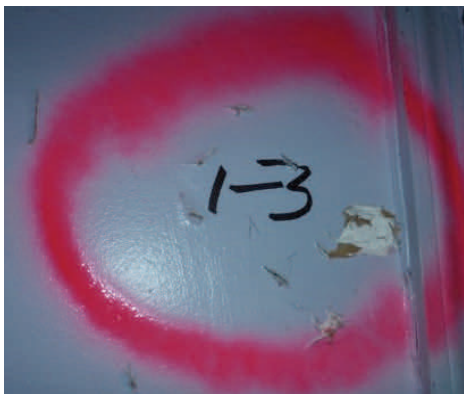
Sample 1-3 Drywall/Joint Compound

SanAir ID / Description	Stereoscopic Appearance	Components		Asbestos Fibers
		% Fibrous	% Non-Fibrous	
1-3 / 15025205-003 Drywall/ Joint Compound Upstairs Bedroom, Drywall	White Non-Fibrous Heterogeneous	10% Cellulose	90% Other	None Detected
1-3 / 15025205-003 Drywall/ Joint Compound Upstairs Bedroom, Joint Compound	White Non-Fibrous Heterogeneous		100% Other	None Detected

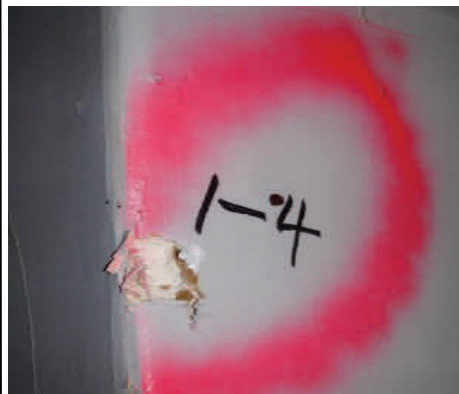
Sample 1-4 Drywall/Joint Compound

SanAir ID / Description	Stereoscopic Appearance	% Fibrous	Components		Asbestos Fibers
			% Non-Fibrous		
1-4 / 15026328-003 Drywall Upstairs Bedroom, Joint Compound	White Non-Fibrous Heterogeneous		100%	Other	< 0.25% Chrysotile

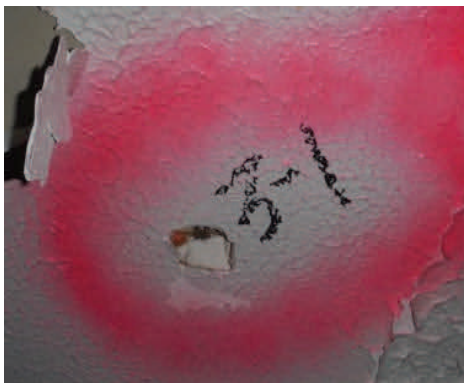
Sample 3-1 Drywall w/ Skim Coat

SanAir ID / Description	Stereoscopic Appearance	Components		Asbestos Fibers
		% Fibrous	% Non-Fibrous	
3-1 / 15025205-006 Drywall W/ Skim Coat Kitchen Ceiling, Drywall	White Non-Fibrous Heterogeneous	10% Cellulose	90% Other	None Detected
3-1 / 15025205-006 Drywall W/ Skim Coat Kitchen Ceiling, Skim Coat	White Non-Fibrous Heterogeneous		100% Other	None Detected

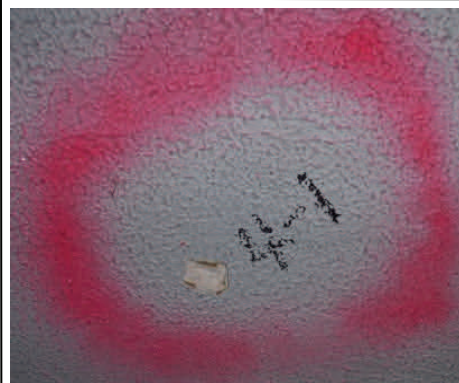
Sample 4-1 Drywall w/ Skim Coat

SanAir ID / Description	Stereoscopic Appearance	Components		Asbestos Fibers
		% Fibrous	% Non-Fibrous	
4-1 / 15025205-007 Drywall W/ Skim Coat Rear Entry Ceiling, Drywall	White Non-Fibrous Heterogeneous		100% Other	None Detected
4-1 / 15025205-007 Drywall W/ Skim Coat Rear Entry Ceiling, Skim Coat	White Non-Fibrous Heterogeneous		100% Other	None Detected

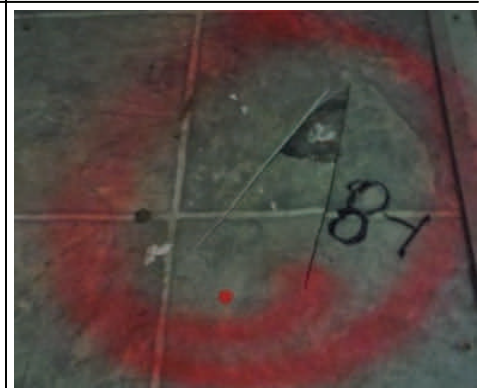
Sample 8-1 Linoleum Flooring

SanAir ID / Description	Stereoscopic Appearance	Components		Asbestos Fibers
		% Fibrous	% Non-Fibrous	
8-1 / 15025205-011 Linoleum Flooring Entryway (3x5), Linoleum	Grey Non-Fibrous Heterogeneous	30% Cellulose	70% Other	None Detected
8-1 / 15025205-011 Linoleum Flooring Entryway (3x5), Mastic	Yellow Non-Fibrous Heterogeneous		100% Other	None Detected

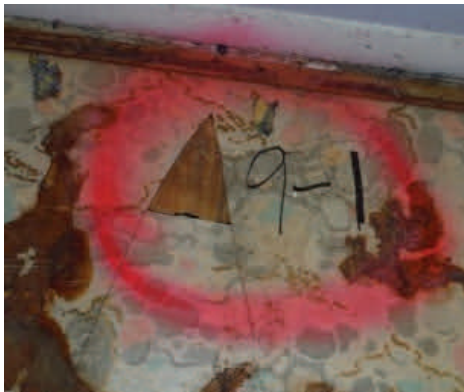
Sample 9-1 Linoleum Flooring

SanAir ID / Description	Stereoscopic Appearance	Components		Asbestos Fibers
		% Fibrous	% Non-Fibrous	
9-1 / 15025205-012 Linoleum Flooring 1st Floor Bedroom (11x11)	Cream Fibrous Heterogeneous	65% Cellulose	35% Other	None Detected

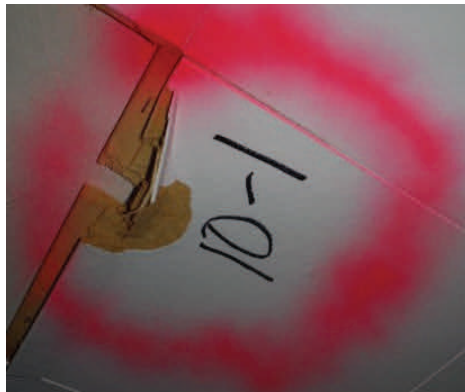
Sample 10-1, 12" Ceiling Tile

SanAir ID / Description	Stereoscopic Appearance	Components		Asbestos Fibers
		% Fibrous	% Non-Fibrous	
10-1 / 15025205-013 Ceiling Tile (12") Living Room (13x16)	White Fibrous Heterogeneous	90% Cellulose	10% Other	None Detected

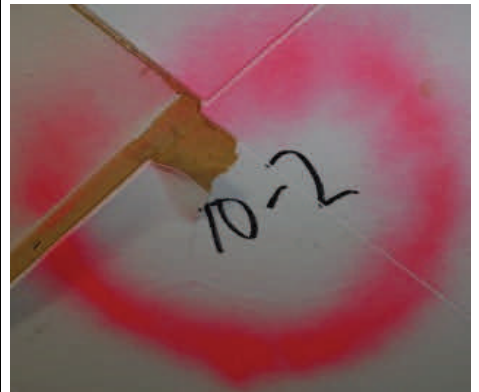
Sample 10-2 12" Ceiling Tile

SanAir ID / Description	Stereoscopic Appearance	Components		Asbestos Fibers
		% Fibrous	% Non-Fibrous	
10-2 / 15025205-014 Ceiling Tile (12") 1st Floor Bedroom (11x11)	White Fibrous Heterogeneous	90% Cellulose	10% Other	None Detected

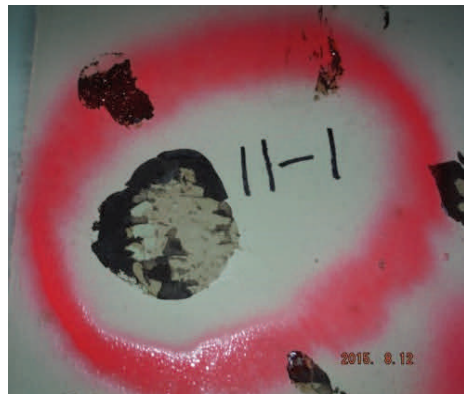
Sample 11-1 Adhesive

SanAir ID / Description	Stereoscopic Appearance	Components		Asbestos Fibers
		% Fibrous	% Non-Fibrous	
11-1 / 15025205-015 Adhesive Living Room Wall On Paneling	Brown Non-Fibrous Heterogeneous		100% Other	None Detected

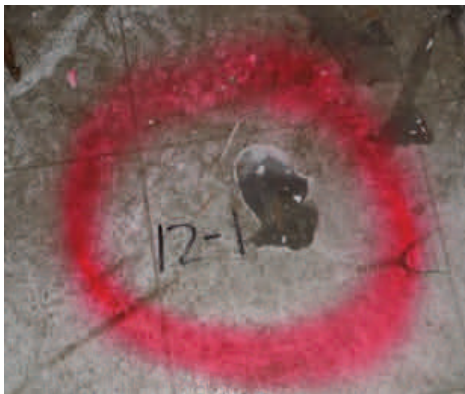
Sample 12-1 Linoleum Flooring

SanAir ID / Description	Stereoscopic Appearance	Components		Asbestos Fibers
		% Fibrous	% Non-Fibrous	
12-1 / 15025205-016 Linoleum Flooring Kitchen	Cream Non-Fibrous Heterogeneous	40% Cellulose	60% Other	None Detected

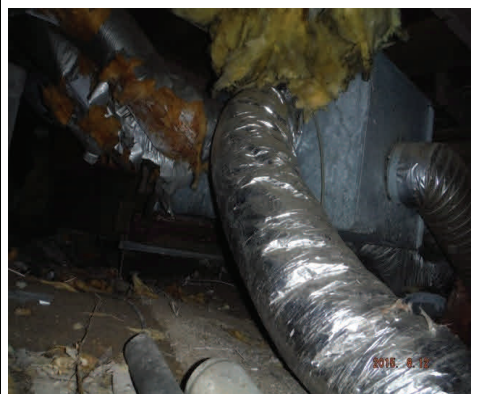
Duct work in Basement

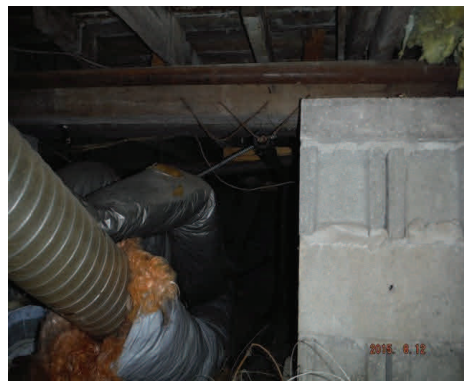
Duct work in Basement
