Turn-Key Environmental Consultants, Inc.

March 24, 2016

RE: Comprehensive Pre-Demolition Asbestos Survey, NOP TK-27, Vacant Residence, 2912 N. Main St., Dayton, OH, TKEC Project #TK-27A

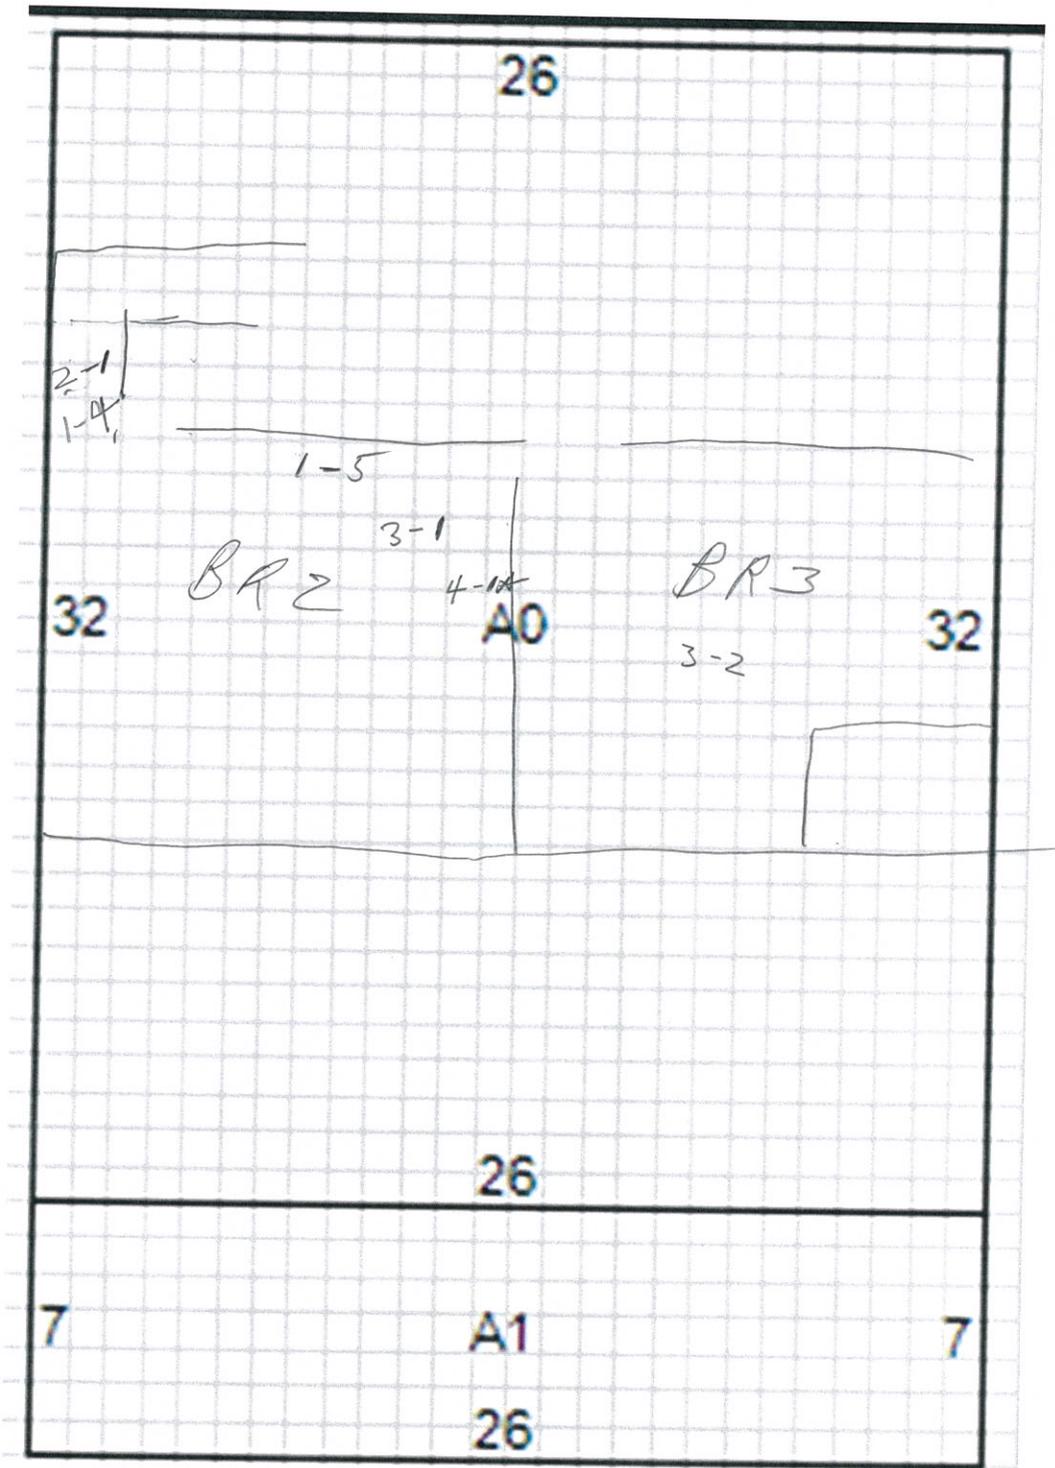
2nd Floor
FLOOR PLAN
TK-27A
2912 N Main

Two (2) samples of duct wrap taken from a heating vent in bedrooms 1 and 2 were determined to contain 65% chrysotile each.

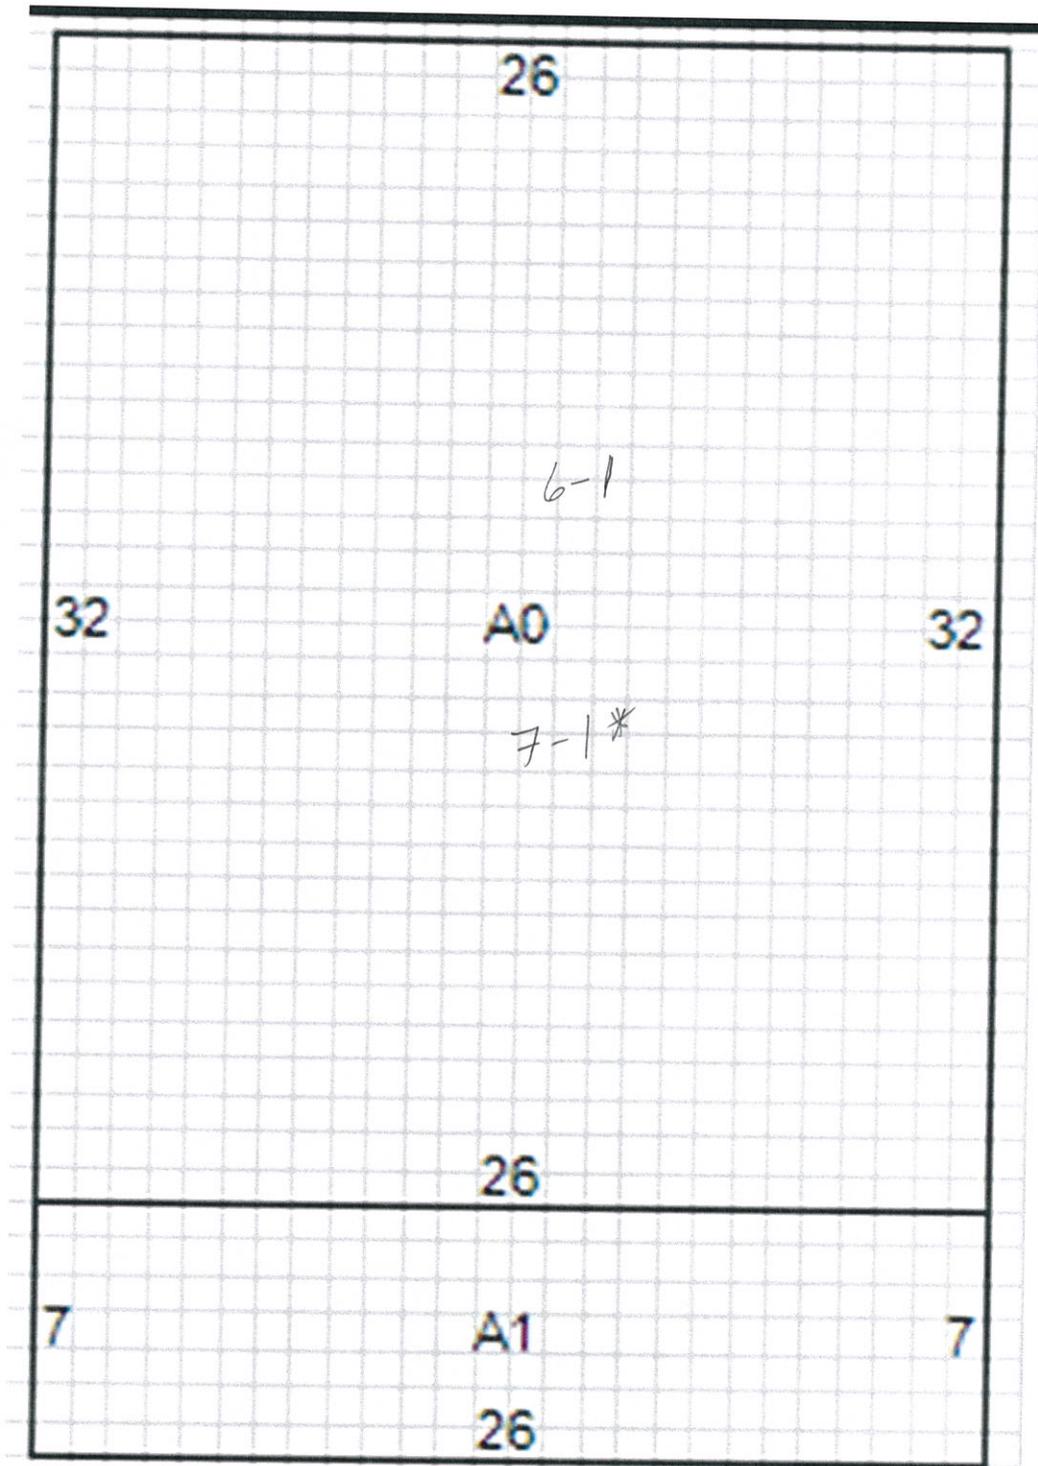
Basement
FLOOR PLAN
TK-27A
2912 N Main

One (1) sample of millboard taken in the basement, above the furnace, was determined to contain 55% chrysotile.
