August 28, 2015

RE: Comprehensive Pre-Demolition Asbestos Survey, NOP TK-7amended, Vacant Residence, 3848 Merrimac Ave., Dayton, OH, TKEC Project #TK-7aH

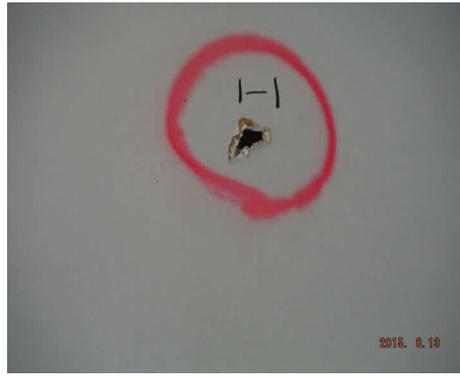
Sample 1-1 Drywall/Plaster/Skim Coat

SanAir ID / Description	Stereoscopic Appearance	Components		Asbestos Fibers
		% Fibrous	% Non-Fibrous	
1-1 / 15025195-001 Drywall/ Plaster/ Skim Coat Living Room, Drywall	Off-White Non-Fibrous Homogeneous	5% Cellulose	95% Other	None Detected
1-1 / 15025195-001 Drywall/ Plaster/ Skim Coat Living Room, Plaster	Grey Non-Fibrous Homogeneous		100% Other	None Detected
1-1 / 15025195-001 Drywall/ Plaster/ Skim Coat Living Room, Skim Coat	White Non-Fibrous Homogeneous		100% Other	None Detected

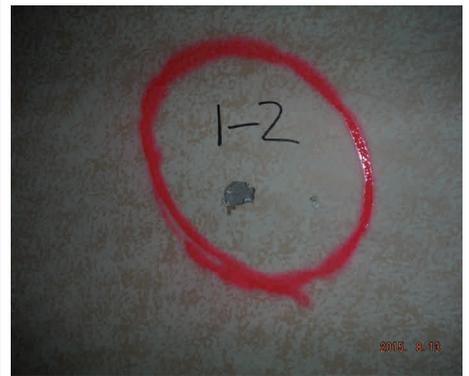
Sample 1-2 Drywall/Plaster/Skim Coat

SanAir ID / Description	Stereoscopic Appearance	Components		Asbestos Fibers
		% Fibrous	% Non-Fibrous	
1-2 / 15025195-002 Drywall/ Plaster/ Skim Coat Bed 1, Drywall				Not Submitted
1-2 / 15025195-002 Drywall/ Plaster/ Skim Coat Bed 1, Plaster	Grey Non-Fibrous Homogeneous		100% Other	None Detected
1-2 / 15025195-002 Drywall/ Plaster/ Skim Coat Bed 1, Skim Coat	White Non-Fibrous Homogeneous		100% Other	None Detected

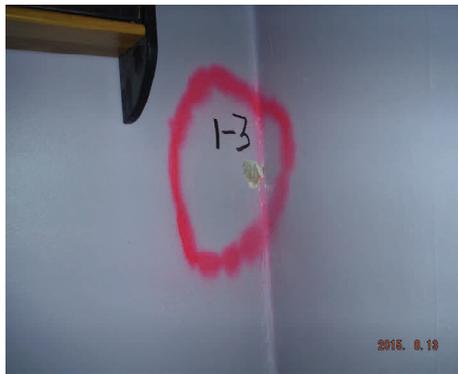
Sample 1-3 Drywall/Plaster/Skim Coat

SanAir ID / Description	Stereoscopic Appearance	Components		Asbestos Fibers
		% Fibrous	% Non-Fibrous	
1-3 / 15025195-003 Drywall/ Plaster/ Skim Coat Bed 2, Drywall				Not Submitted
1-3 / 15025195-003 Drywall/ Plaster/ Skim Coat Bed 2, Plaster	Grey Non-Fibrous Homogeneous		100% Other	None Detected
1-3 / 15025195-003 Drywall/ Plaster/ Skim Coat Bed 2, Skim Coat	White Non-Fibrous Homogeneous		100% Other	None Detected
1-3 / 15025195-003 Drywall/ Plaster/ Skim Coat Bed 2, Texture	Various Non-Fibrous Heterogeneous		100% Other	None Detected

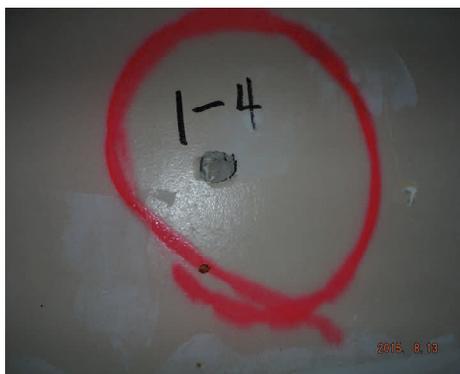
Sample 1-4 Drywall/Plaster/Skim Coat

SanAir ID / Description	Stereoscopic Appearance	Components		Asbestos Fibers
		% Fibrous	% Non-Fibrous	
1-4 / 15025195-004 Drywall/ Plaster/ Skim Coat Kitchen, Drywall	Off-White Non-Fibrous Homogeneous	5% Cellulose	95% Other	None Detected
1-4 / 15025195-004 Drywall/ Plaster/ Skim Coat Kitchen, Plaster	Grey Non-Fibrous Homogeneous		100% Other	None Detected
1-4 / 15025195-004 Drywall/ Plaster/ Skim Coat Kitchen, Skim Coat	White Non-Fibrous Homogeneous		100% Other	None Detected

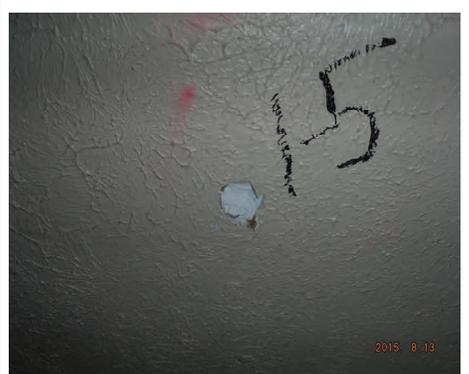
Sample 1-5 Drywall/Texture

SanAir ID / Description	Stereoscopic Appearance	Components		Asbestos Fibers
		% Fibrous	% Non-Fibrous	
1-5 / 15025195-005 Drywall/ Texture Living Room Ceiling, Drywall	Off-White Non-Fibrous Homogeneous	5% Cellulose	95% Other	None Detected
1-5 / 15025195-005 Drywall/ Texture Living Room Ceiling, Plaster				Not Submitted
1-5 / 15025195-005 Drywall/ Texture Living Room Ceiling, Skim Coat				Not Submitted
1-5 / 15025195-005 Drywall/ Texture Living Room Ceiling, Texture	Off-White Non-Fibrous Homogeneous		100% Other	None Detected

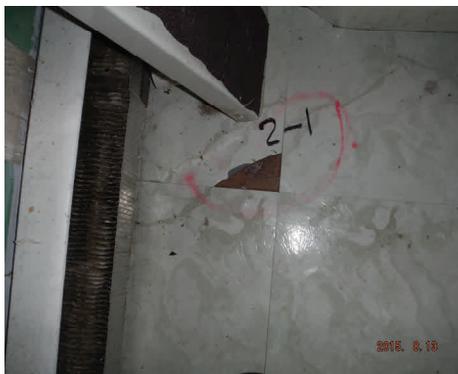
Sample 2-1 12" Floor Tile

SanAir ID / Description	Stereoscopic Appearance	Components		Asbestos Fibers
		% Fibrous	% Non-Fibrous	
2-1 / 15025195-006 12" Floor Tile Bath	White Non-Fibrous Homogeneous		100% Other	None Detected

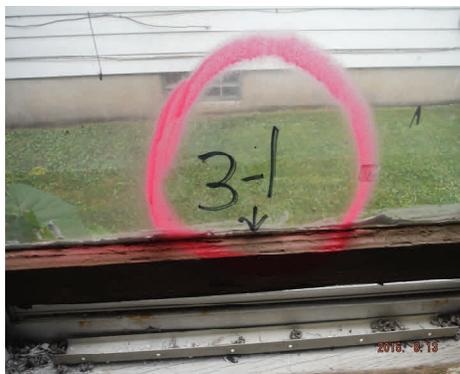
Sample 3-1 Window Glazing

One (1) sample of window glazing contained 2% asbestos. This sample was subsequently analyzed by EPA PLM 400 Point Count. This sample was determined to contain 0.5% chrysotile asbestos and will not need to be abated.

SanAir ID / Description	Stereoscopic Appearance	Components		Asbestos Fibers
		% Fibrous	% Non-Fibrous	
3-1 / 15025195-007 Window Glazing Kitchen Window	Various Non-Fibrous Heterogeneous		98% Other	2% Chrysotile

SanAir ID / Description	Stereoscopic Appearance	Components		Asbestos Fibers
		% Fibrous	% Non-Fibrous	
3-1 / 15026334-001 Window Glazing Kitchen Window	Various Non-Fibrous Heterogeneous		99.5% Other	0.5% Chrysotile

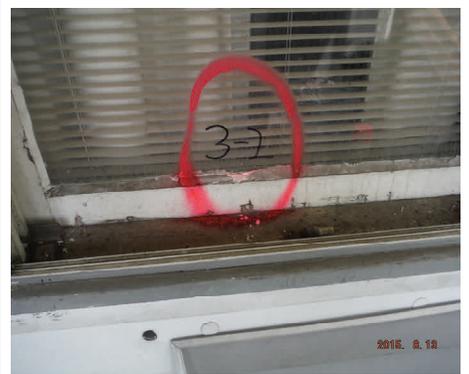
Sample 3-2 Window Glazing

SanAir ID / Description	Stereoscopic Appearance	Components		Asbestos Fibers
		% Fibrous	% Non-Fibrous	
3-2 / 15025195-008 Window Glazing Porch Window	White Non-Fibrous Homogeneous		100% Other	None Detected

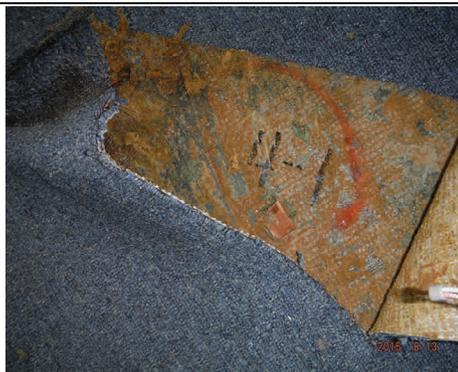
Sample 4-1 Flooring

SanAir ID / Description	Stereoscopic Appearance	Components		Asbestos Fibers
		% Fibrous	% Non-Fibrous	
4-1 / 15025195-009 Flooring Entire Kitchen (12x18), Flooring	Green Non-Fibrous Homogeneous		100% Other	None Detected
4-1 / 15025195-009 Flooring Entire Kitchen (12x18), Mastic	Yellow Non-Fibrous Homogeneous		100% Other	None Detected

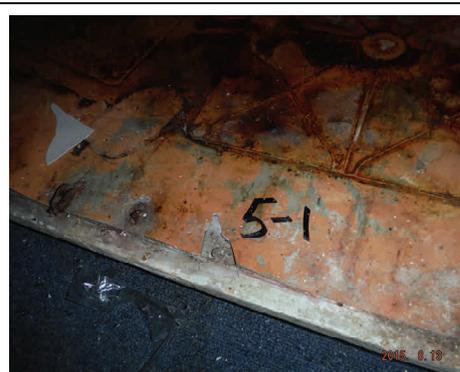
Sample 5-1 Linoleum Flooring

SanAir ID / Description	Stereoscopic Appearance	Components		Asbestos Fibers
		% Fibrous	% Non-Fibrous	
5-1 / 15025195-010 Linoleum Under Sink In Kitchen	Orange Non-Fibrous Heterogeneous		100% Other	None Detected

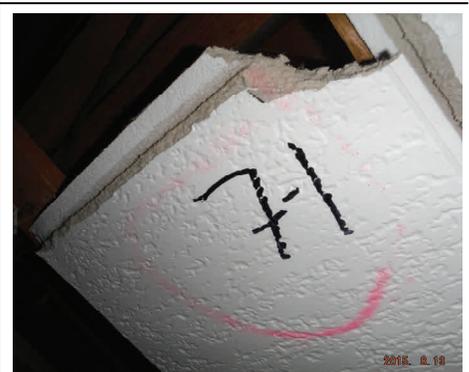
Sample 7-1 Ceiling Tile

SanAir ID / Description	Stereoscopic Appearance	Components		Asbestos Fibers
		% Fibrous	% Non-Fibrous	
7-1 / 15025195-012 Ceiling Tile Basement	White Fibrous Homogeneous	80% Cellulose	20% Other	None Detected
