RE: Comprehensive Pre-Demolition Asbestos Survey, NOP TK-7a, Vacant Residence, 4198 Salem Ave., Dayton, OH, TKEC Project #TK-7aK

EXECUTIVE SUMMARY

Site Sketch/Photographs

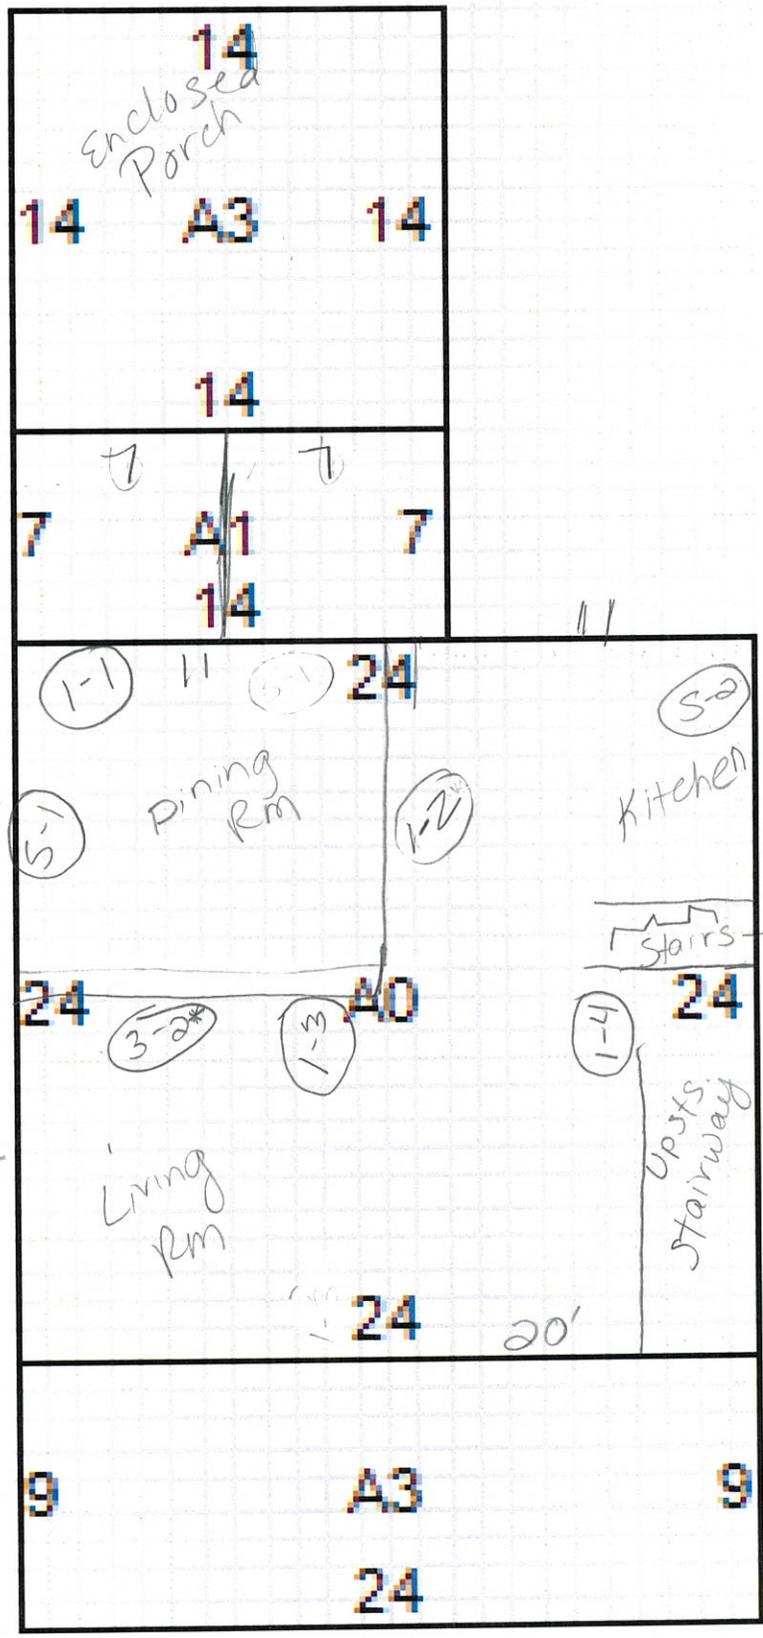
Floor 1
4198 Salem Ave.
TK-7aK

4 vents downstairs

1-1 Approximate Sample Location
1-1* Asbestos > 1%

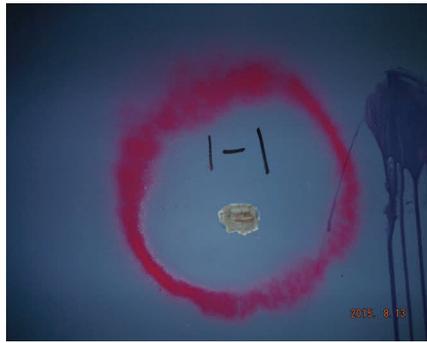
Sample 1-1 Plaster/Skim Coat

SanAir ID / Description	Stereoscopic Appearance	% Fibrous	Components		Asbestos Fibers
			% Non-Fibrous		
1-1 / 15026340-001 Plaster/ Skim Coat Dining Room Wall, Plaster	Brown Non-Fibrous Heterogeneous		100%	Other	< 0.25% Chrysotile

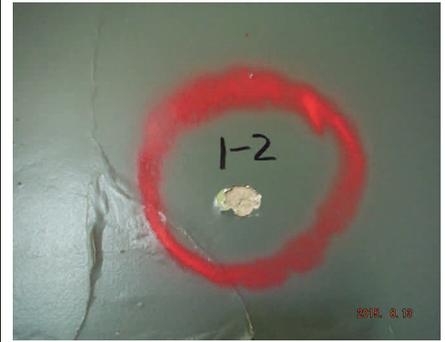
Sample 1-2 Plaster/Skim Coat

SanAir ID / Description	Stereoscopic Appearance	% Fibrous	Components		Asbestos Fibers
			% Non-Fibrous		
1-2 / 15026340-002 Plaster/ Skim Coat Kitchen Wall, Plaster	Brown Non-Fibrous Heterogeneous		100%	Other	< 0.25% Chrysotile

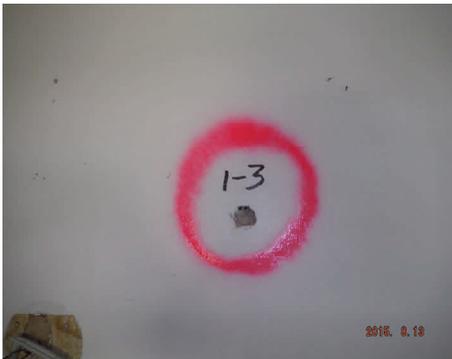
Sample 1-3 Plaster/Skim Coat

SanAir ID / Description	Stereoscopic Appearance	% Fibrous	Components		Asbestos Fibers
			% Non-Fibrous		
1-3 / 15026340-003 Plaster/ Skim Coat Living Room Wall, Plaster	Brown Non-Fibrous Heterogeneous		100%	Other	< 0.25% Chrysotile

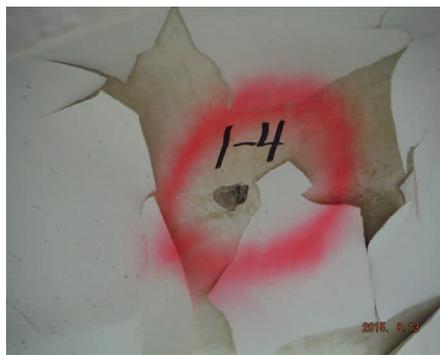
Sample 1-4 Plaster/Skim Coat

SanAir ID / Description	Stereoscopic Appearance	% Fibrous	Components		Asbestos Fibers
			% Non-Fibrous		
1-4 / 15026340-004 Plaster/ Skim Coat Living Room Ceiling, Plaster	Brown Non-Fibrous Heterogeneous		100%	Other	< 0.25% Chrysotile

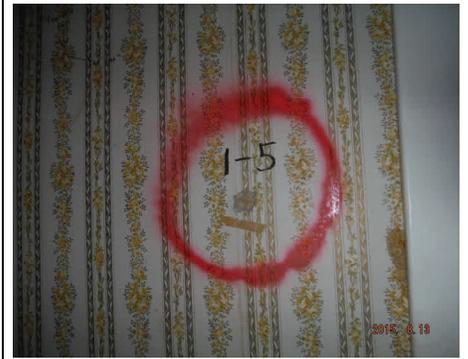
Sample 1-5 Plaster/Skim Coat

SanAir ID / Description	Stereoscopic Appearance	% Fibrous	Components		Asbestos Fibers
			% Non-Fibrous		
1-5 / 15026340-005 Plaster/ Skim Coat Upstairs Bedroom 1, Plaster	Brown Non-Fibrous Heterogeneous		100%	Other	< 0.25% Chrysotile

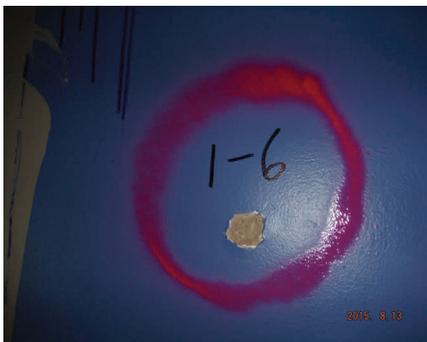
Sample 1-6 Plaster/Skim Coat

SanAir ID / Description	Stereoscopic Appearance	% Fibrous	Components		Asbestos Fibers
			% Non-Fibrous		
1-6 / 15026340-006 Plaster/ Skim Coat Upstairs Bedroom 2, Plaster	Brown Non-Fibrous Heterogeneous		100%	Other	< 0.25% Chrysotile

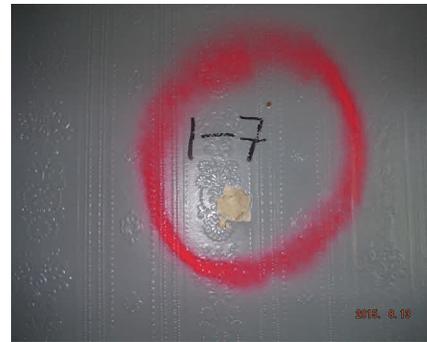
Sample 1-7 Plaster/Skim Coat

SanAir ID / Description	Stereoscopic Appearance	% Fibrous	Components		Asbestos Fibers
			% Non-Fibrous		
1-7 / 15026340-007 Plaster/ Skim Coat Upstairs Bedroom 3, Plaster	Brown Non-Fibrous Heterogeneous		100%	Other	< 0.25% Chrysotile

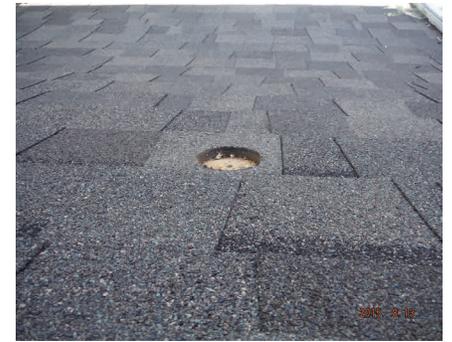
Sample 2-1 Roofing Shingles

SanAir ID / Description	Stereoscopic Appearance	Components		Asbestos Fibers
		% Fibrous	% Non-Fibrous	
2-1 / 15025197-008 Roofing Shingles - 3 Layers Roof, Roof Shingle	Black Non-Fibrous Heterogeneous	100%	Other	None Detected
2-1 / 15025197-008 Roofing Shingles - 3 Layers Roof, Felt Paper	Black Fibrous Heterogeneous	75%	Cellulose 25% Other	None Detected

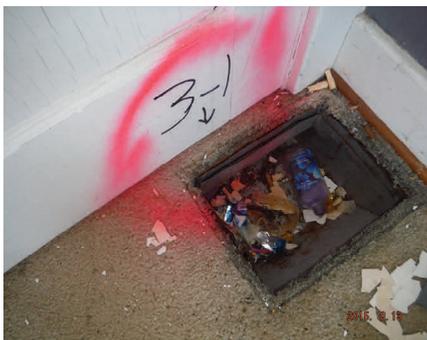
Sample 3-1 Duct Wrap

Two (2) samples of duct wrap were determined to contain greater than 1% asbestos. Approximately 176 SF of this Category 2 Non Friable material will need to be abated prior to demolishing the structure.

- **Duct Wrap, [Throughout House], [Fair], [176 SF]**

SanAir ID / Description	Stereoscopic Appearance	Components		Asbestos Fibers
		% Fibrous	% Non-Fibrous	
3-1 / 15025197-009 Duct Wrap Upstairs Bedroom Vent	Grey Fibrous Heterogeneous	25%	Other	75% Chrysotile

<u>Material</u>	<u>Estimated Quantity</u>	<u>Estimated Unit Costs</u>	<u>Estimated Costs</u>
Duct Wrap	176 SF	\$3.50/SF	\$616.00

1. Prior to any outside contractor(s) working at the subject structure, the contractor(s) must be notified of the presence of the building materials identified as containing asbestos.
2. Trained workers and supervisors certified by the Ohio Department of Health must be used to remove the identified asbestos-containing building materials using special procedures and protective equipment to ensure that workers are not overexposed to airborne asbestos.

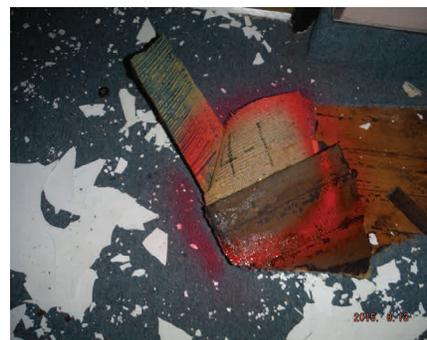
Sample 4-1 9" Floor Tile/Underlay

SanAir ID / Description	Stereoscopic Appearance	Components		Asbestos Fibers
		% Fibrous	% Non-Fibrous	
4-1 / 15025197-011 9" Floor Tile & Underlay Bathroom Upstairs (9x7), Floor Tile	Green Fibrous Heterogeneous	75% Cellulose	25% Other	None Detected
4-1 / 15025197-011 9" Floor Tile & Underlay Bathroom Upstairs (9x7), Underlayment	Black Fibrous Heterogeneous	90% Cellulose	10% Other	None Detected

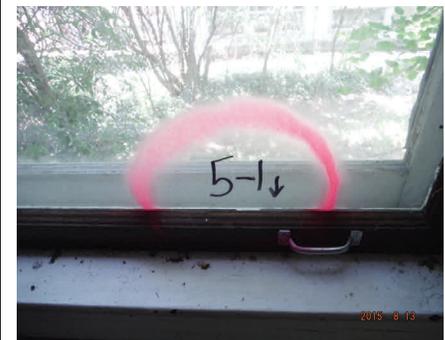
Sample 5-1 Window Glazing

SanAir ID / Description	Stereoscopic Appearance	% Fibrous	Components		Asbestos Fibers
			% Non-Fibrous		
5-1 / 15026340-008 Window Glazing Dining Room	White Non-Fibrous Heterogeneous		100%	Other	< 0.25% Chrysotile

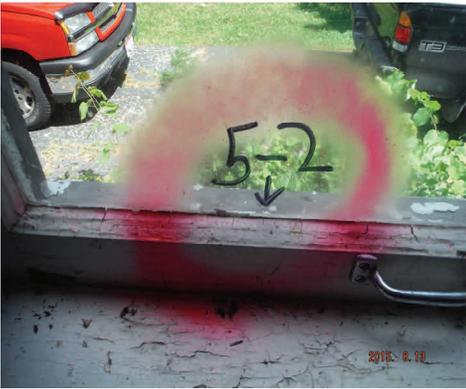
Sample 5-2 Window Glazing

SanAir ID / Description	Stereoscopic Appearance	% Fibrous	Components		Asbestos Fibers
			% Non-Fibrous		
5-2 / 15026340-009 Window Glazing Kitchen	White Non-Fibrous Heterogeneous		100%	Other	< 0.25% Chrysotile
