RE: Comprehensive Pre-Demolition Asbestos Survey, NOP TK-7amended, Vacant Residence, 2222 Harding Ave., Dayton, OH, TKEC Project #TK-7aC rev.

On August 13, 2015, Mr. Joseph Saunders (Ohio Department of Health Certified Asbestos Hazard Evaluation Specialist #ES34837) of Turn-Key Environmental Consultants, Inc. (TKEC) visited the vacant residence located at 2222 Harding Ave. in Dayton, Ohio (subject property). The purpose of the visit was to perform a pre-demolition asbestos survey of the structure to identify asbestos containing materials (ACMs) located in the structure prior to demolition activities being performed.

2222 Harding Ave.
 Pre-Demolition Asbestos Survey
 Table I - Bulk Sample Data Summary

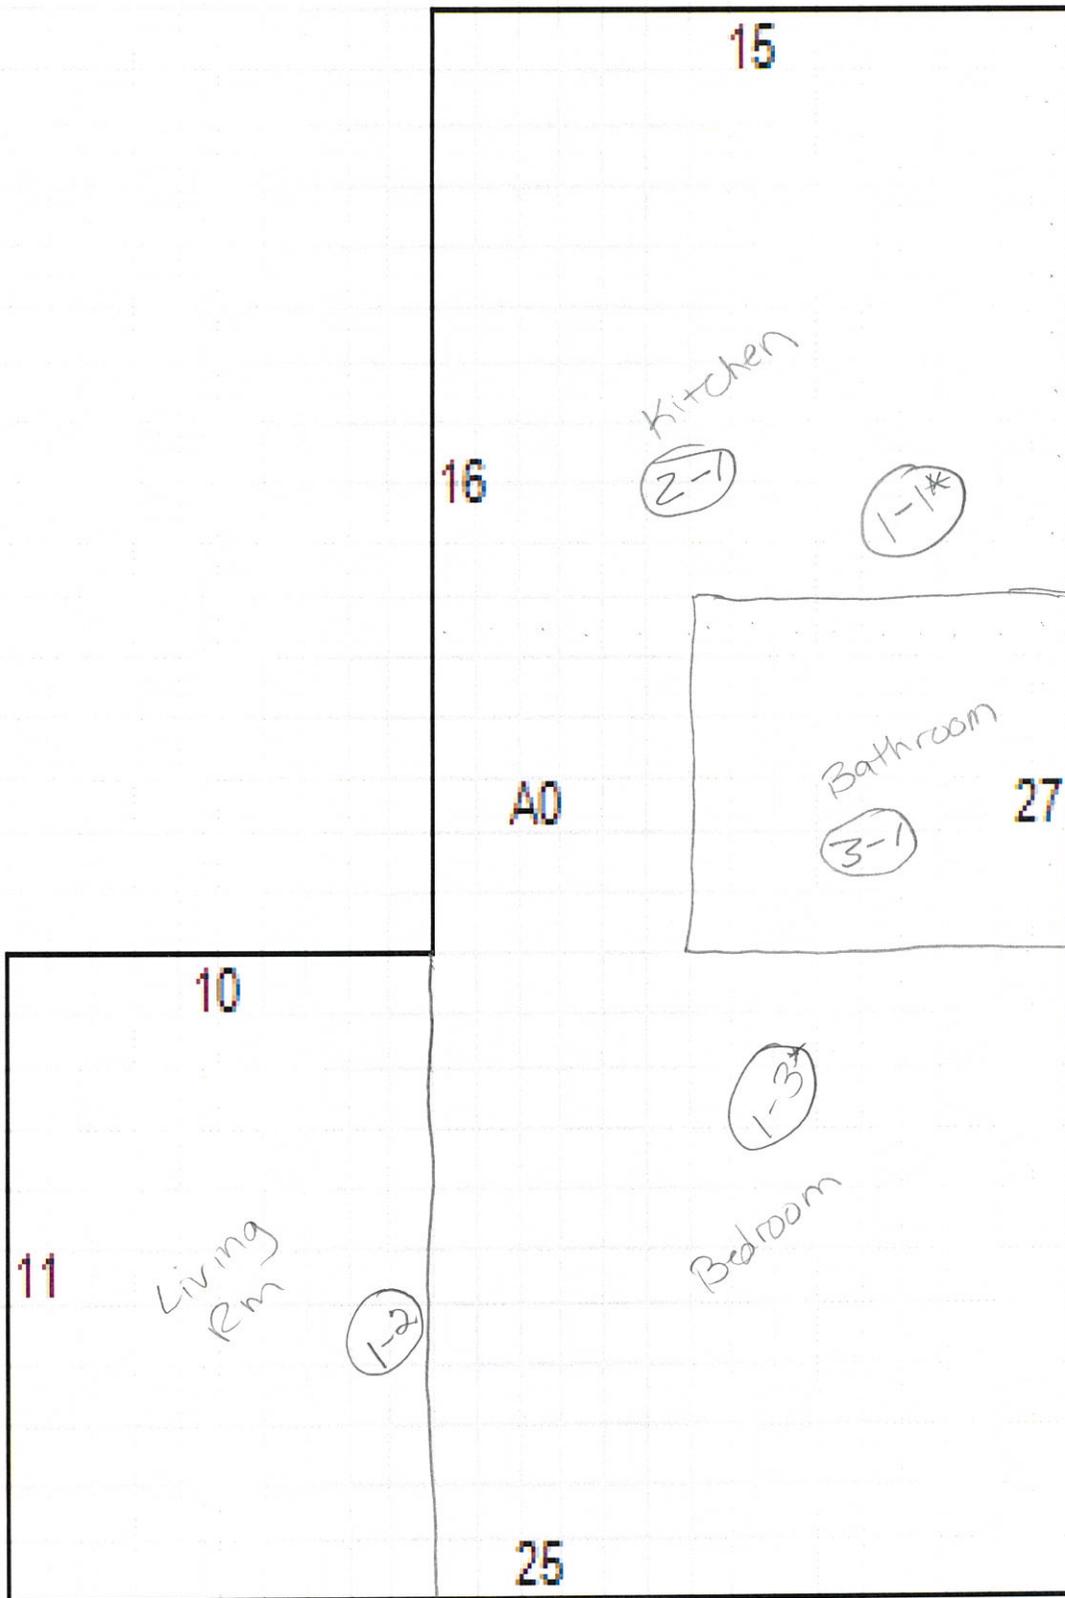
Floor 1

1-1 Approximate
Sample Location

1-1* Asbestos > 1%

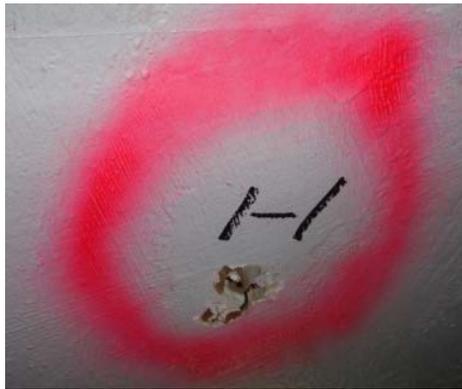
Sample 1-1 Drywall/Skim Coat

Two (2) drywall/joint compound samples contained 2% asbestos, and were subsequently analyzed by EPA PLM 400 Point Count. One (1) sample was determined to contain 1% chrysotile asbestos and one (1) sample was determined to contain 0.75% chrysotile asbestos. This material will not need to be abated from the structure prior to demolition.

Homogeneous Area					Quantity & Condition			
Sample Description (Material Type)	Sample Location	NSHAP Category	ACM Type	Bulk Sample No.	Good	Fair	Poor	Asbestos Content
Drywall/Joint Compound - Joint Compound	Kitchen Ceiling	Cat 2 Non Friable	Misc	1-1				1% Chrysotile
Drywall/Joint Compound - Joint Compound	Bedroom Ceiling	Cat 2 Non Friable	Misc	1-3				0.75% Chrysotile

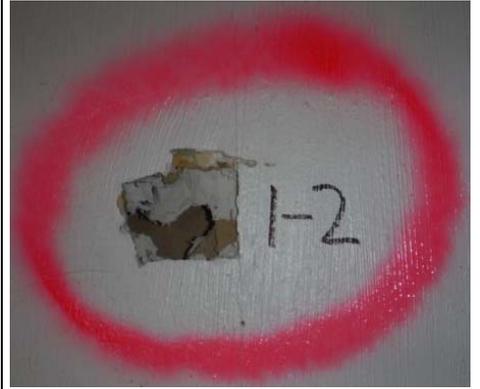
Sample 1-2 Drywall/Skim Coat

SanAir ID / Description	Stereoscopic Appearance	Components		Asbestos Fibers
		% Fibrous	% Non-Fibrous	
1-2 / 15025209-002 Drywall/ Skim Coat Living Room Wall, Drywall	Grey Non-Fibrous Homogeneous	5% Cellulose	95% Other	None Detected
1-2 / 15025209-002 Drywall/ Skim Coat Living Room Wall, Joint Compound	Tan Non-Fibrous Homogeneous		100% Other	None Detected

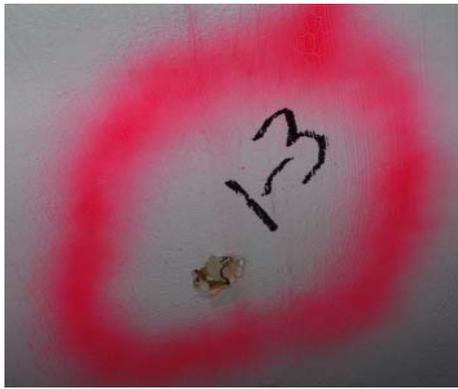
Sample 1-3 Drywall/Skim Coat

SanAir ID / Description	Stereoscopic Appearance	Components		Asbestos Fibers
		% Fibrous	% Non-Fibrous	
1-3 / 15025209-003 Drywall/ Skim Coat Bedroom Ceiling, Drywall	Grey Non-Fibrous Homogeneous	5% Cellulose	95% Other	None Detected
1-3 / 15025209-003 Drywall/ Skim Coat Bedroom Ceiling, Joint Compound	Tan Non-Fibrous Homogeneous		98% Other	2% Chrysotile

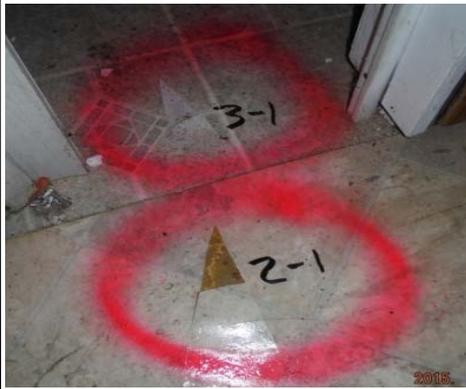
Sample 2-1 & 31, Linoleum Flooring

SanAir ID / Description	Stereoscopic Appearance	Components		Asbestos Fibers
		% Fibrous	% Non-Fibrous	
2-1 / 15025209-004 Linoleum Flooring Kitchen (12x15) & (6x6)	Cream Non-Fibrous Homogeneous		100% Other	None Detected

SanAir ID / Description	Stereoscopic Appearance	Components		Asbestos Fibers
		% Fibrous	% Non-Fibrous	
3-1 / 15025209-005 Linoleum Flooring Bathroom (6x9)	Cream Non-Fibrous Homogeneous	20% Cellulose	80% Other	None Detected

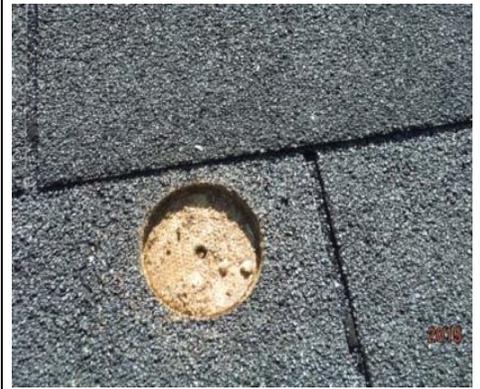
Sample 4-1 Roofing Shingles

SanAir ID / Description	Stereoscopic Appearance	Components		Asbestos Fibers
		% Fibrous	% Non-Fibrous	
4-1 / 15025209-006 Roofing 3 Layers Roof, Shingle	Black Non-Fibrous Heterogeneous		100% Other	None Detected
4-1 / 15025209-006 Roofing 3 Layers Roof, Shingle	Black Non-Fibrous Heterogeneous		100% Other	None Detected
4-1 / 15025209-006 Roofing 3 Layers Roof, Felt	Black Fibrous Homogeneous	60% Cellulose	40% Other	None Detected
