RE: Comprehensive Pre-Demolition Asbestos Survey, NOP TK-25, Vacant Residence, 2171 Malvern Avenue, Dayton, OH, TKEC Project #TK-25E

### **EXECUTIVE SUMMARY**

## **DESCRIPTION OF BUILDING SURVEY AND SAMPLING METHODOLOGY**

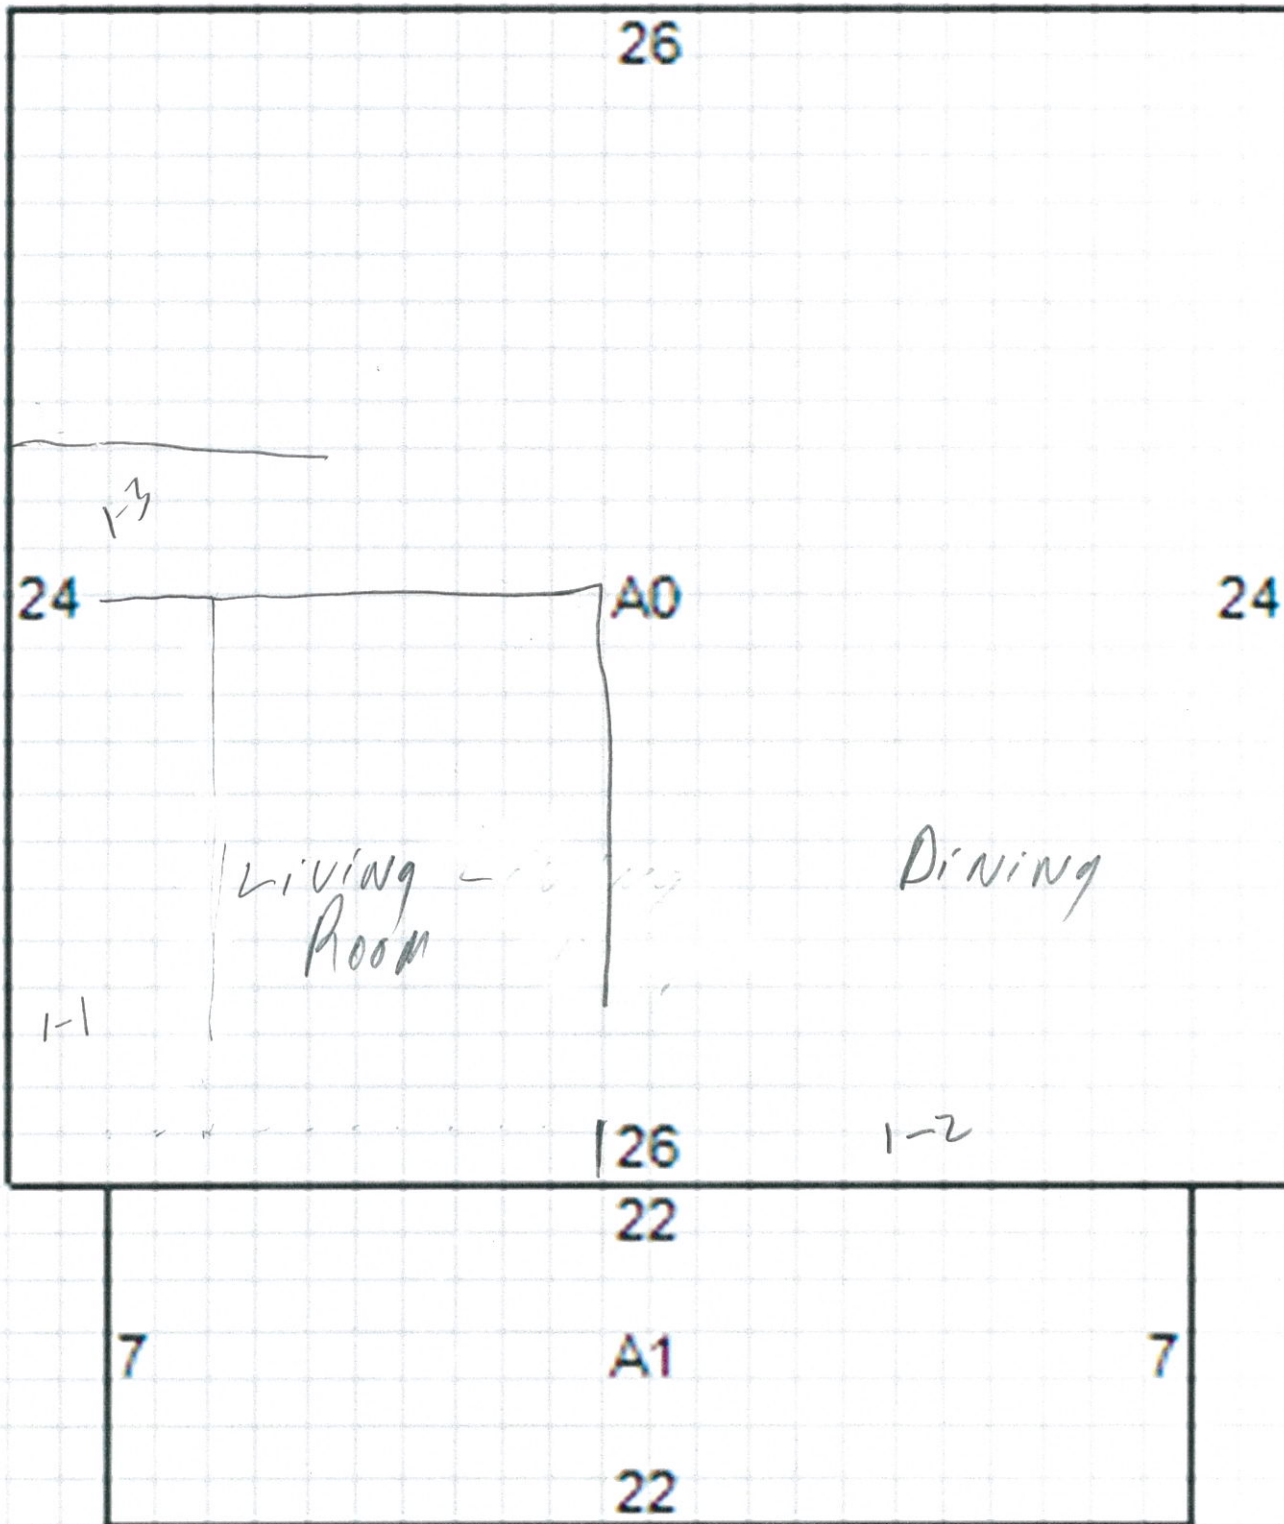
1-1 Approximate  
Sample Location

1-1\* Asbestos > 1%

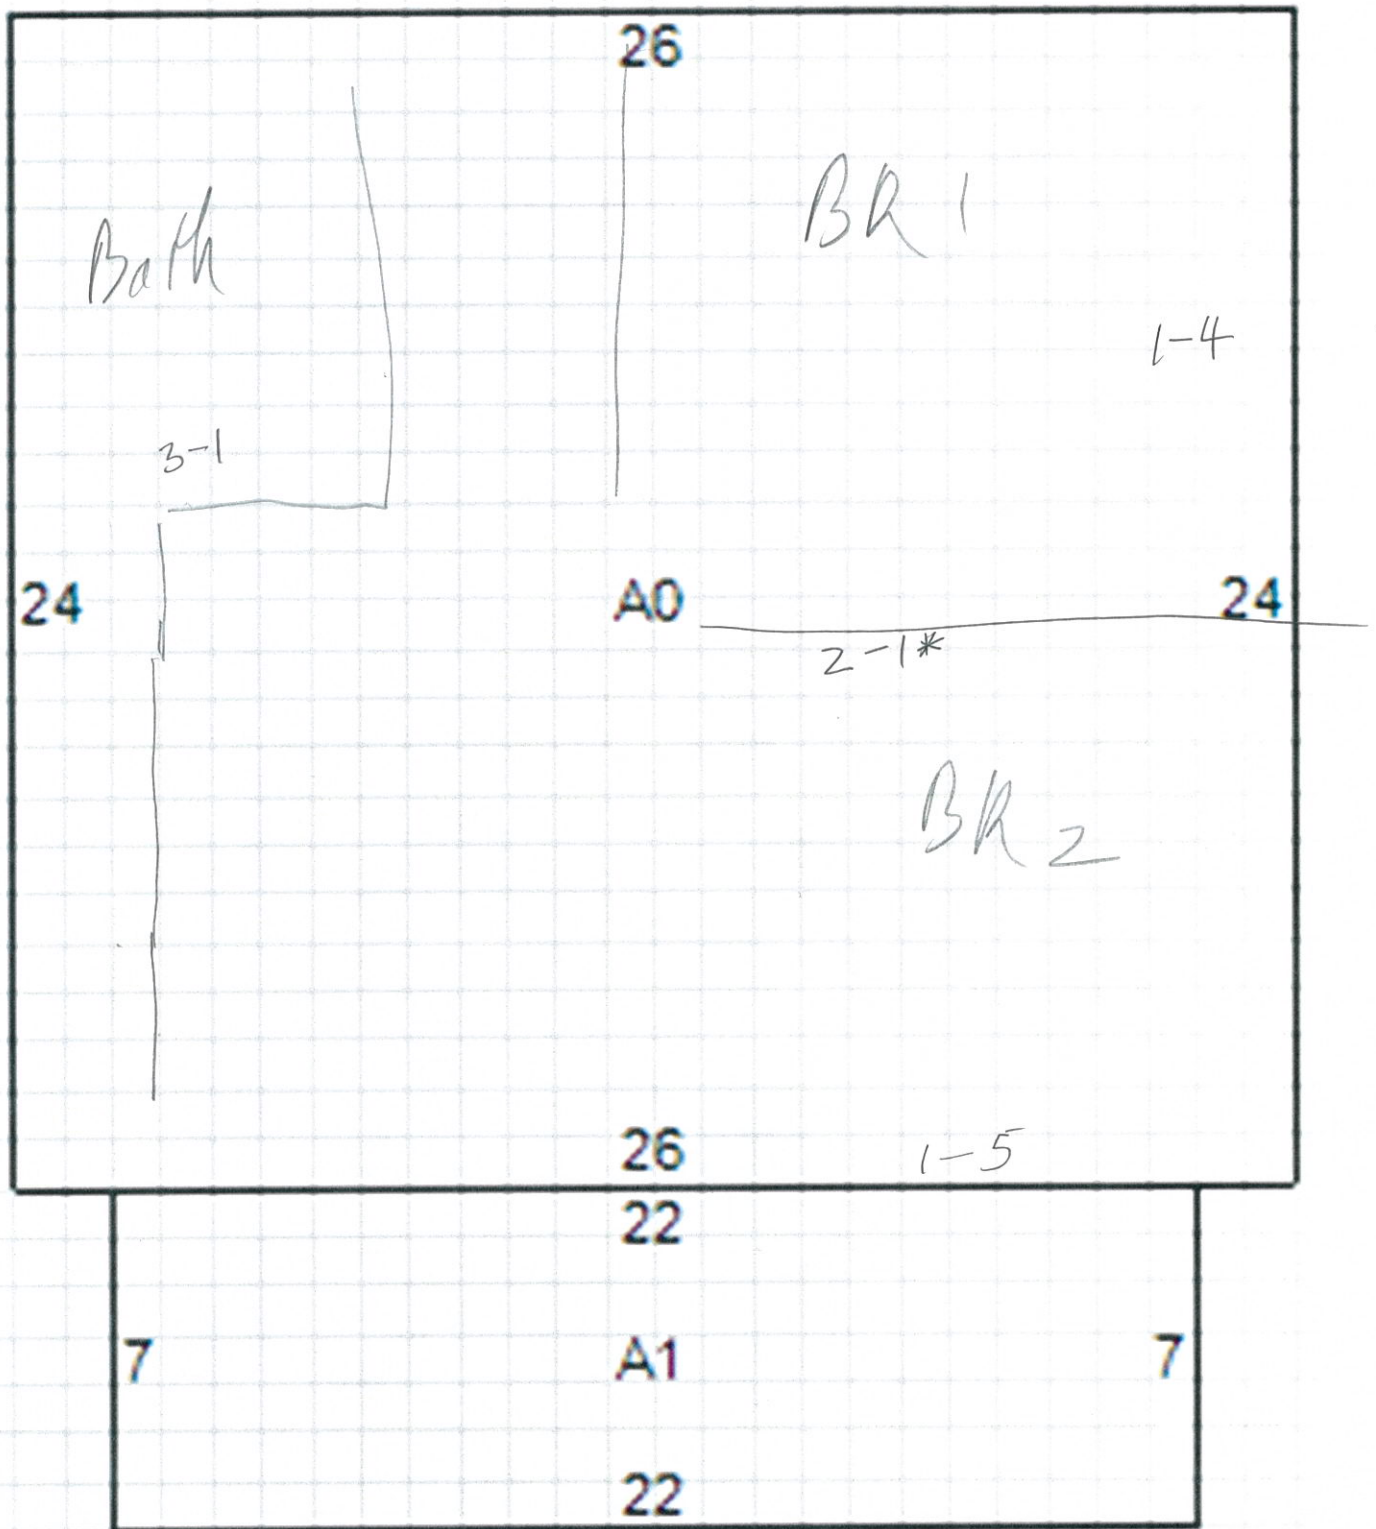
1-1 Approximate  
Sample Location

1-1\* Asbestos > 1%

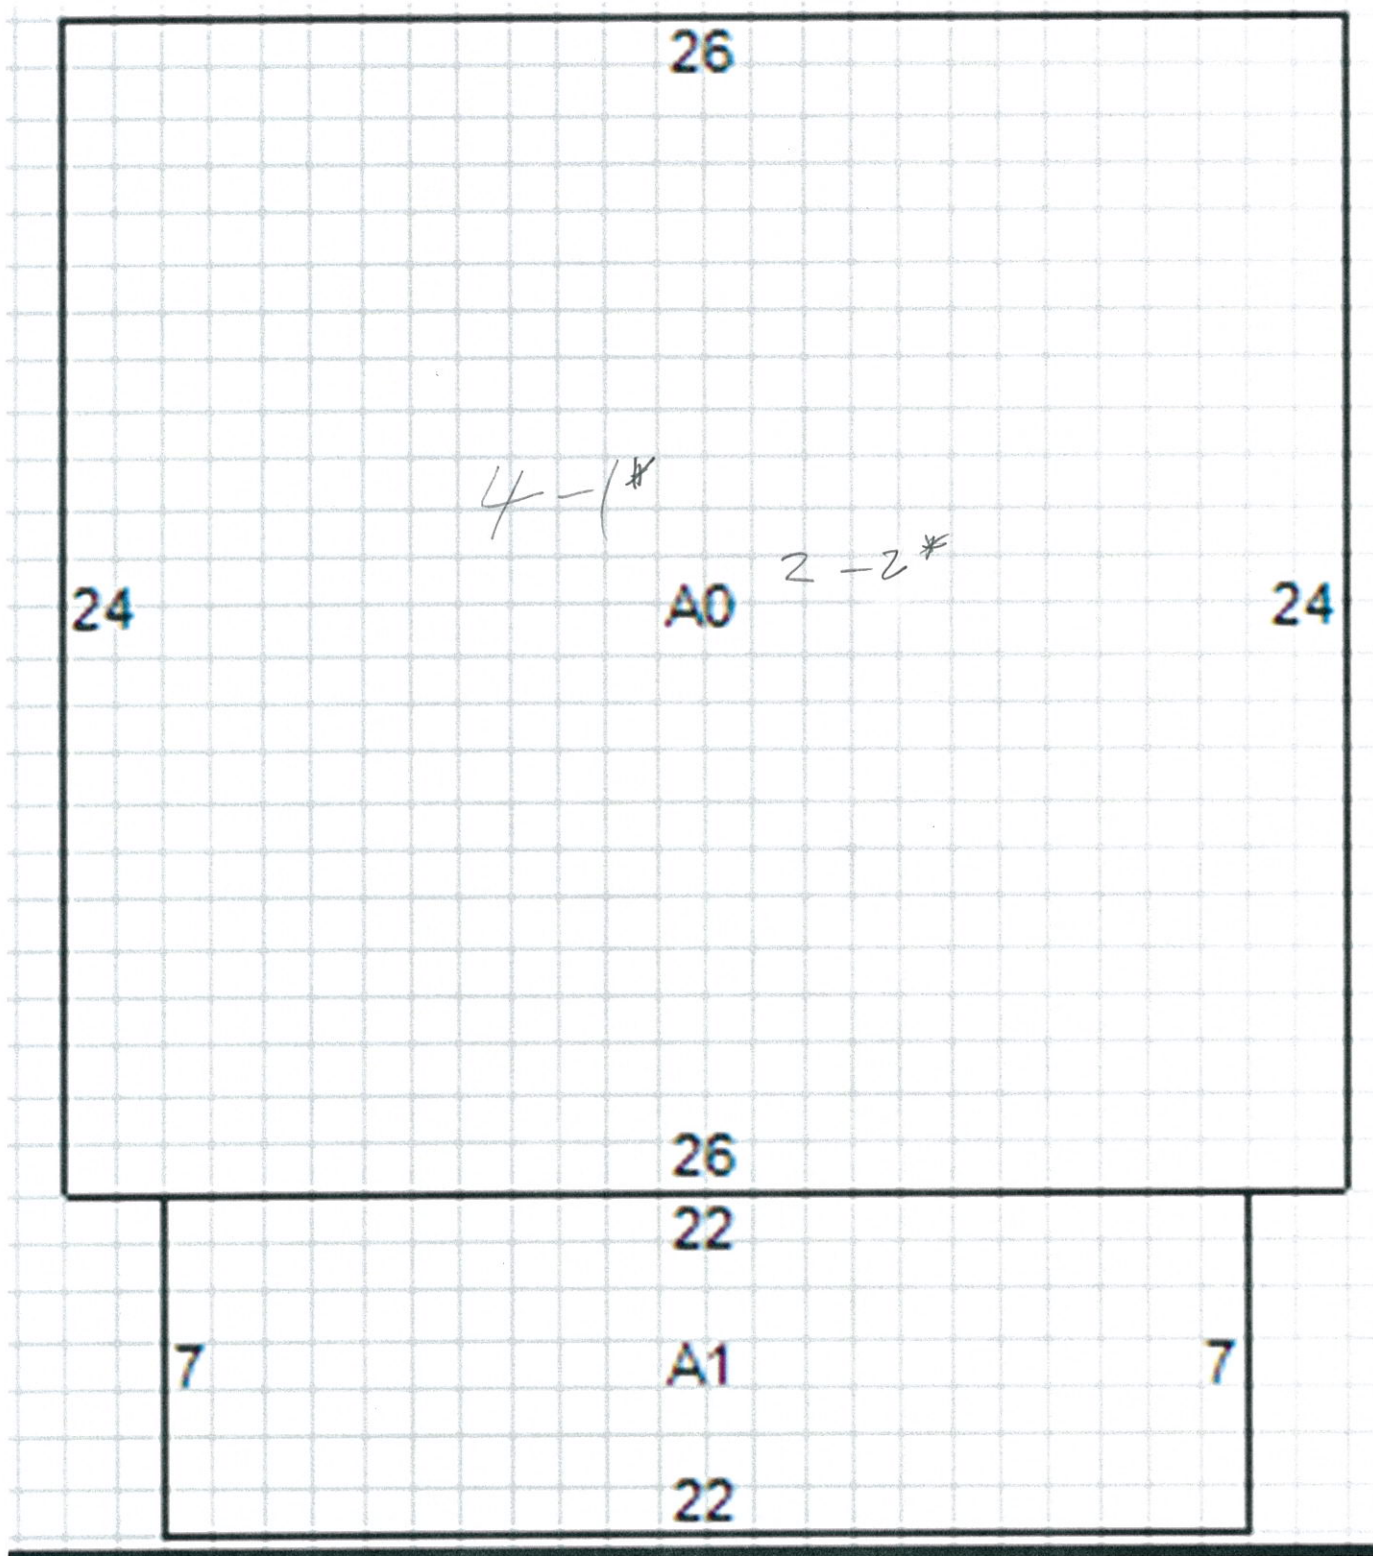
3 Risers to 2<sup>nd</sup> Floor

1-1 Approximate  
Sample Location

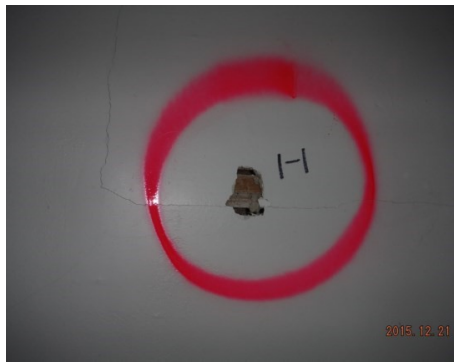
| Homogeneous Area | | | | | Quantity & Condition | | | |
|---|---|---|---|---|---|---|---|---|
| Plaster/Skim Coat - Plaster | Living Room | | | 1-1 | | | | <1% Chrysotile |

| Homogeneous Area | | | | | Quantity & Condition | | | |
|---|---|---|---|---|---|---|---|---|
| Plaster/Skim Coat - Plaster | Living Room | | | 1-1 | | | | <0.25%<br>Chrysotile |

Sample 1-1 Plaster/Skim Coat

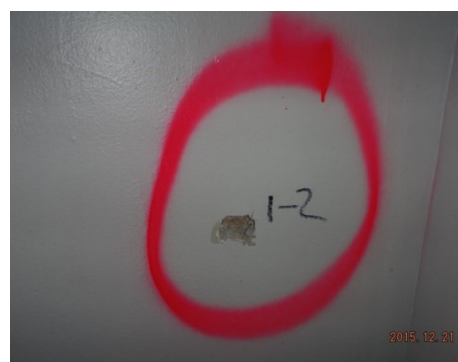
| Homogeneous Area | | | | | Quantity & Condition | | | |
|---|---|---|---|---|---|---|---|---|
| Plaster/Skim Coat - Plaster | Dining Room | | | 1-2 | | | | <1% Chrysotile |

| Homogeneous Area | | | | | Quantity & Condition | | | |
|---|---|---|---|---|---|---|---|---|
| Plaster/Skim Coat - Plaster | Dining Room | | | 1-2 | | | | 0.25%<br>Chrysotile |

Sample 1-2 Plaster/Skim Coat

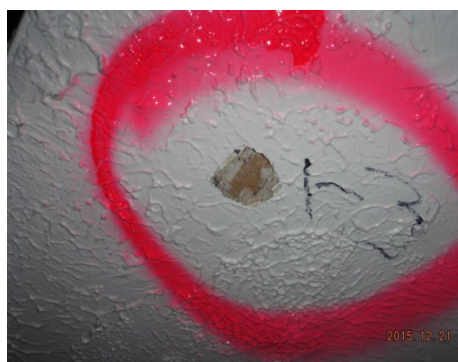
| Homogeneous Area | | | | | Quantity & Condition | | | |
|---|---|---|---|---|---|---|---|---|
| Plaster/Skim Coat - Plaster | Stairway Ceiling | | | 1-3 | | | | <1% Chrysotile |

| Homogeneous Area | | | | | Quantity & Condition | | | |
|---|---|---|---|---|---|---|---|---|
| Plaster/Skim Coat - Plaster | Stairway Ceiling | | | 1-3 | | | | <0.25%<br>Chrysotile |

Sample 1-3 Plaster/Skim Coat

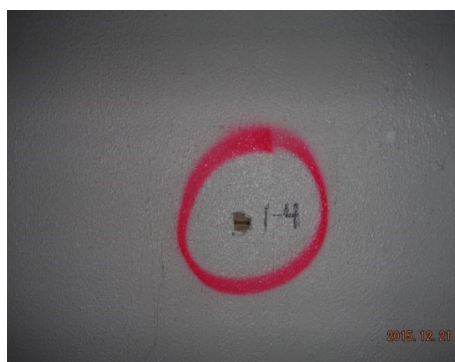
| Homogeneous Area | | | | | Quantity & Condition | | | |
|---|---|---|---|---|---|---|---|---|
| Plaster/Skim Coat - Plaster | 2nd Floor Bedroom 1 | | | 1-4 | | | | NAD |

Sample 1-4 Plaster/Skim Coat

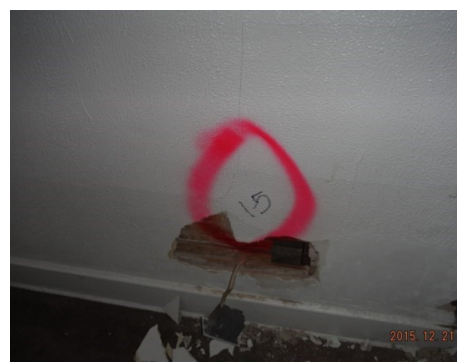
| Homogeneous Area | | | | | Quantity & Condition | | | |
|---|---|---|---|---|---|---|---|---|
| Plaster/Skim Coat - Plaster | 2nd Floor Bedroom 2 | | | 1-5 | | | | <1% Chrysotile |

| Homogeneous Area | | | | | Quantity & Condition | | | |
|---|---|---|---|---|---|---|---|---|
| Plaster/Skim Coat - Plaster | 2nd Floor Bedroom 2 | | | 1-5 | | | | <0.25%<br>Chrysotile |

Sample 1-5 Plaster/Skim Coat

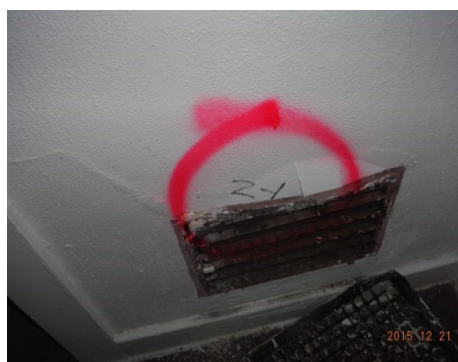
- **Duct Wrap, [Throughout House and Basement], [Fair], [144 SF]**
- **Heat Shield, [Basement], [Fair], [4 SF]**

| Homogeneous Area | | | | | Quantity & Condition | | | |
|---|---|---|---|---|---|---|---|---|
| <b>Duct Wrap</b> | <b>Bedroom 2</b> | <b>Cat II Non Friable</b> | <b>Misc.</b> | <b>2-1</b> | | <b>144 SF</b> | | <b>65% Chrysotile</b> |

Sample 2-1 Duct Wrap

2. Trained workers and supervisors certified by the Ohio Department of Health must be used to remove the identified asbestos-containing building materials using special procedures and protective equipment to ensure that workers are not overexposed to airborne asbestos.

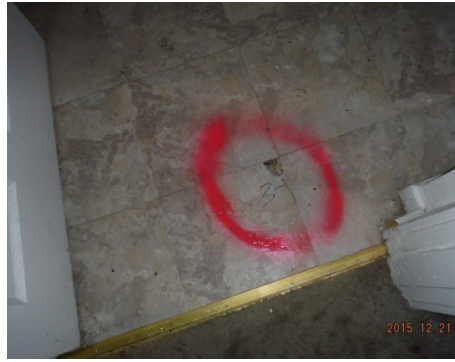
| Homogeneous Area | | | | | Quantity & Condition | | | |
|---|---|---|---|---|---|---|---|---|
| Floor Tile/Mastic - Tile | Bathroom | | | 3-1 | | | | NAD |

| Homogeneous Area | | | | | Quantity & Condition | | | |
|---|---|---|---|---|---|---|---|---|
| Floor Tile/Mastic - Mastic | Bathroom | | | 3-1 | | | | NAD |

Sample 3-1 Floor Tile/Mastic
